Morro Bay National Estuary Program

Morro Bay Eelgrass Report 2020

December 2021

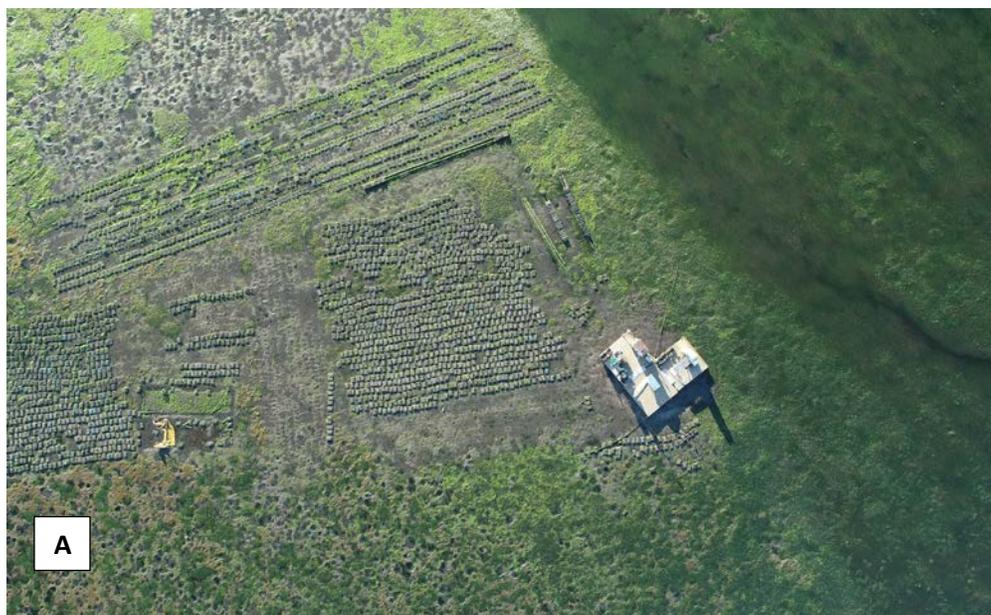
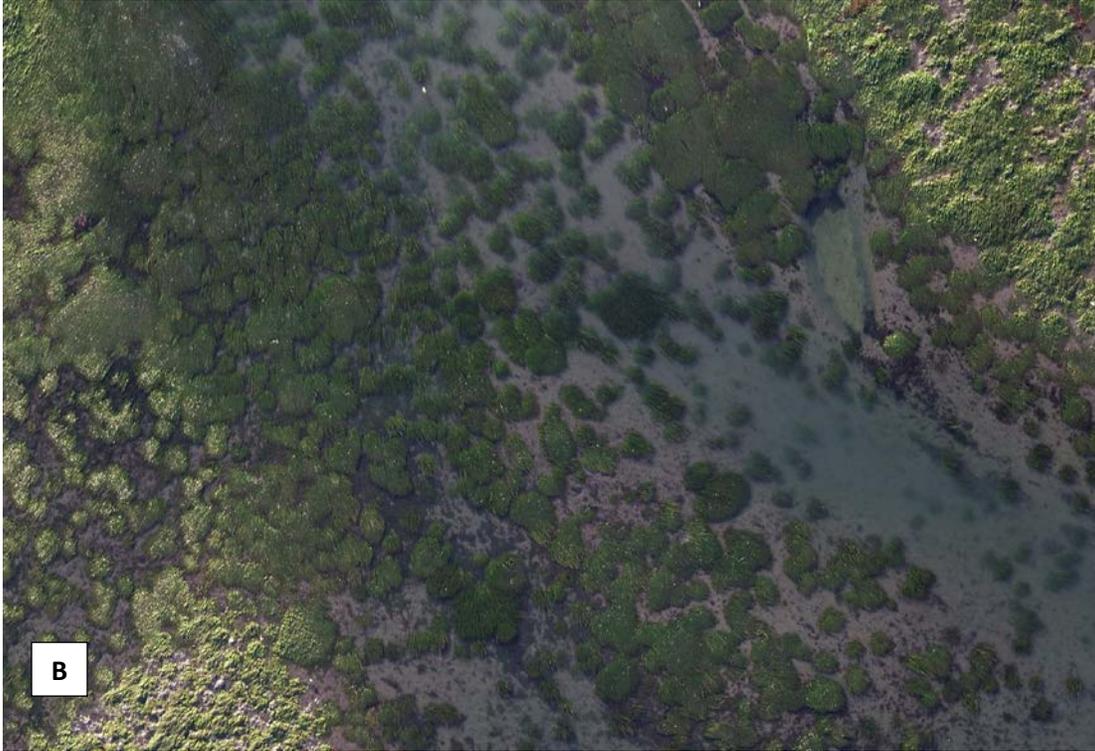
Figures 2A, 3B. Resolution of photos captured with Cal Poly’s UAV drone during fall of 2020. Figure 2A shows shellfish farm infrastructure, and Figure 2B shows a series of smaller patches of intertidal eelgrass.

During the fall of 2020, Cal Poly collected approximately 5,900 photos to produce a cohesive bay-wide map. The following images demonstrate the resolution of photos captured with the drone. Figure 2A shows shellfish farm infrastructure and Figure 2B shows sections of intermittent eelgrass. The dark green patches in each photo are eelgrass, and the lighter patches are algae.

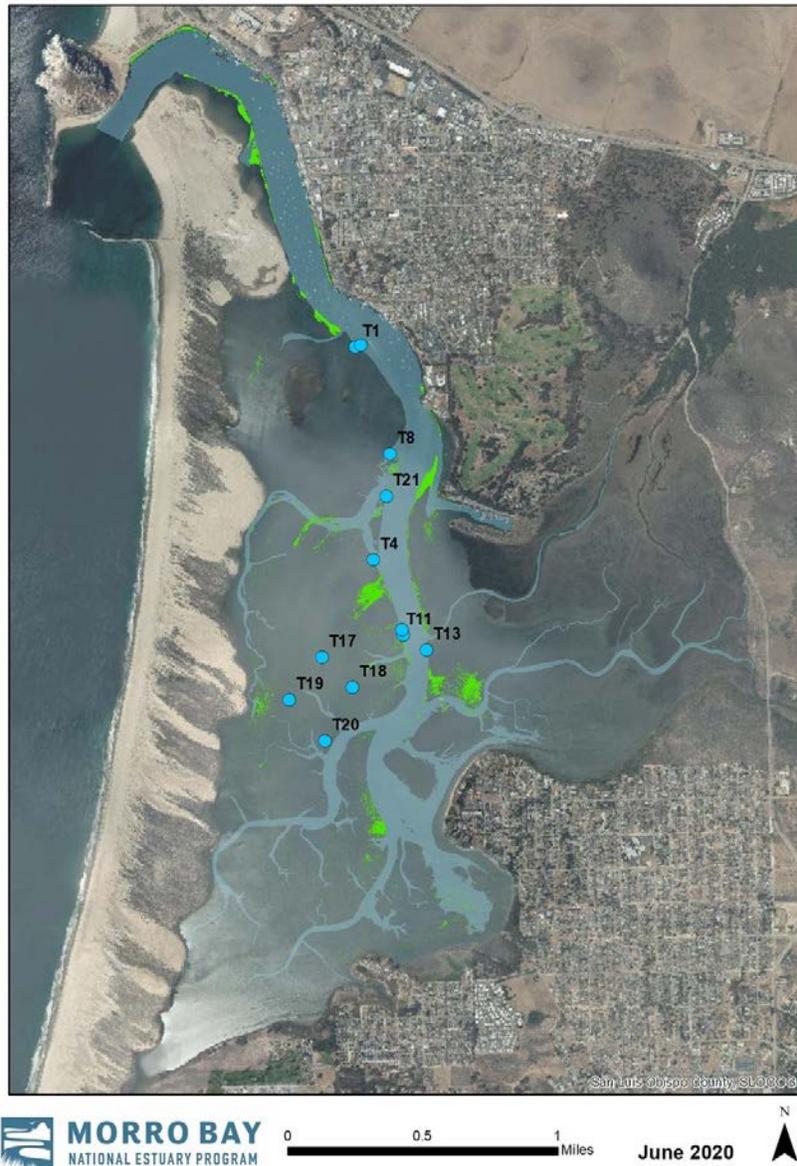
Figure 4. Map of 2020 eelgrass transplanting locations with 2019 eelgrass extent in green.

Eelgrass restoration efforts during 2020 included intertidal and subtidal eelgrass transplanting. Intertidal transplanting was completed on foot by Estuary Program staff and volunteers during February and March 2020, and subtidal eelgrass transplanting were completed by Tenera Environmental, Inc. (Tenera) during April and May 2020. All intertidal and subtidal restoration sites are outlined in the table below. Restoration locations for 2020 are visualized spatially in relation to the 2019 eelgrass extent in Figure 4.

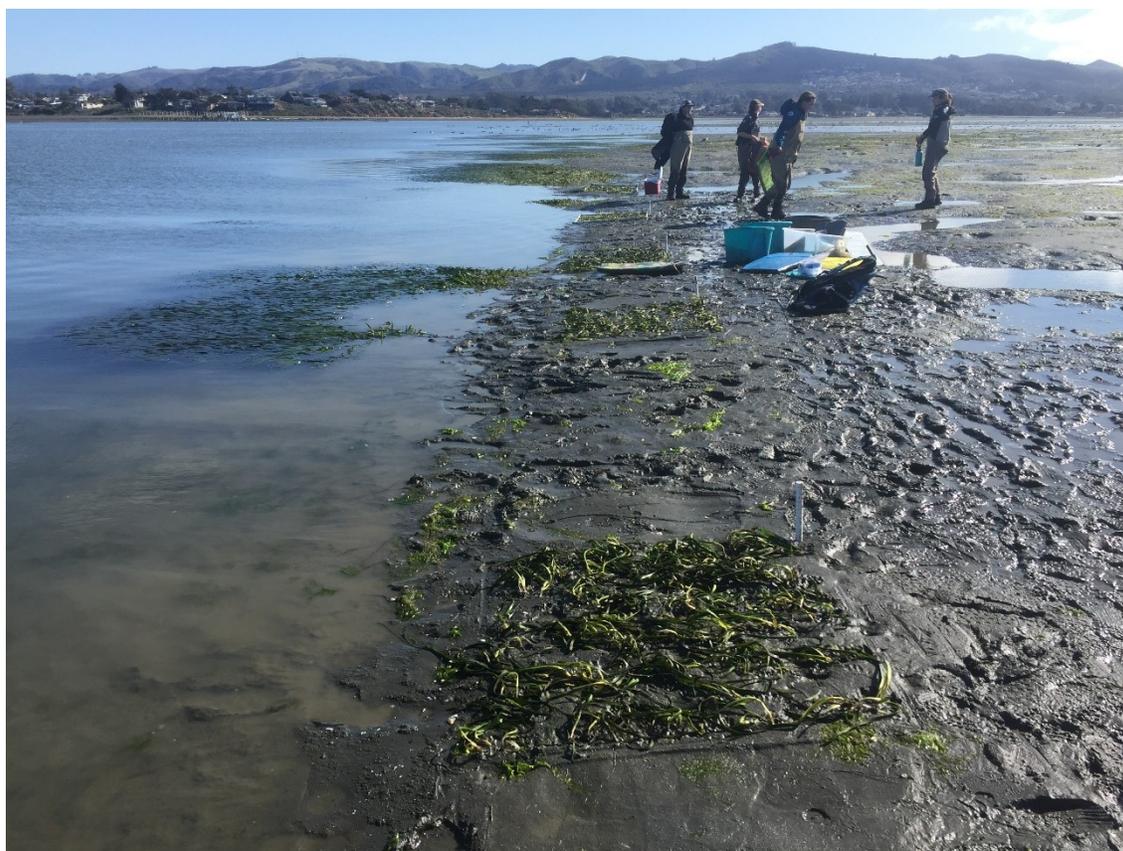
Figure 5. Example of an intertidal restoration site (T11) along the main tidal channel with five plots planted in March 2020.

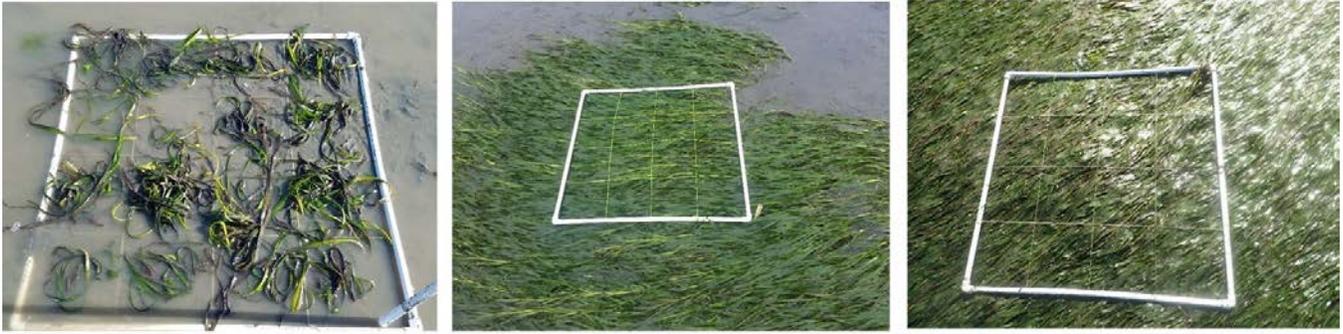
Figure 6. Example of Site T8 immediately after planting (left), approximately six months after (middle), and approximately one year after planting (right).

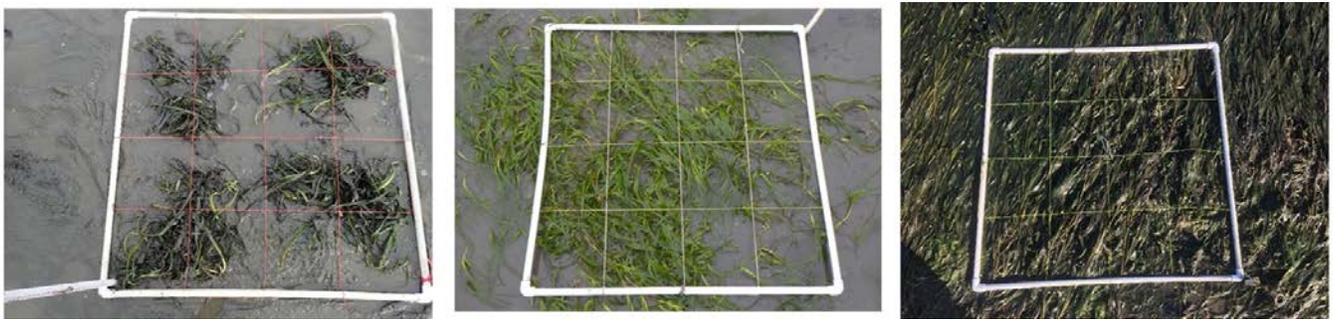
Figure 7. Example of Site T21 immediately after planting (left), approximately six months after (middle), and approximately one year after planting (right).

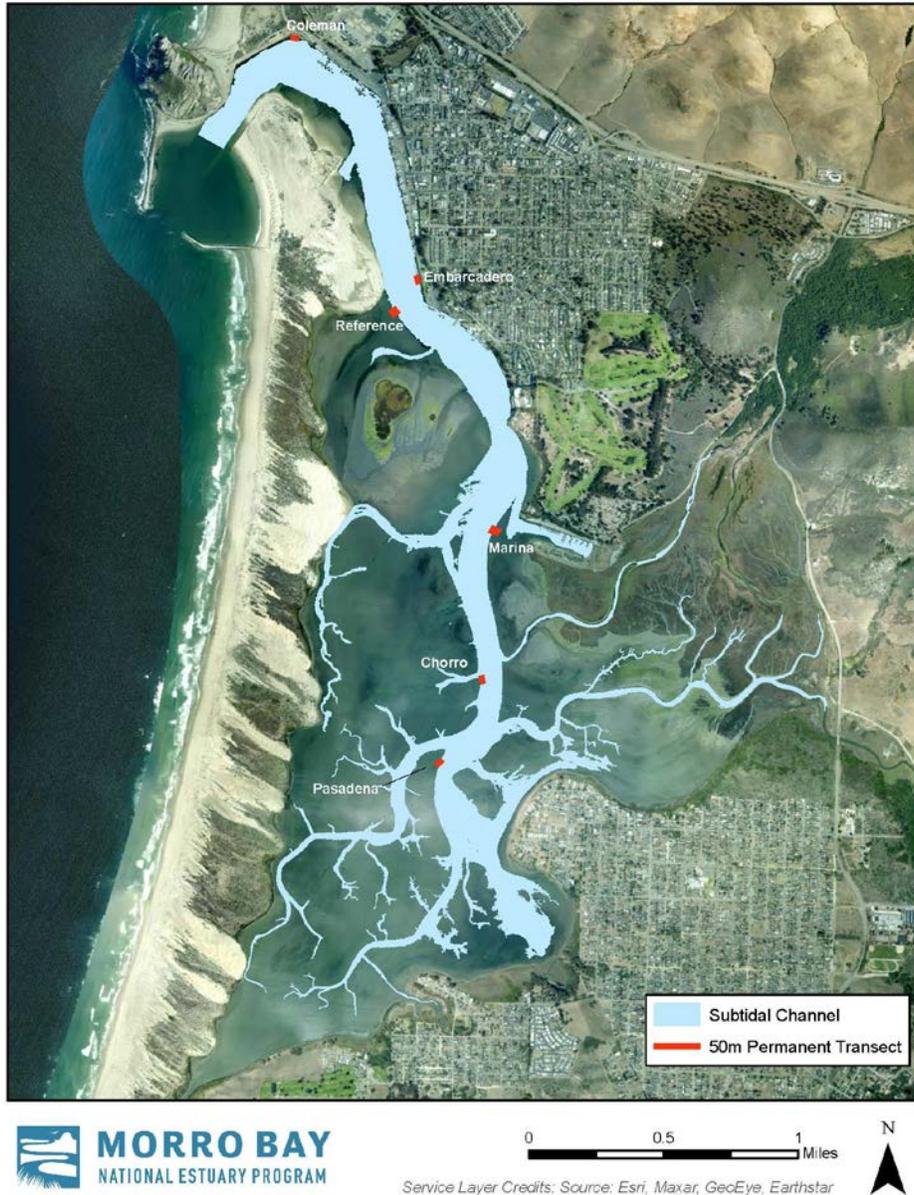
Figure 12. The six current permanent transect monitoring locations: Coleman, Embarcadero, Reference (previously named Tidelands), Marina, Chorro, and Pasadena.

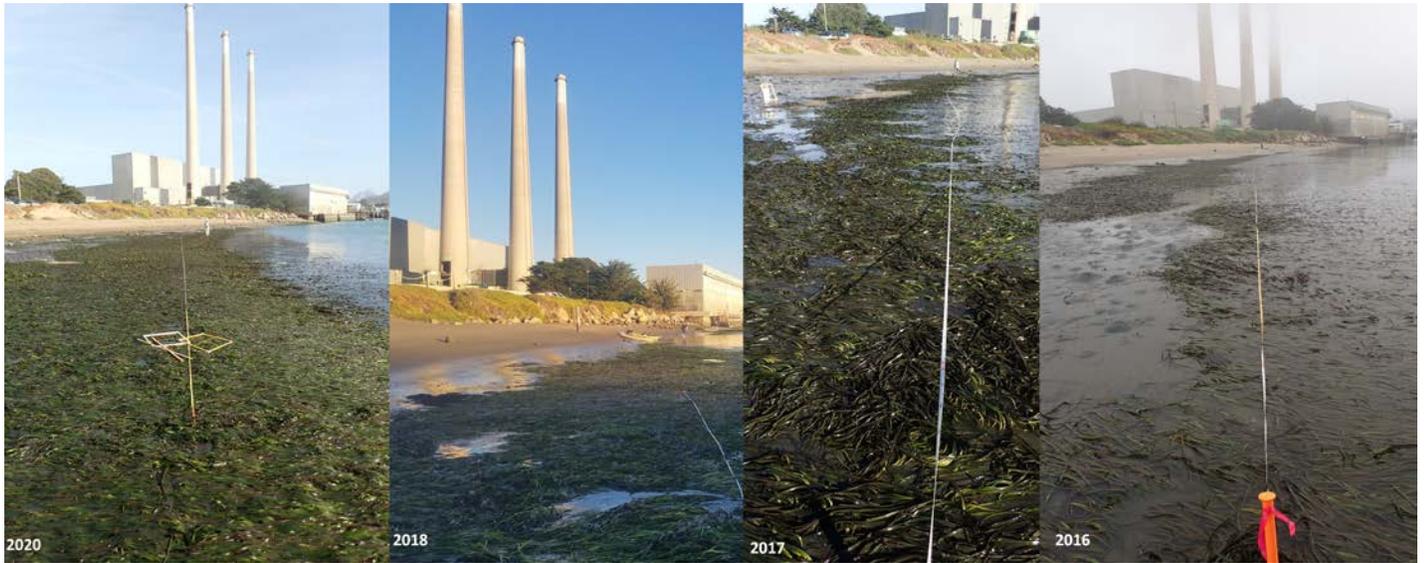
Figure 14. Coleman Transect, 2016 to 2020.

Eelgrass shoot density remained relatively stable at this transect from 2016 to 2019, with a slight density increase during 2020. This is documented in the photos below, although photos for 2019 are not available.

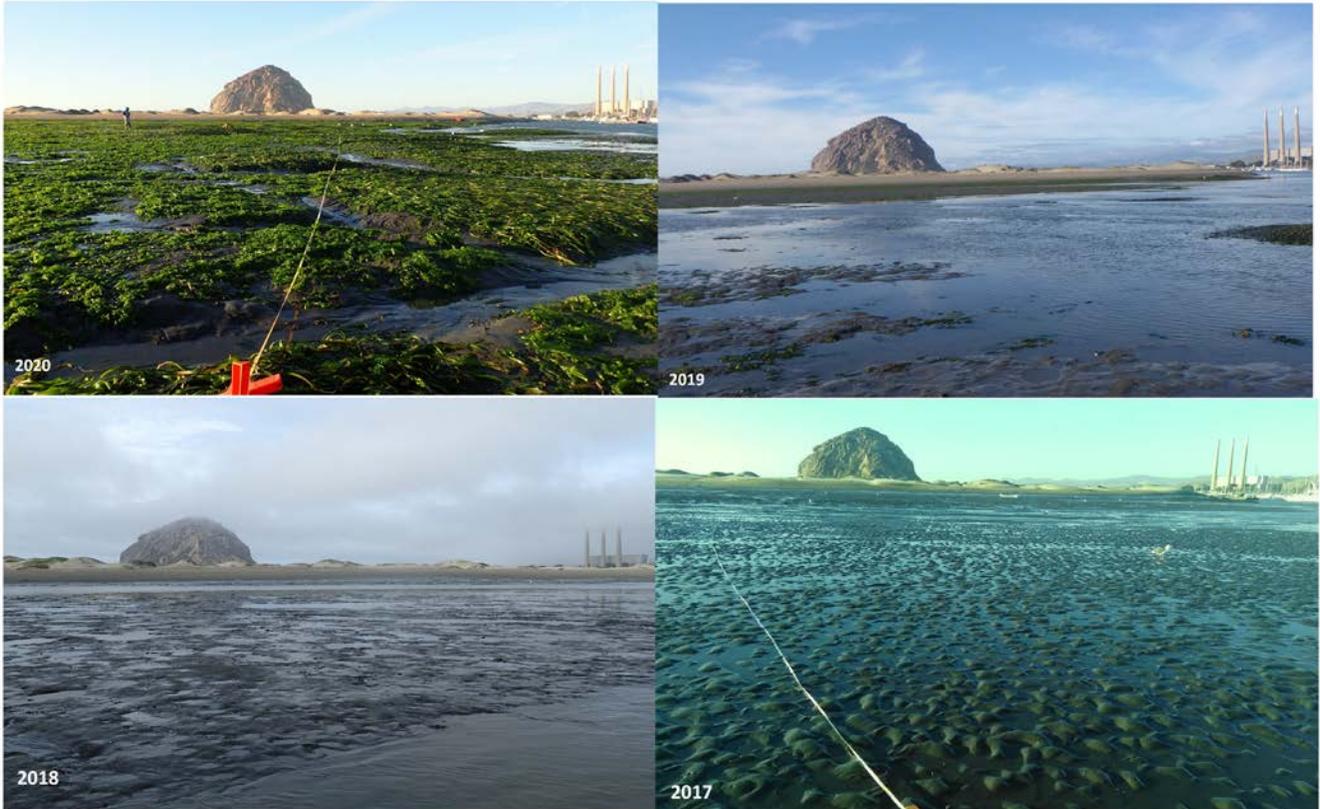
Figure 15. Reference Transect (previously “Tidelands”), 2017 to 2020.

Between 2017 and 2019, the Reference transect (previously known as Tidelands) had no eelgrass present on the transect itself. During 2019, new small patches of eelgrass were developing near the transect, and during 2020, many new patches of eelgrass had emerged. This eelgrass has grown at notably higher elevations than other sites, forming small, patchy eelgrass islands as seen in the photo below. Density counts from 2020 resemble that of 2013, but not of pre-decline levels.

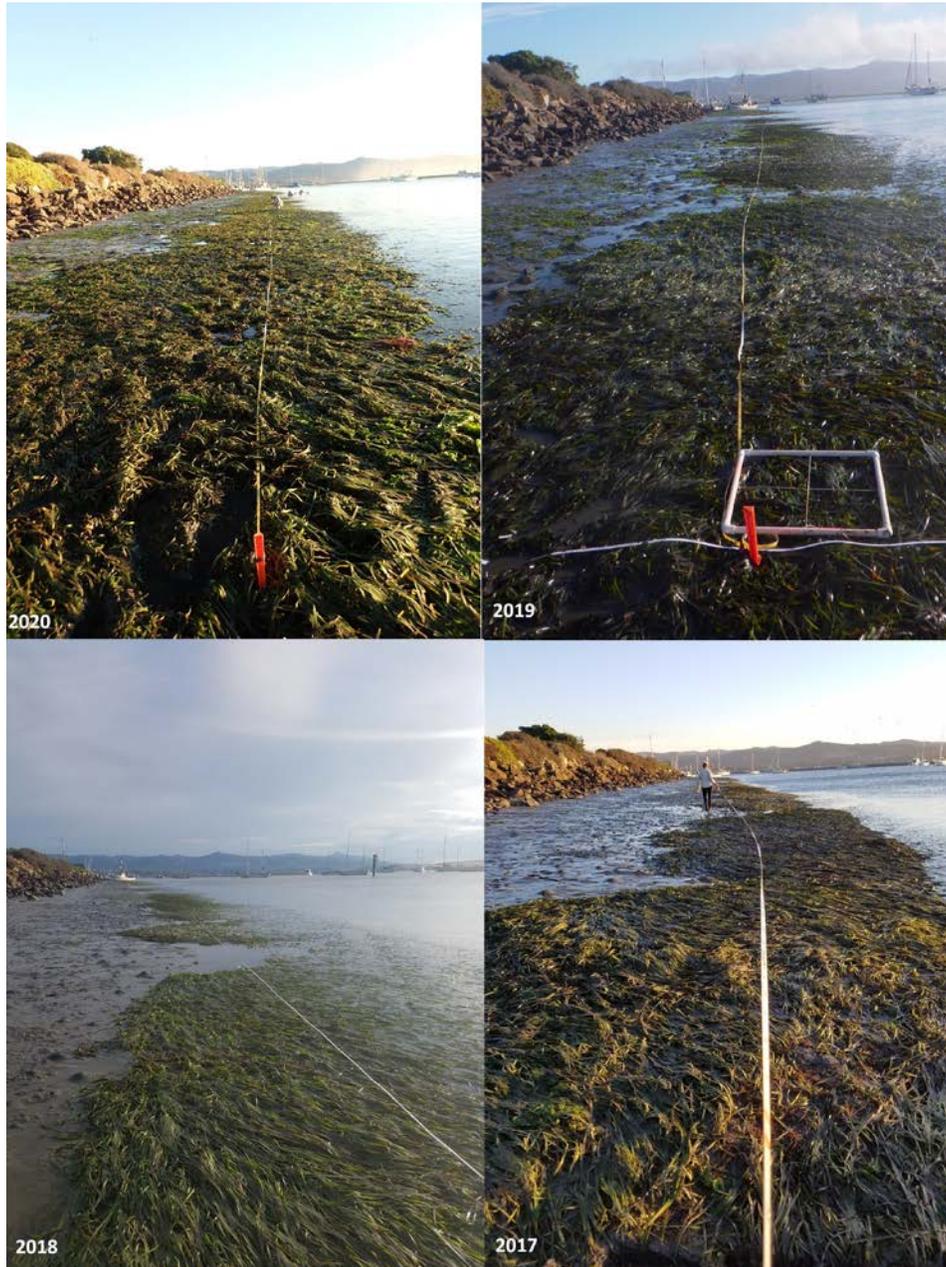
Figure 16. Embarcadero Transect, 2017 to 2020.

This transect was established in 2017 on the eastern side of the channel at Tidelands Park at the south end of the dock. Since then, the eelgrass bed has remained mostly continuous with a high shoot density and low density of epiphytes. During 2018, 2019, and 2020, the Embarcadero transect had the highest shoot density of all the sites. This site has been a harvest site for restoration efforts for multiple years, although there is no indication of impairment to the overall health of the bed.

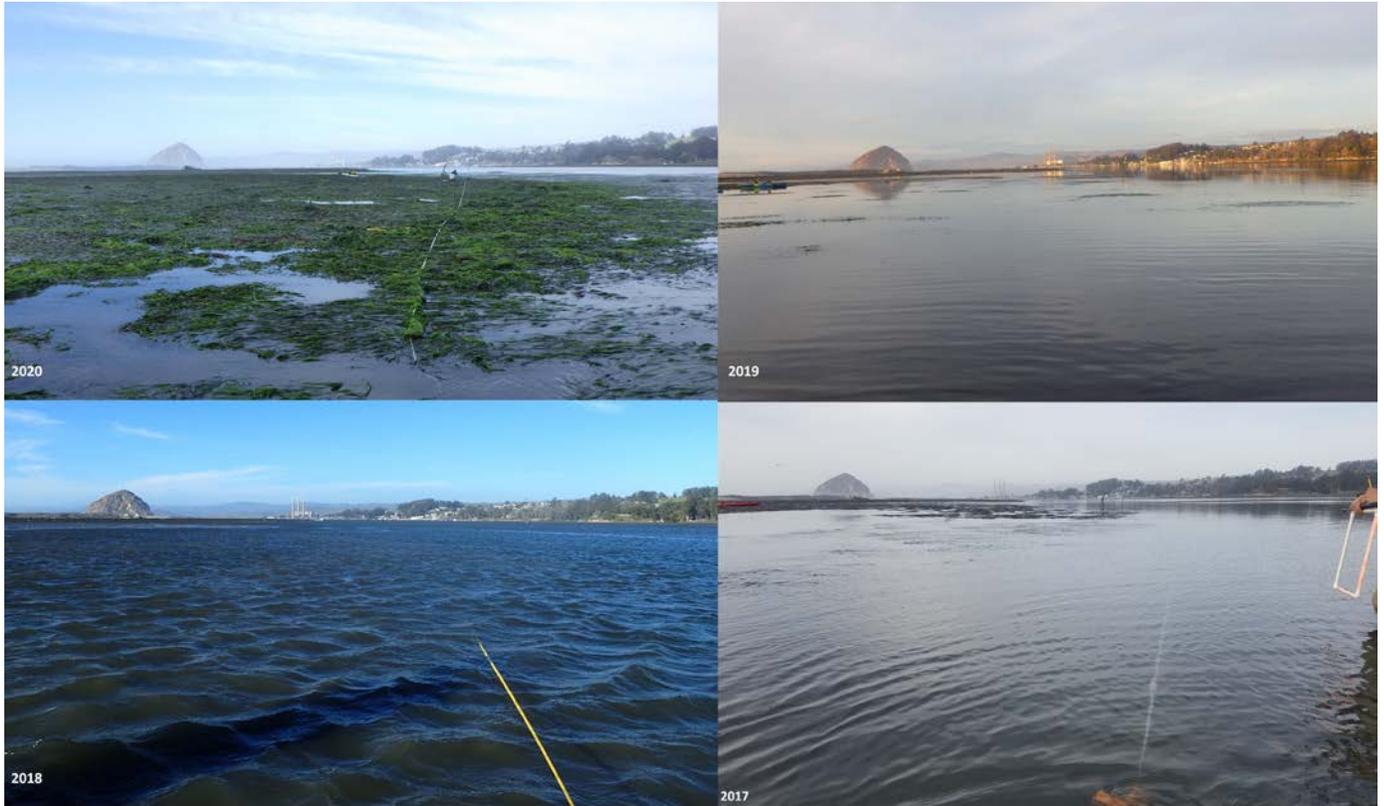
Figure 18. Chorro Transect, 2017 to 2020.

Of all the sites surveyed in 2020, the Chorro transect saw the most substantial shoot density increase. In 2018, no eelgrass was found, and during 2019, only one patch of eelgrass was found along the transect. During 2020, the shoot density reflected that of the Coleman transect, with an average shoot count of nearly 74 shoots per quadrat, up from an average of nearly 6 shoots per quadrat (see Figure 13).

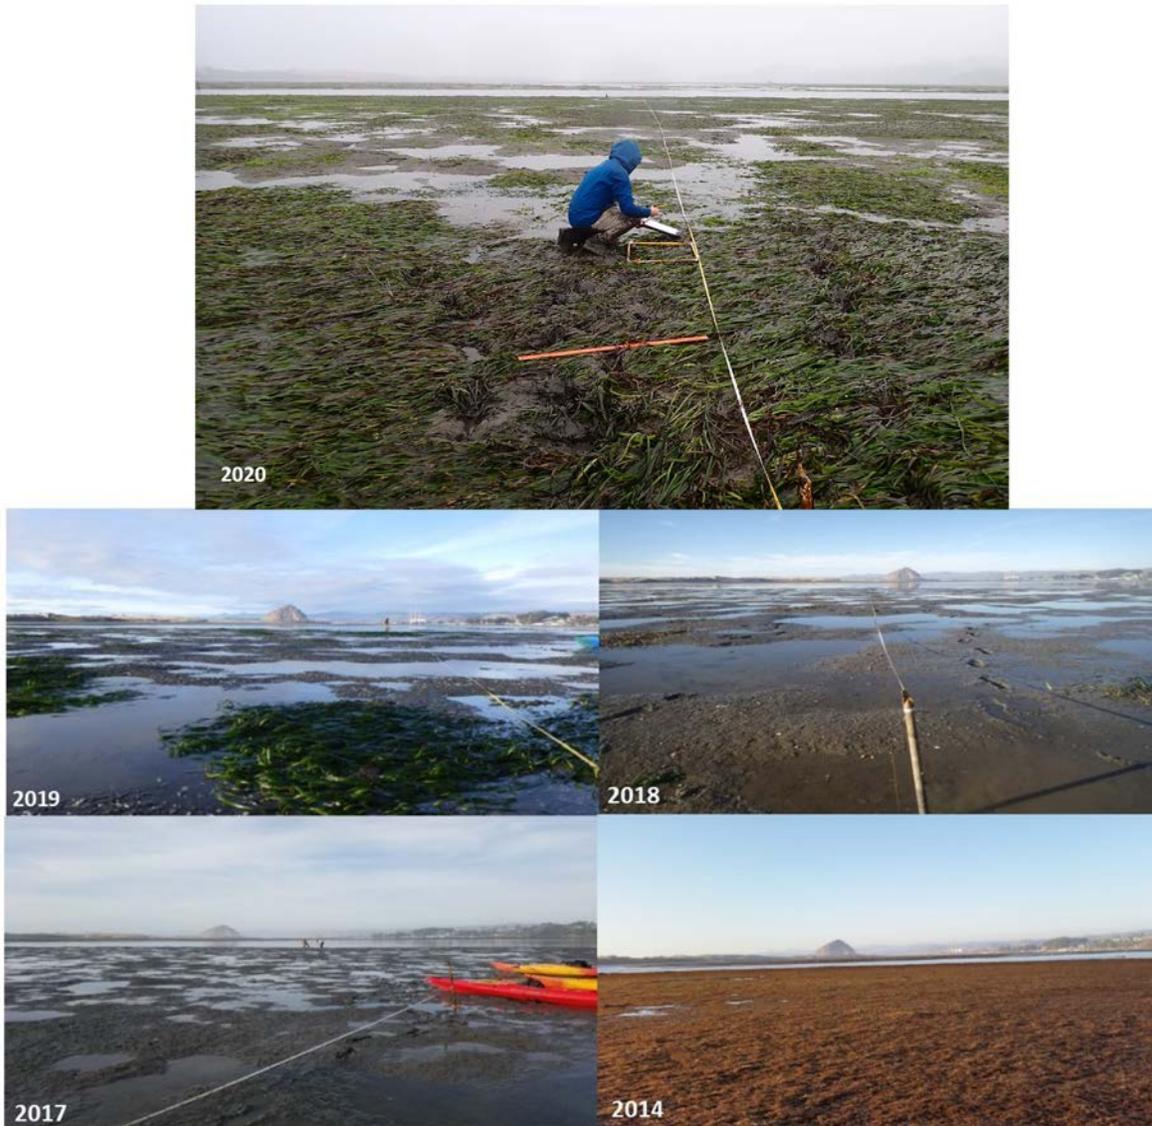
Figure 19. Pasadena Transect, 2014 to 2020.

The Pasadena transect also showed substantial change during 2020, with nearly triple the amount of eelgrass from the previous year. It appears that small patches of eelgrass have spread into one continuous eelgrass bed, with healthy blades and low epiphytic cover. Note that data prior to 2017 is no longer included in the graphs, due to uncertainty around the location of the transects.

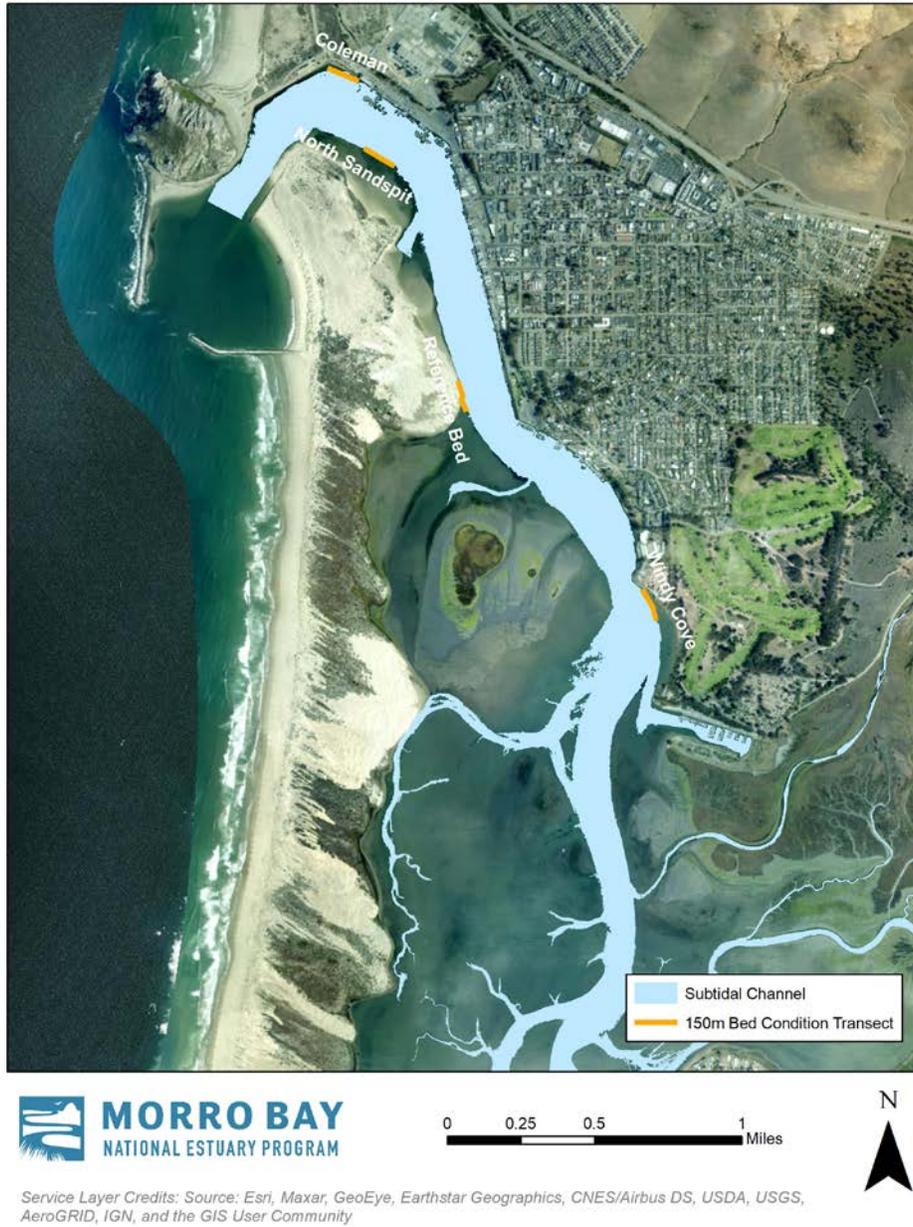
Figure 20. Bed condition monitoring sites at Coleman Beach, North Sand spit, Reference Bed, and Windy Cove.

Monitoring occurs at five significant beds in Morro Bay along a 150-meter, seven-quadrat survey. Both intertidal and subtidal eelgrass are surveyed, as much of the intertidal eelgrass was lost in the decline from 2009 to 2016. Monitoring has occurred twice per year since 2015, once in late fall and again in the spring. Due to the lack of adequately low tides during daylight hours during the fall, the fall monitoring was halted and monitoring only occurs in the spring.
