# STATE OF THE BAY | 2023

*A report on the health of the Morro Bay Estuary*

# How healthy are the estuary and the lands that surround it?

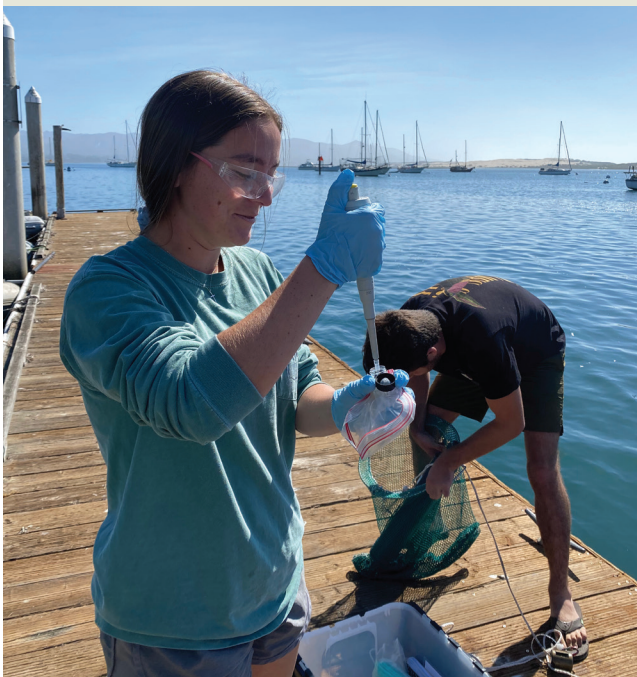
*Dr. Bockmon and her students collected water samples each month from six sites along the bay shoreline as part of the research effort. Samples were analyzed for nutrients and carbonate chemistry. Photo courtesy of Dr. Emily Bockmon.*

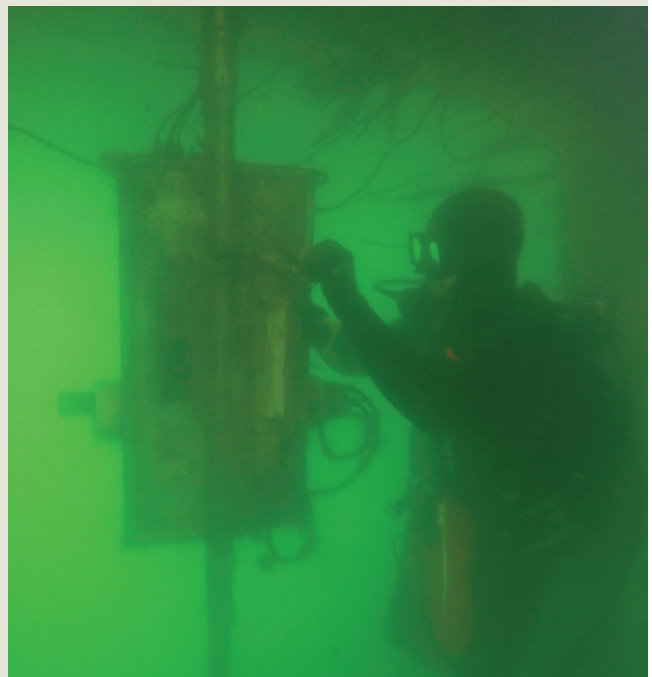
*Senior Research Scientist Ian Robbins conducted maintenance on a monitoring sensor station at the north T-pier that measures water quality parameters such as temperature, pH, oxygen, and salinity. Photo courtesy of Dr. Ryan Walter.*

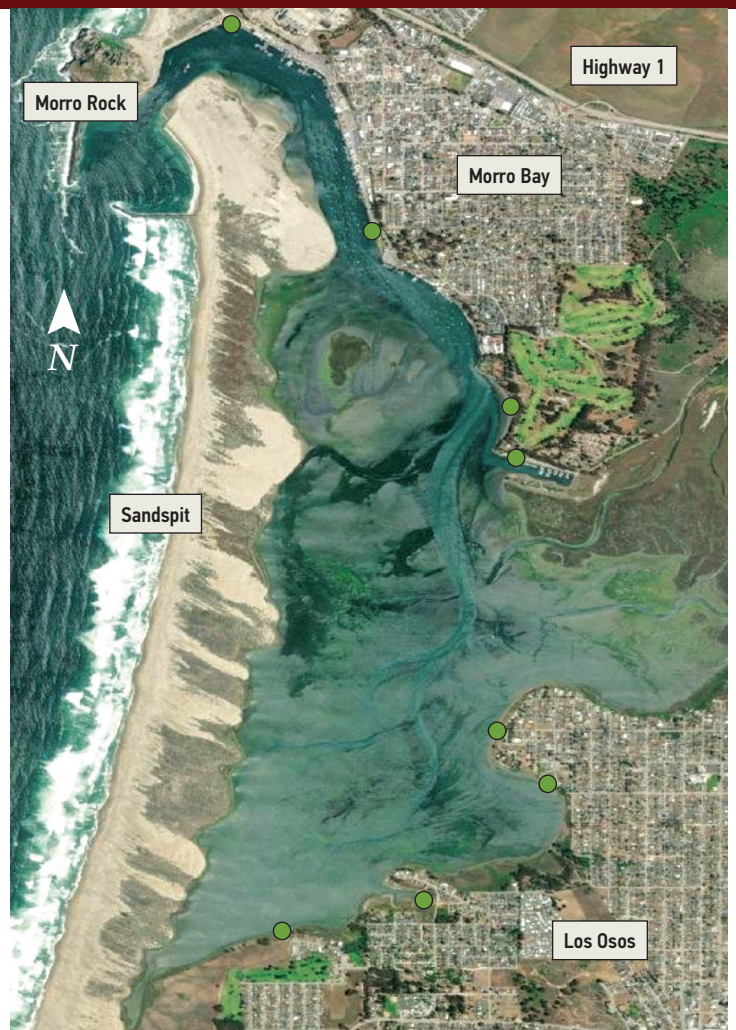
### Bay Bacteria Status

This map shows the safe swimming status of eight bay sites using data from 2005 through 2021. The green circles indicate that the bacteria levels are low at these locations and that the waters are typically safe for swimming. However, storm runoff can bring contaminants into the bay, so Surfrider and Heal the Bay recommend staying out of the water for 72 hours following a storm.

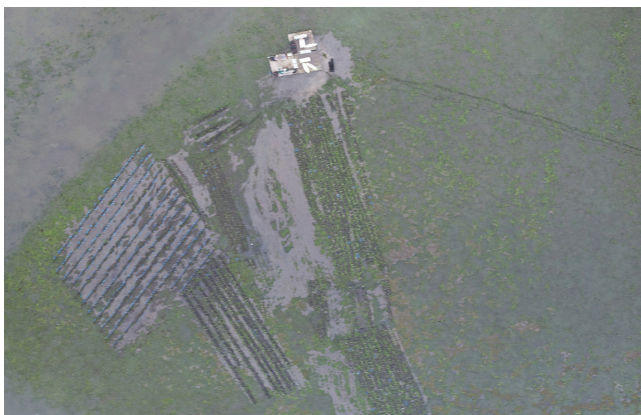
Morro Bay is home to two oyster growing operations. This drone image of Grassy Bar Oyster Company at a low tide shows the barge where oysters are prepared for market (at the top of the image). The long lines are cables anchored to the bay floor, with mesh bags attached that contain the growing oysters. Drone image courtesy of Cal Poly.

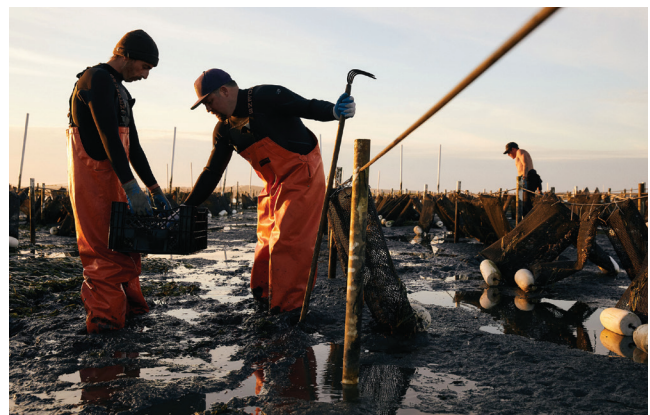
This close-up view of Morro Bay Oyster Company at low tide shows the mesh growing bags with floats on one end. As the tide comes in, the floats rise up and the oysters are tipped to the bottom of the bag. Without this periodic mixing of the oysters, they would grow in a clump that would not produce marketable shellfish. Photo courtesy of Morro Bay Oyster Company and Christa Renee.

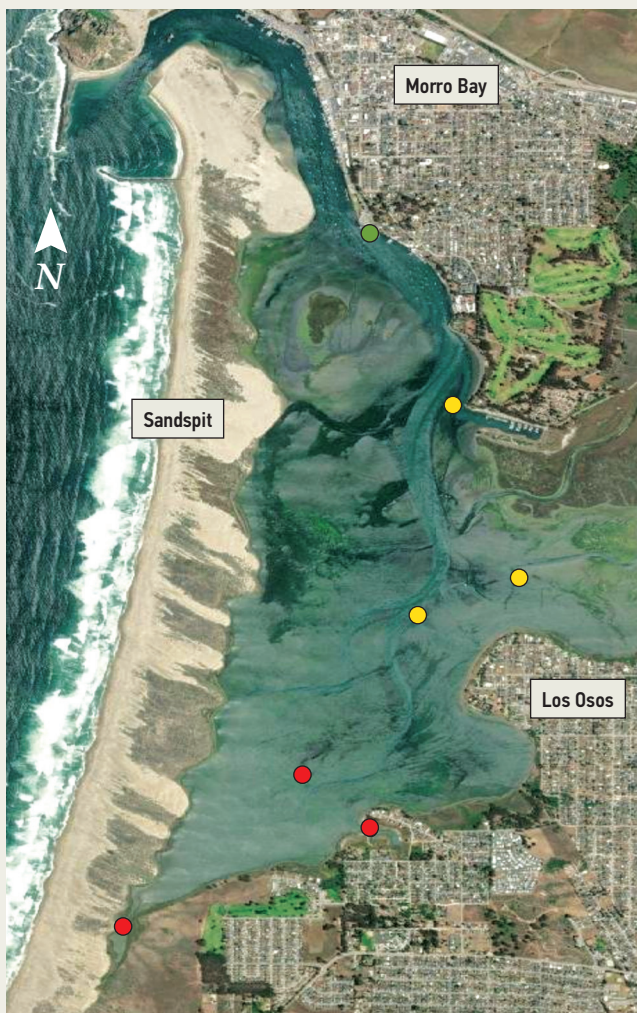
## Bay Oxygen Status

Fish and other aquatic life need adequate levels of oxygen to thrive. Typically, the lowest oxygen values of the day occur around sunrise. So, to track the minimum oxygen levels around the bay each month, Estuary Program volunteers paddle to seven sites in the early morning hours to measure the levels of oxygen in the water. The data, which goes back to 2002, shows a consistent trend of higher oxygen levels toward the front of the bay and lower levels toward the back of the bay. This is thought to be due at least in part to the shallowness of the back bay waters. The incoming tide easily pushes colder well-oxygenated water from Estero Bay through the deeper channels in the front bay, but these waters don't always make it to the southern-most part of the bay. The shallower waters also warm more quickly in the sun, which can reduce their oxygen levels. Oxygen trends have been relatively stable, with some improvement at Tidelands Park.

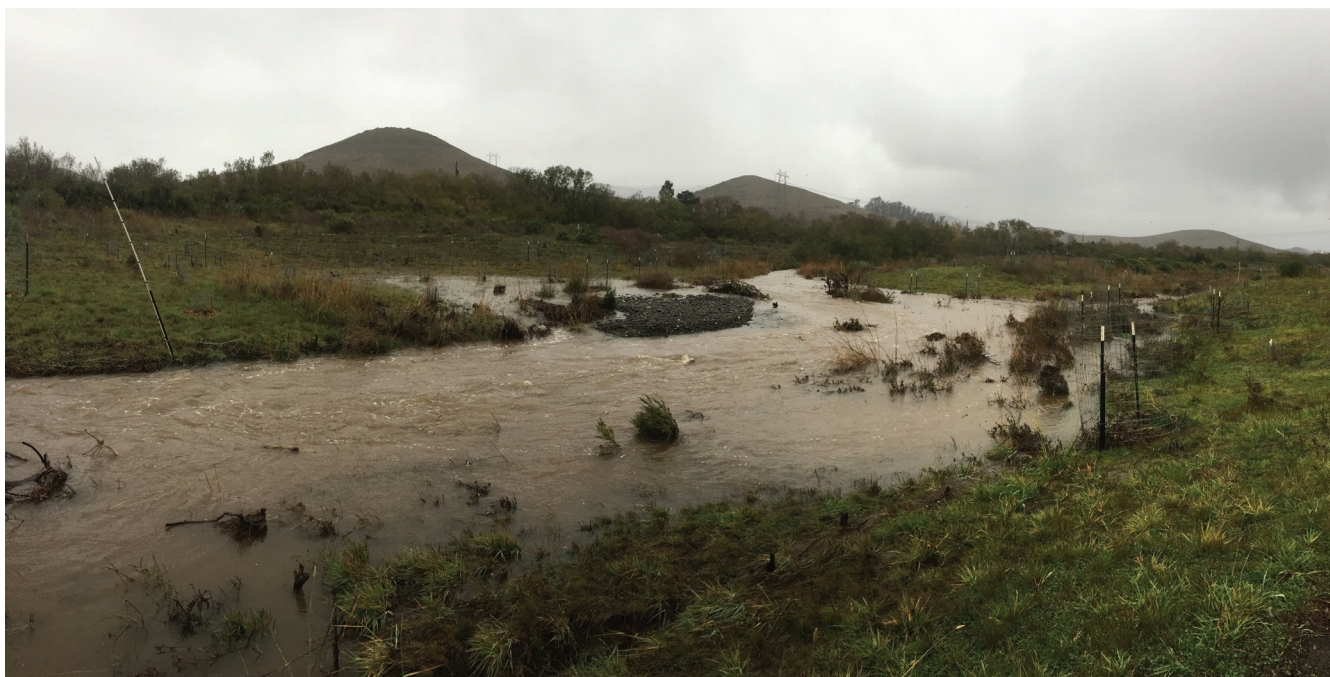
*Above: This photo shows the Ecological Reserve in action during a ten-year storm in January 2021 where eight inches of rain fell in a three-day period. The stormwater in the creek was able to spread out and slow down, allowing sediment to filter out before the water continued on its way to the estuary.*

Nearly twenty years ago, the Estuary Program helped purchase and protect 580 acres at the foot of Hollister Peak, which later became known as the Chorro Creek Ecological Reserve and is now managed by the California Department of Fish and Wildlife. We completed a nearly five-acre floodplain restoration project there in 2019 to reduce the amount of sediment flowing to the estuary, improve creek water quality, support groundwater recharge, and create habitat for sensitive species like steelhead and red-legged frogs. Floodplains are low-lying areas along creeks that allow water to spread out and slow down during storms. This gives time for sediment, nutrients, and other pollutants to filter out of the water, rather than continuing downstream to the estuary.

The project involved creating a new side creek channel and additional floodplain space, installing large pieces of wood in the creek to create fish habitat and slow water flows, and planting close to 1,500 native trees and shrubs. The project was put to the test in January 2021 during a ten-year storm (a storm that happens on average once every ten years). As planned, the rushing waters were able to overflow into the new floodplain and created deep pools and gravel bars.

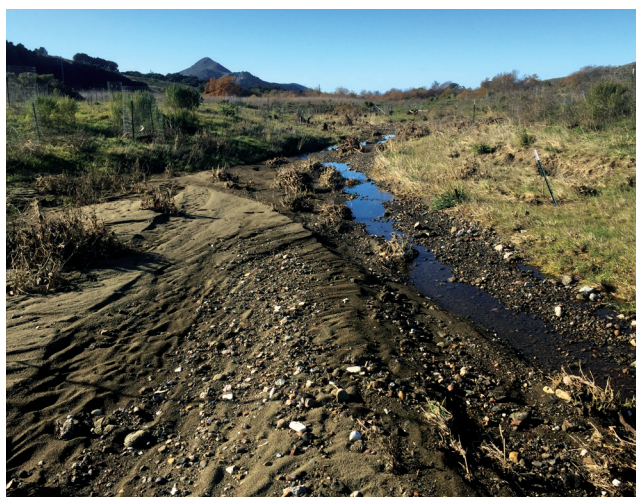
*Right: Reconnecting the creek to the floodplain allows creeks to deposit excess sediment at the project site during storms, reducing the amount of sediment that flows to the estuary.*

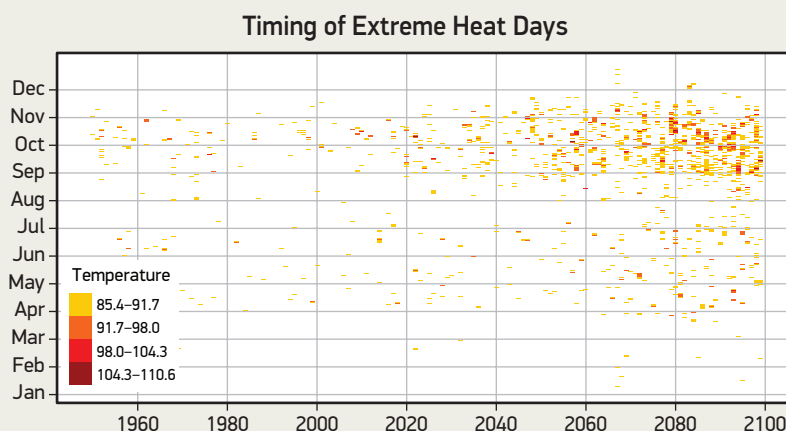
The graph shows in which months extreme heat days occurred each year over the past seventy years. These days tended to occur in the summer and early fall. The graph also shows when climate models forecast extreme heat days to fall from now until the end of the century. We are likely to experience more of these extreme heat days throughout the year, and they are likely to be hotter than they were historically.

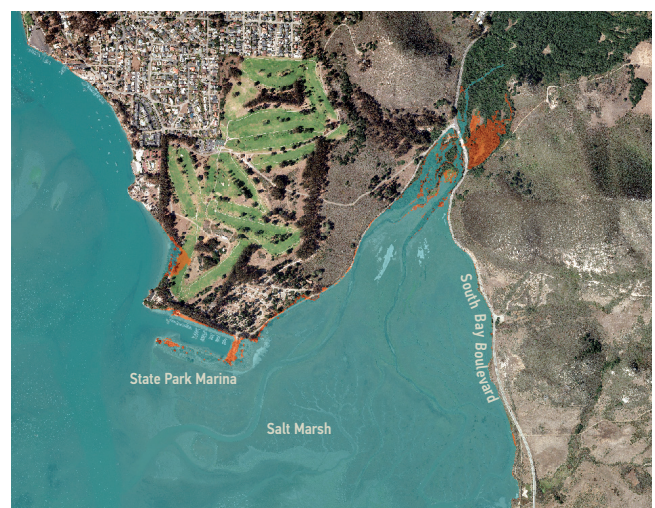
*This map of the salt marsh shows which areas the CoSMoS model predicts will be inundated given one meter of sea level rise (pictured in blue). The orange areas represent further flooding when sea level rise is coupled with a 20-year storm event, which is a storm so large that it has only a one-in-twenty chance of occurring in a given year.*

One meter of sea level rise results in complete inundation of the State Park Marina as well as the nearby salt marsh area. Storm surge coupled with this sea level rise could flood the lower portions of the golf course and push salt water up Chorro Creek. One meter of sea level rise would flood nearly 90 acres in this area.
