Health of Our Creeks

NITRATE STATUS IN THE WATERSHED

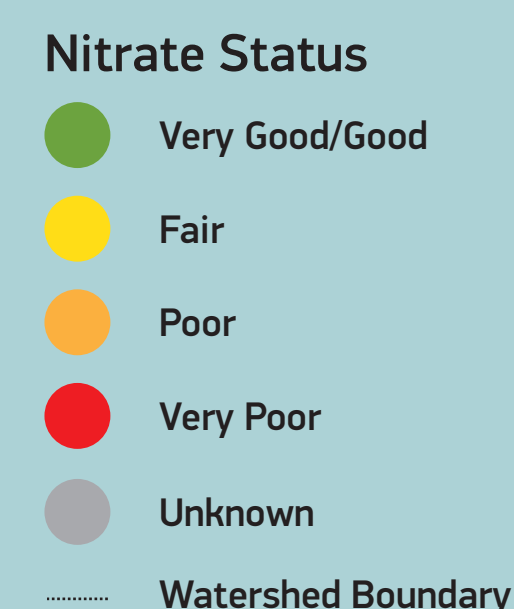
Summary of nitrate data collected from 2002 through 2021 for creeks in the Morro Bay watershed.

While nitrates are essential for plant growth, excess nitrates can cause an imbalance in an aquatic system. In our watershed creeks, nitrate levels were good (low) for upper Chorro Creek, the tributaries to Chorro Creek, and upper Los Osos Creek. Middle and lower Chorro Creek and Warden Creek frequently have elevated nitrate levels, which can make it difficult for sensitive wildlife to thrive. The creek segments that are grayed out show areas where we lack adequate data to make an assessment.

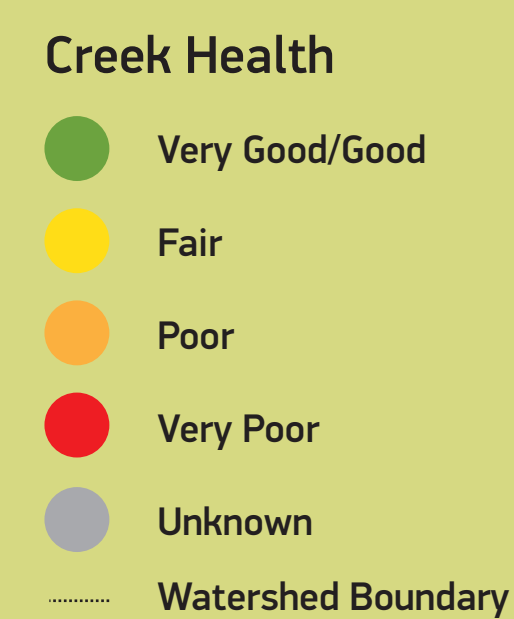
This symbol summarizes creek health data from 1994 to 2021 for the watershed. Scores remain stable but we lack data from areas that we suspect are heavily impacted.

Fish and other aquatic life rely on a healthy creek ecosystem. The types of bugs living in a creek give us clues about the water quality. Some bugs are sensitive and can survive only in very clean waters, while other species can tolerate high levels of pollution. Most creeks in the watershed support a healthy diversity of bugs. We have not assessed conditions for lower Los Osos Creek and Warden Creek due to lack of access.

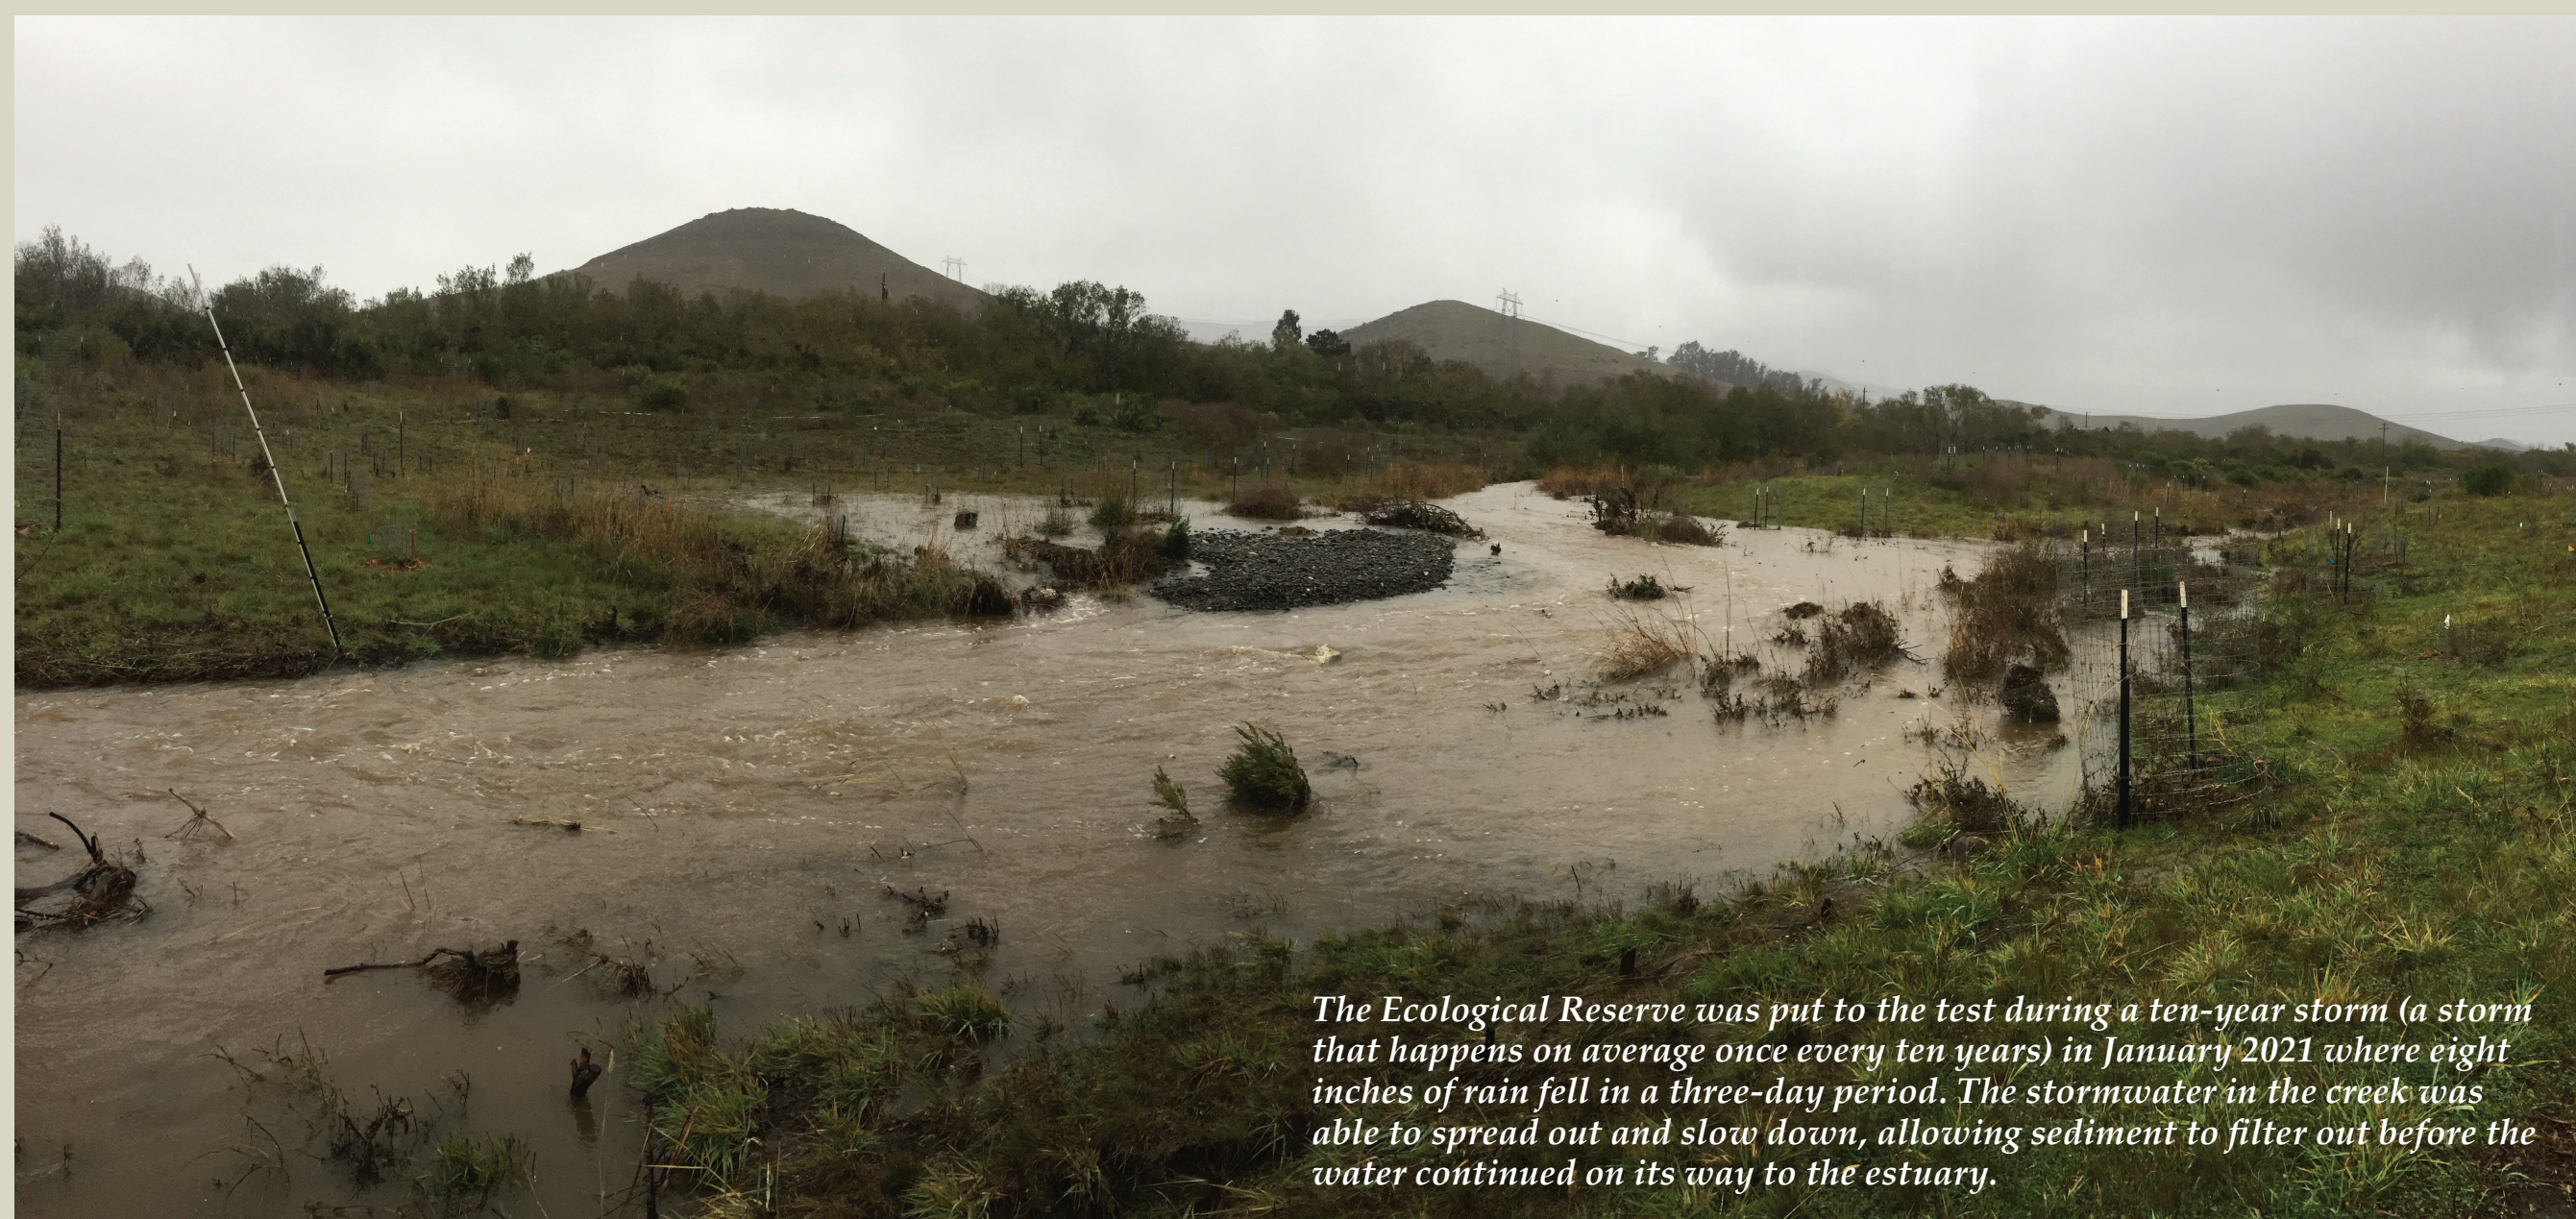
Nearly twenty years ago, the Estuary Program helped purchase and protect 580 acres at the foot of Hollister Peak, which later became known as the Chorro Creek Ecological Reserve. We completed a nearly five-acre floodplain restoration project there in 2019 to reduce the amount of sediment flowing to the estuary and create habitat for sensitive species like steelhead. Floodplains are low-lying areas along creeks that allow water to spread out and slow down during storms. This gives time for sediment, nutrients, and other pollutants to filter out of the water, rather than continuing downstream to the estuary.

The Ecological Reserve was put to the test during a ten-year storm (a storm that happens on average once every ten years) in January 2021 where eight inches of rain fell in a three-day period. The stormwater in the creek was able to spread out and slow down, allowing sediment to filter out before the water continued on its way to the estuary.
