Chorro Creek Ecological Reserve

Floodplain Restoration Project Implementation

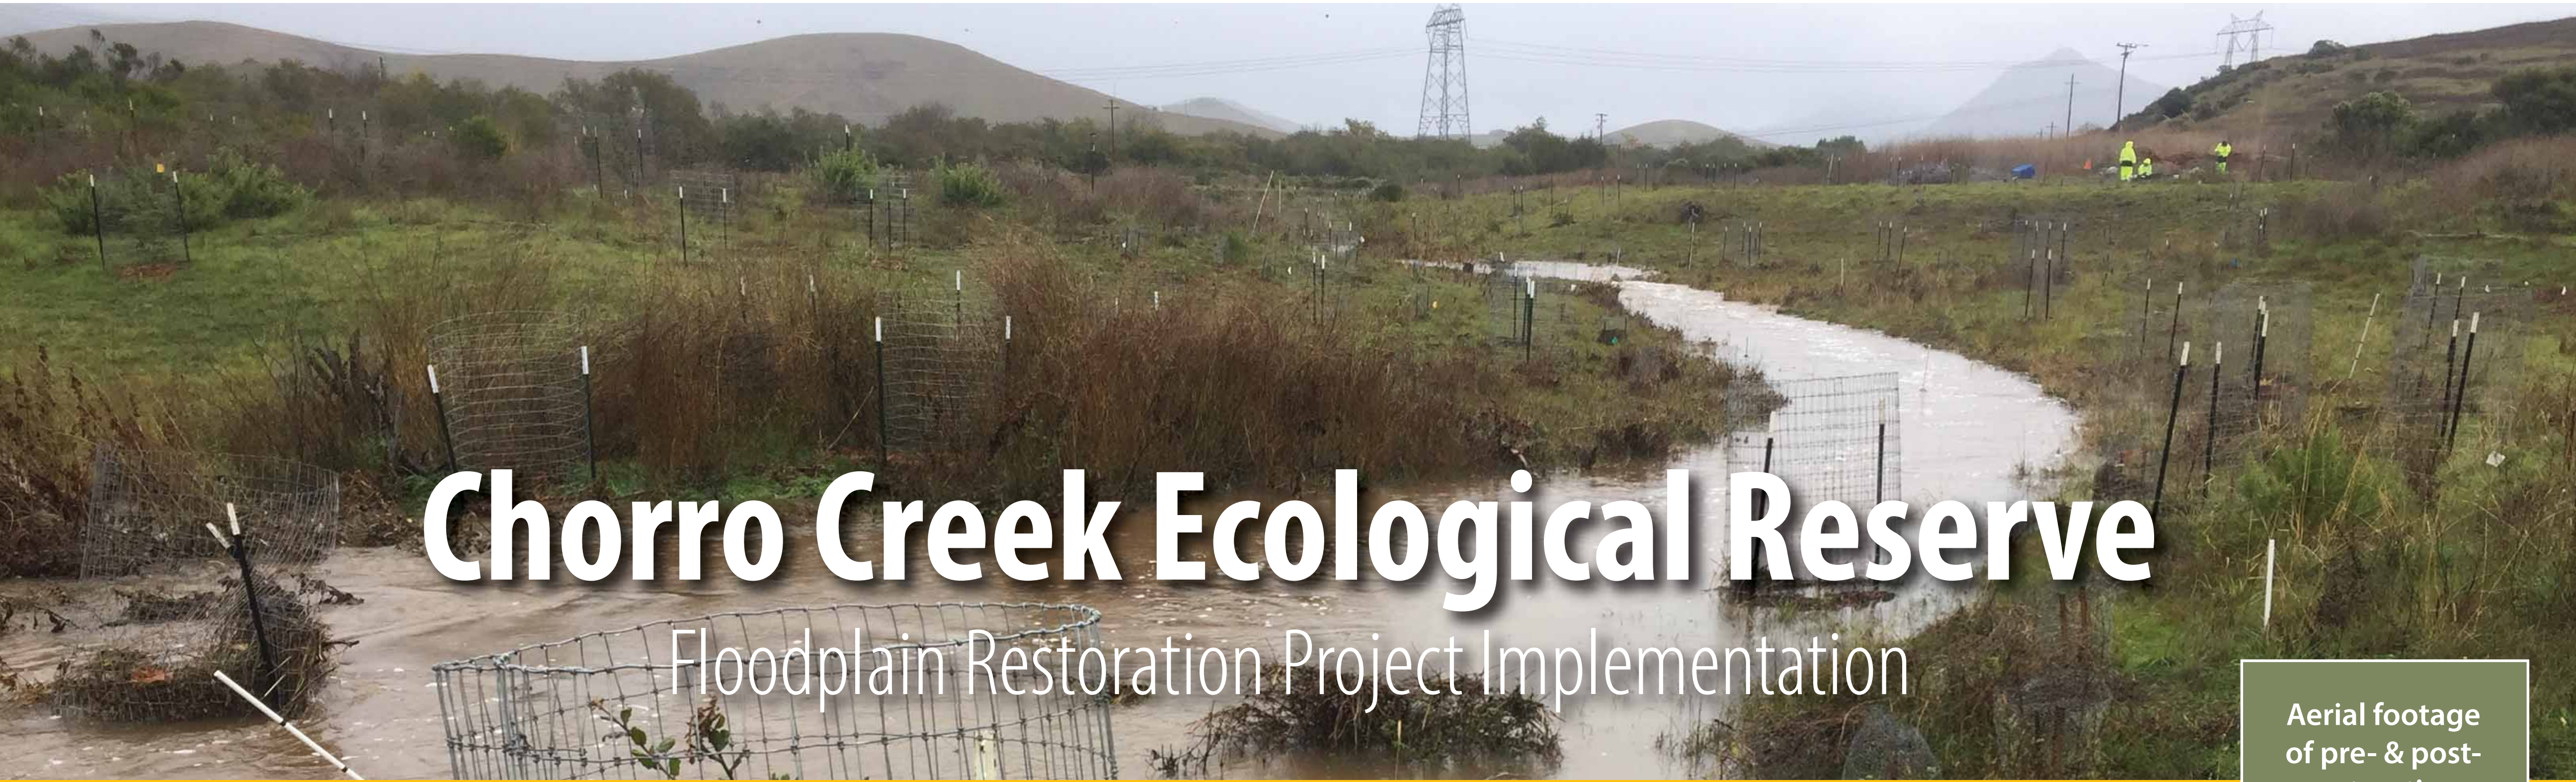
Aerial footage of pre- & post-restoration project site.

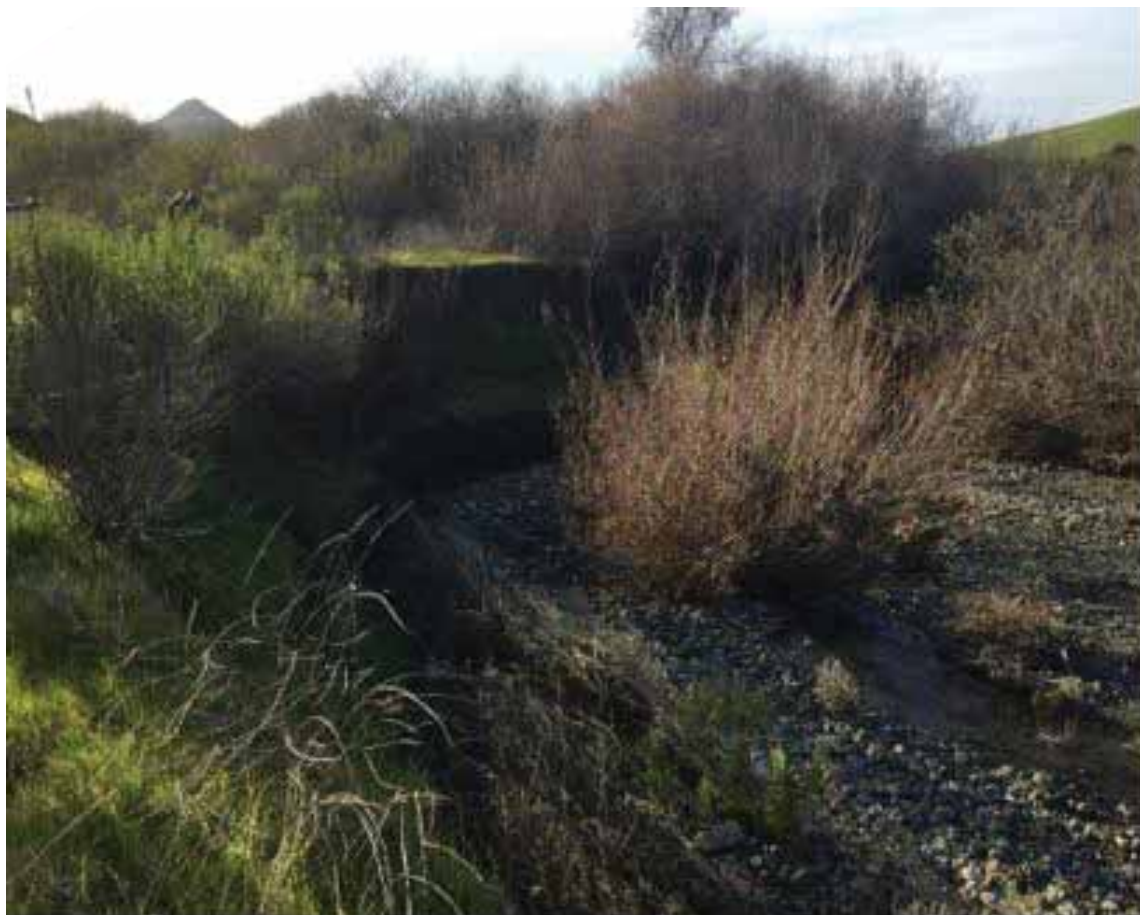
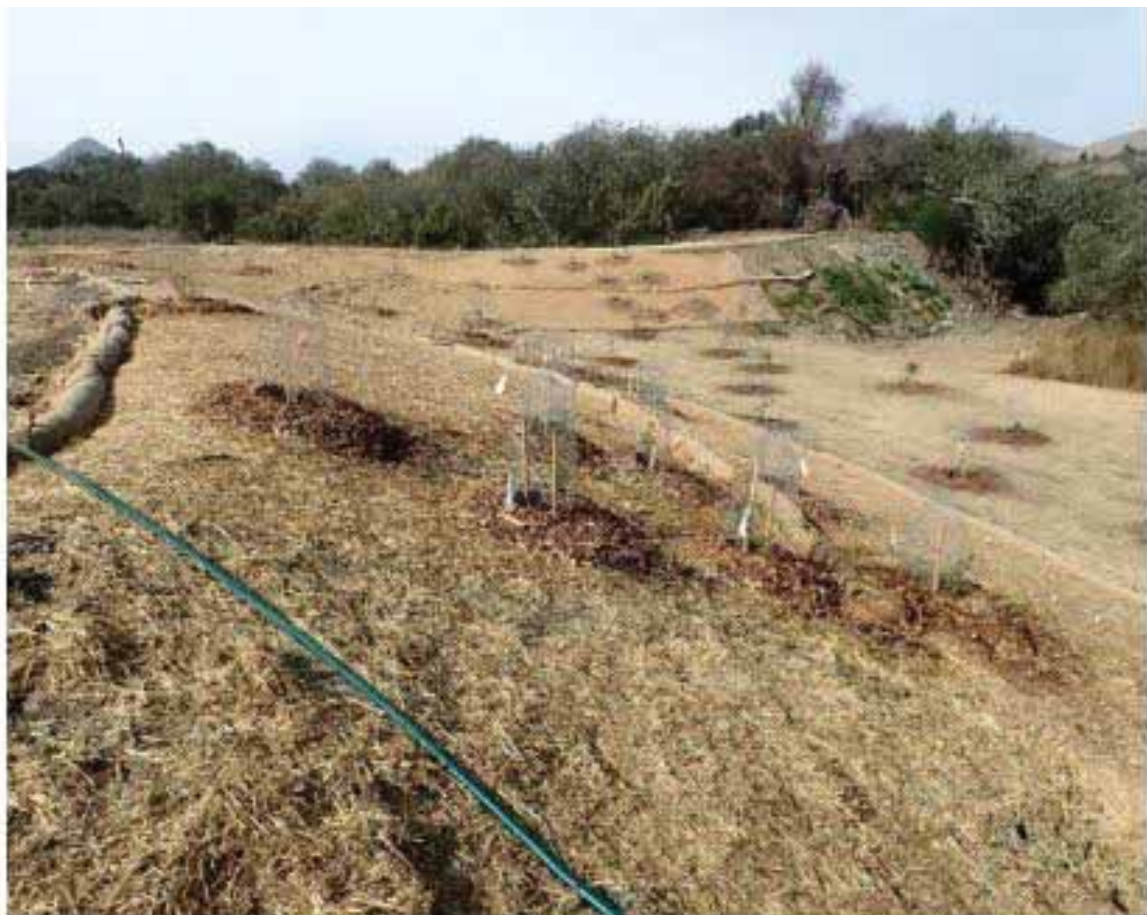
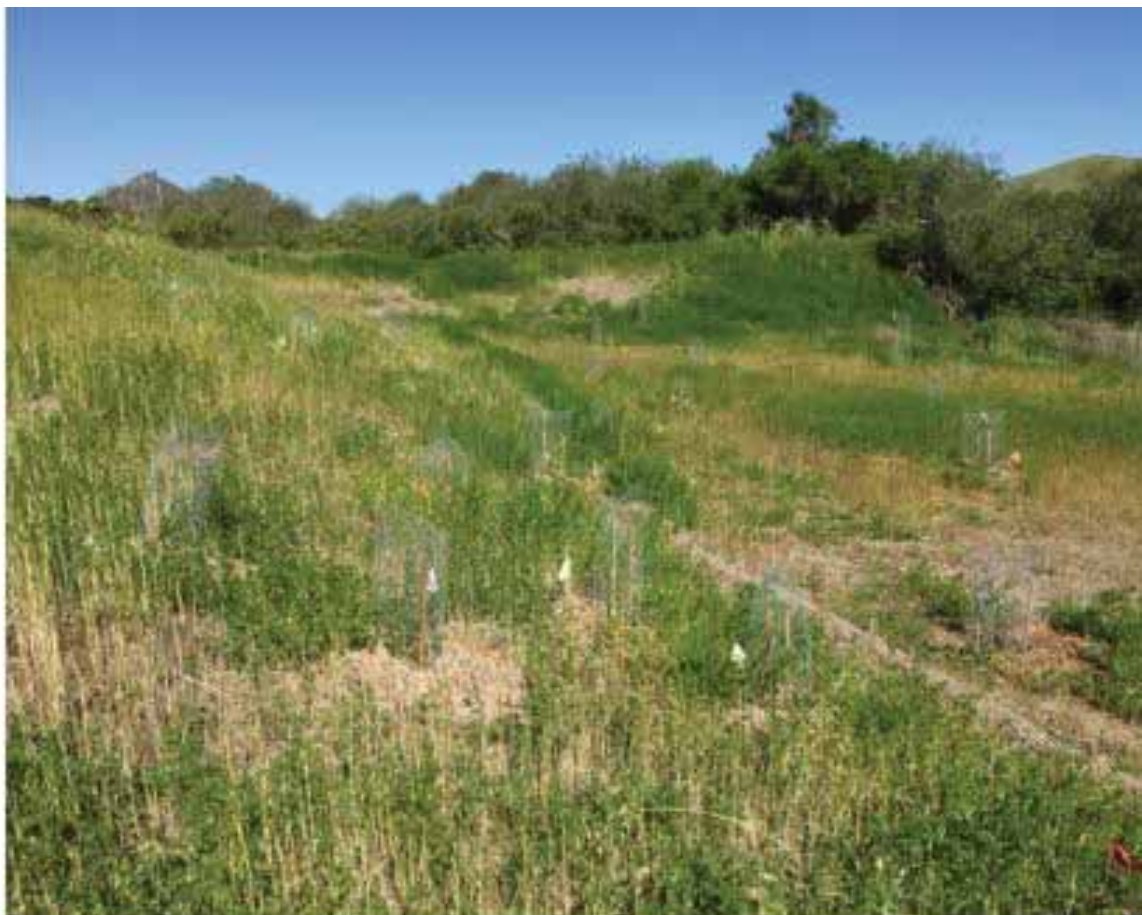
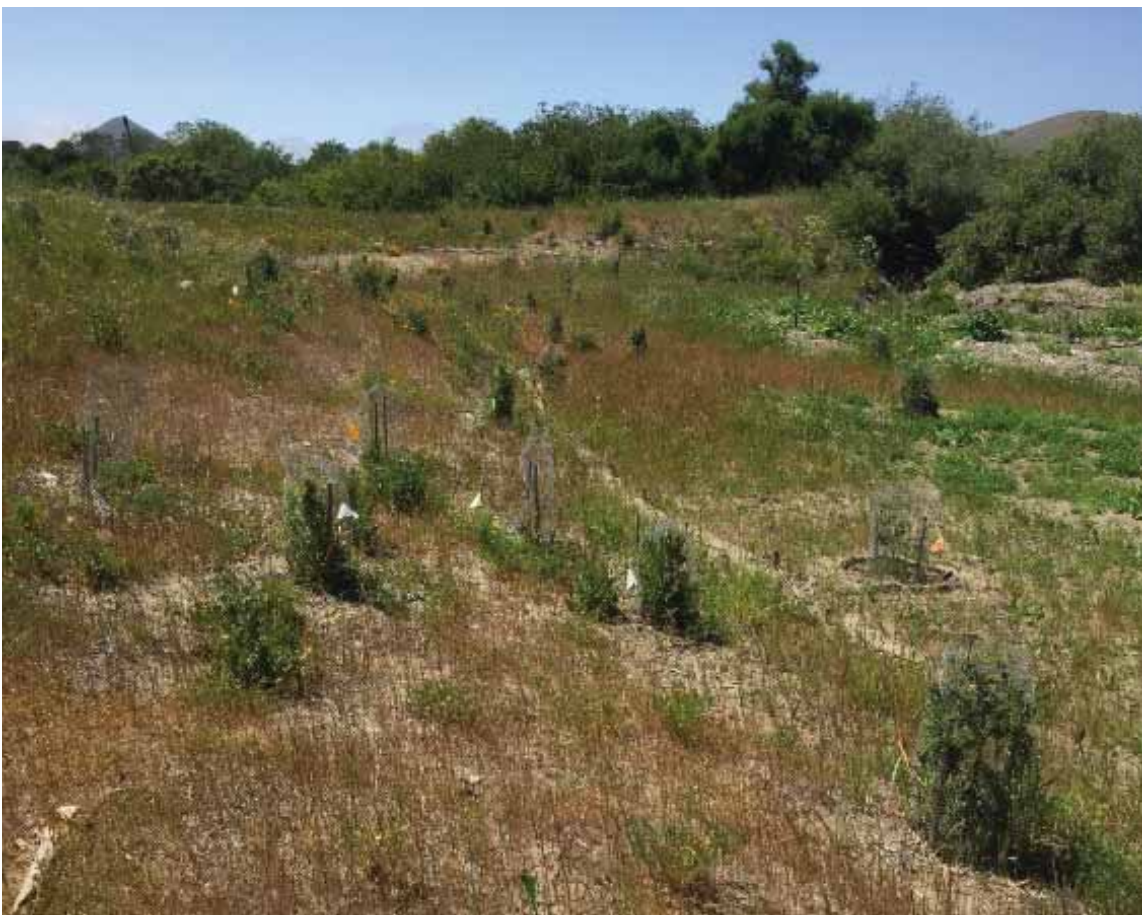
Pre-project eroded creek bank (left) that was re-sloped to expand the floodplain. Native plantings have begun to be established (right).

Pre-project

November 2019

April 2020

May 2021

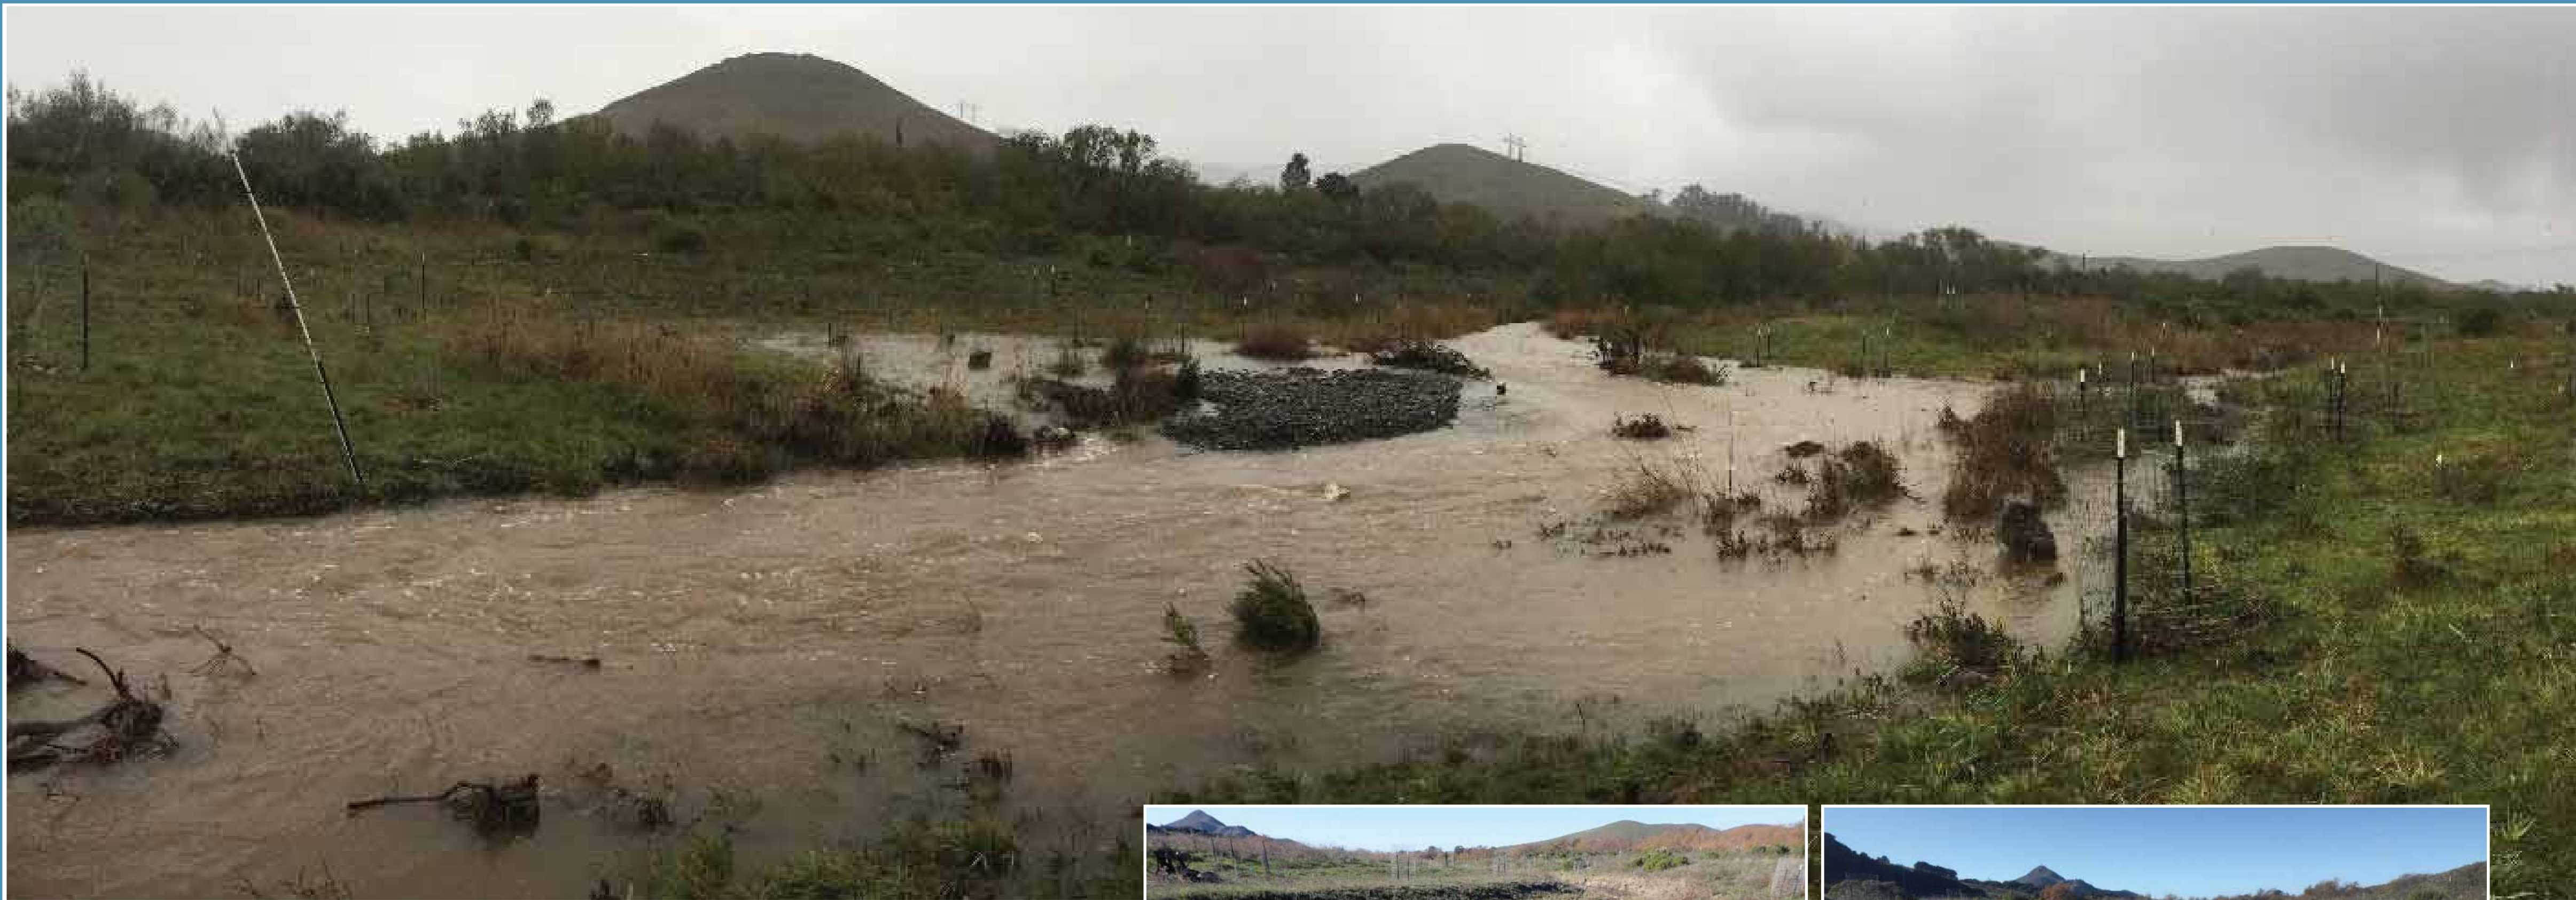
The Floodplain Project in Action

The restored Chorro Creek floodplain had its first major test in January 2021 during a 10-year storm event (a storm that happens on average once in ten years, measured according to rainfall.) Water overflowed into the new floodplain and created new deep pools, gravel bars, and areas of erosion and sediment deposition. Some of the native plantings were lost but overall, the project held up during the large storm.

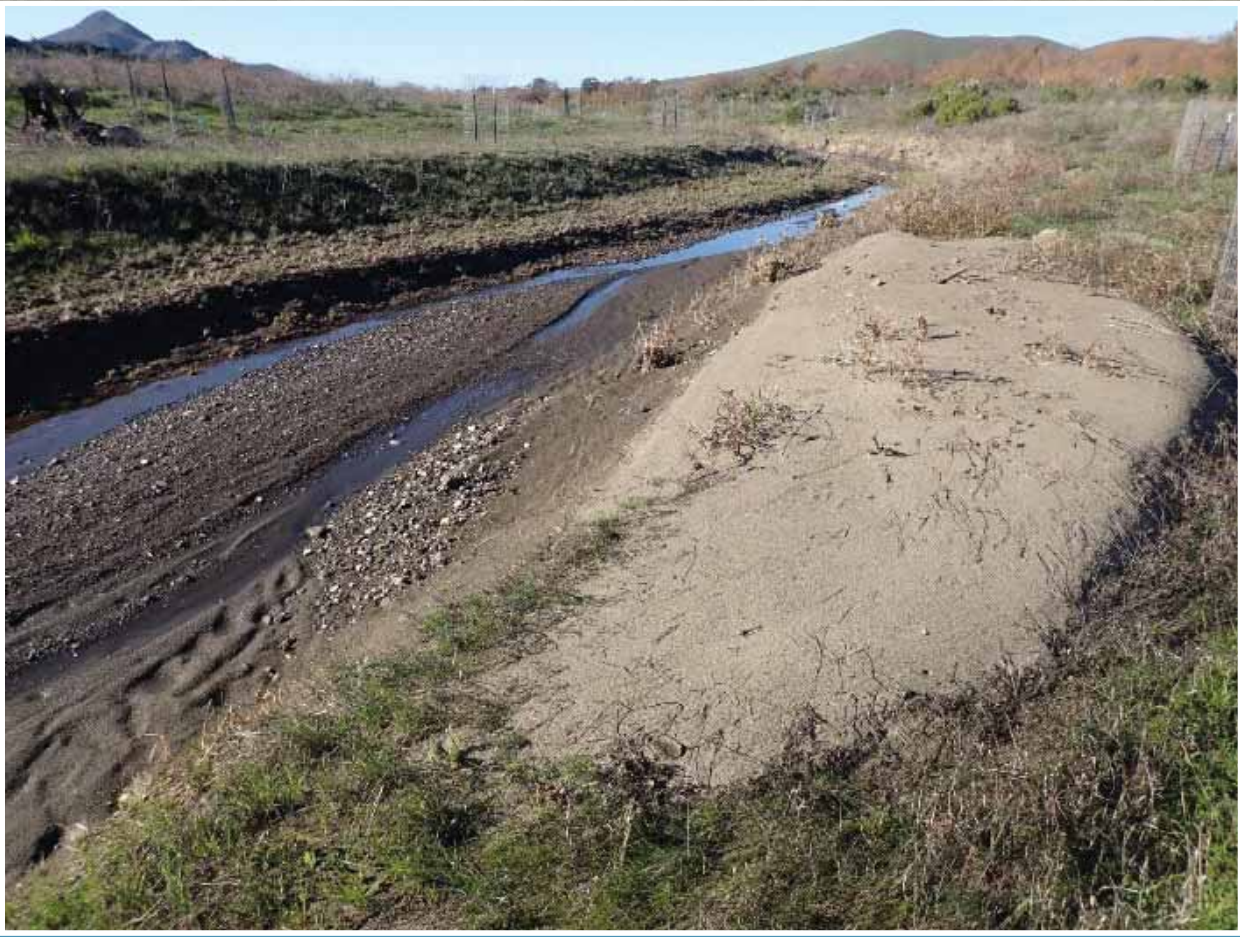
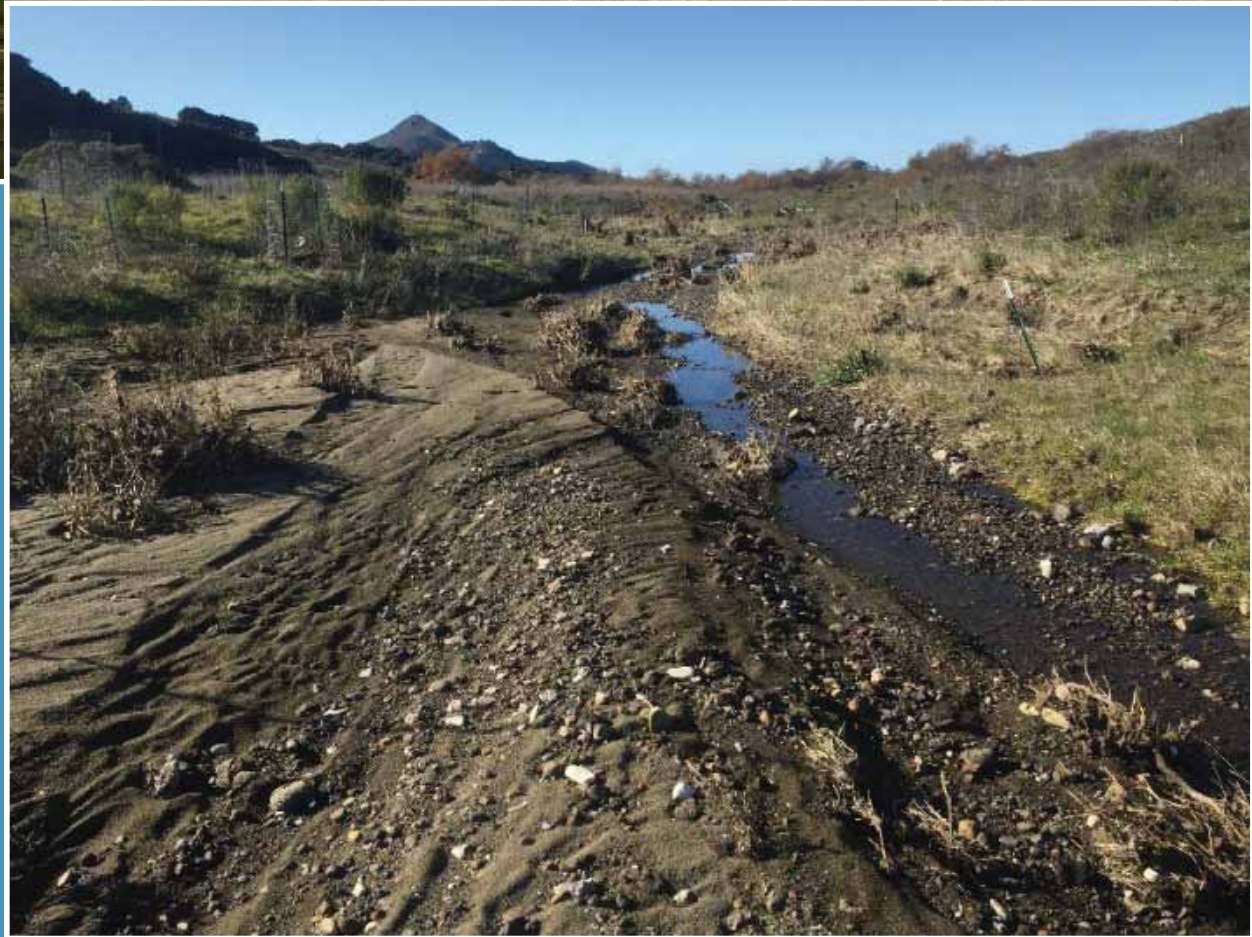
Sediment deposited during storm events along the floodplain of Chorro Creek.
