MORRO BAY

Sediment Monitoring Report

Water Year 2022

September 2023

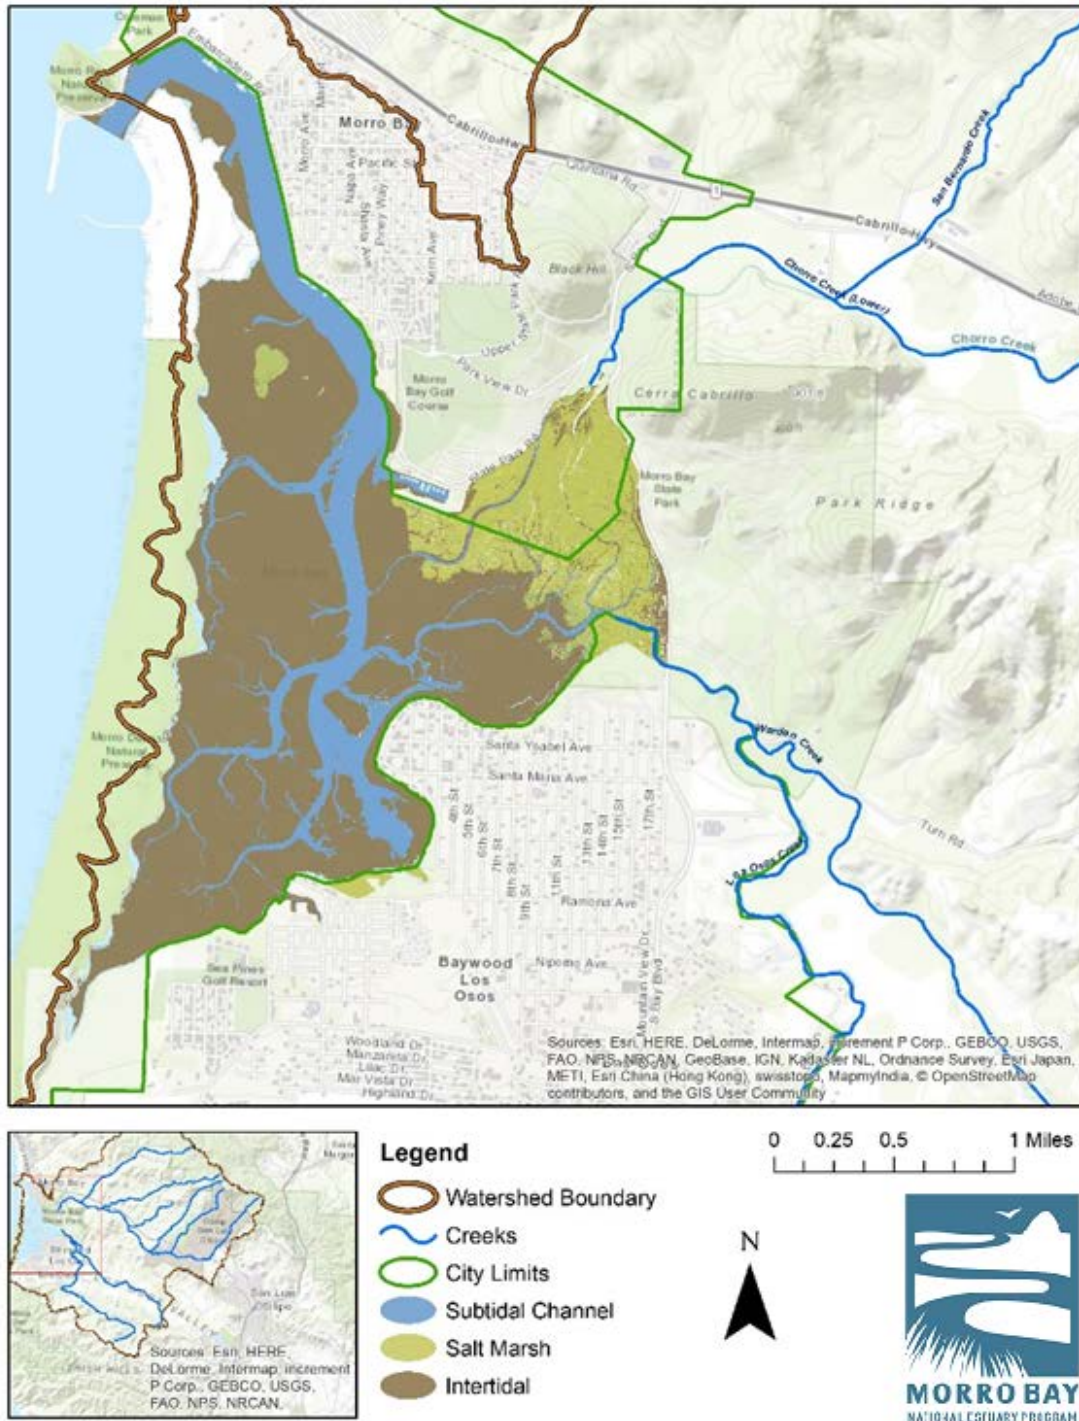
Figure 1: Map of Morro Bay estuary habitat types

The Morro Bay estuary is comprised of approximately 2,300 acres of shallow, semi-enclosed intertidal and sub-tidal habitat. The estuary is bordered to the west by a four-mile vegetated natural sandspit that separates Morro Bay from the Pacific Ocean (Figure 1).

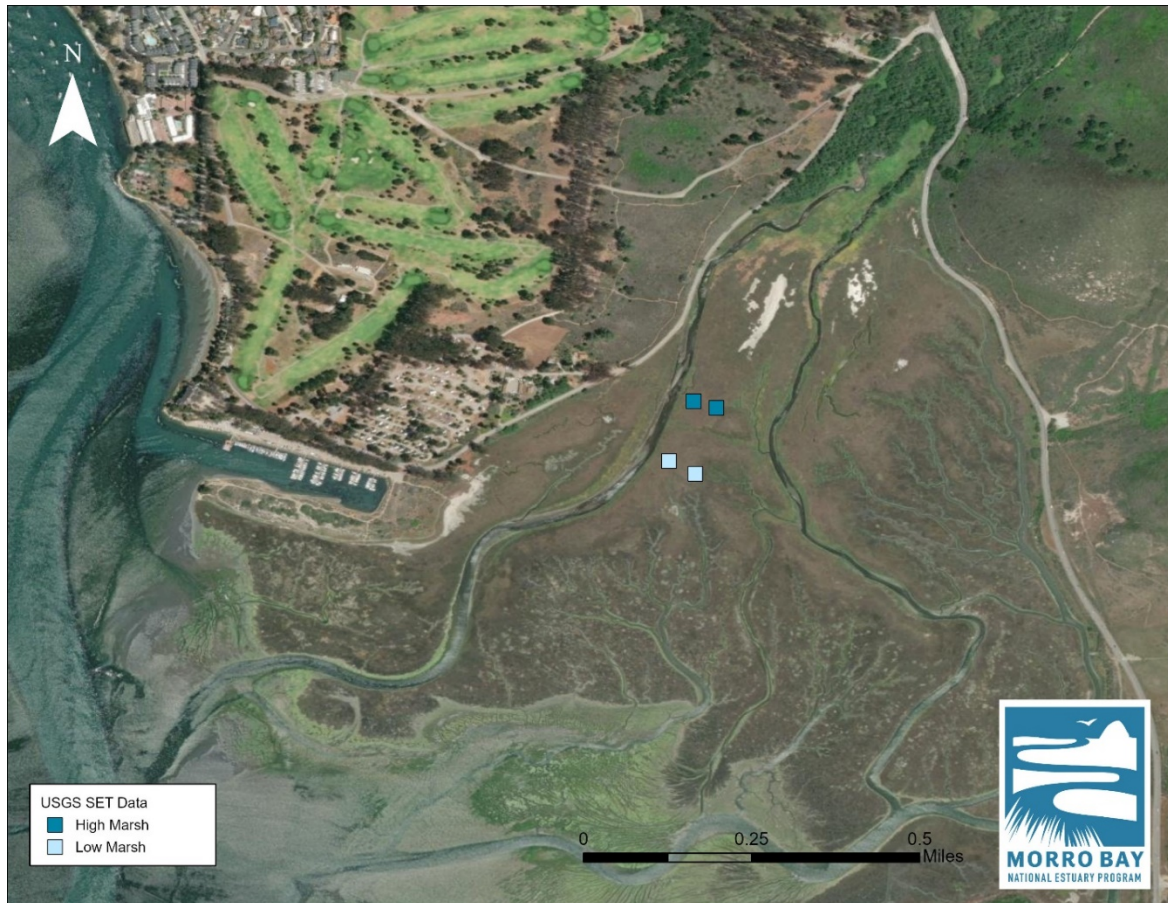
Figure 3: USGS SET and feldspar locations in Morro Bay.

The U.S. Geological Survey (USGS) monitors sediment deposition in Morro Bay as part of a larger study of sedimentation rates on the west coast. There are four monitoring locations in the Morro Bay salt marsh, including two high marsh and two low marsh sites (Figure 3). USGS established the sites in 2013

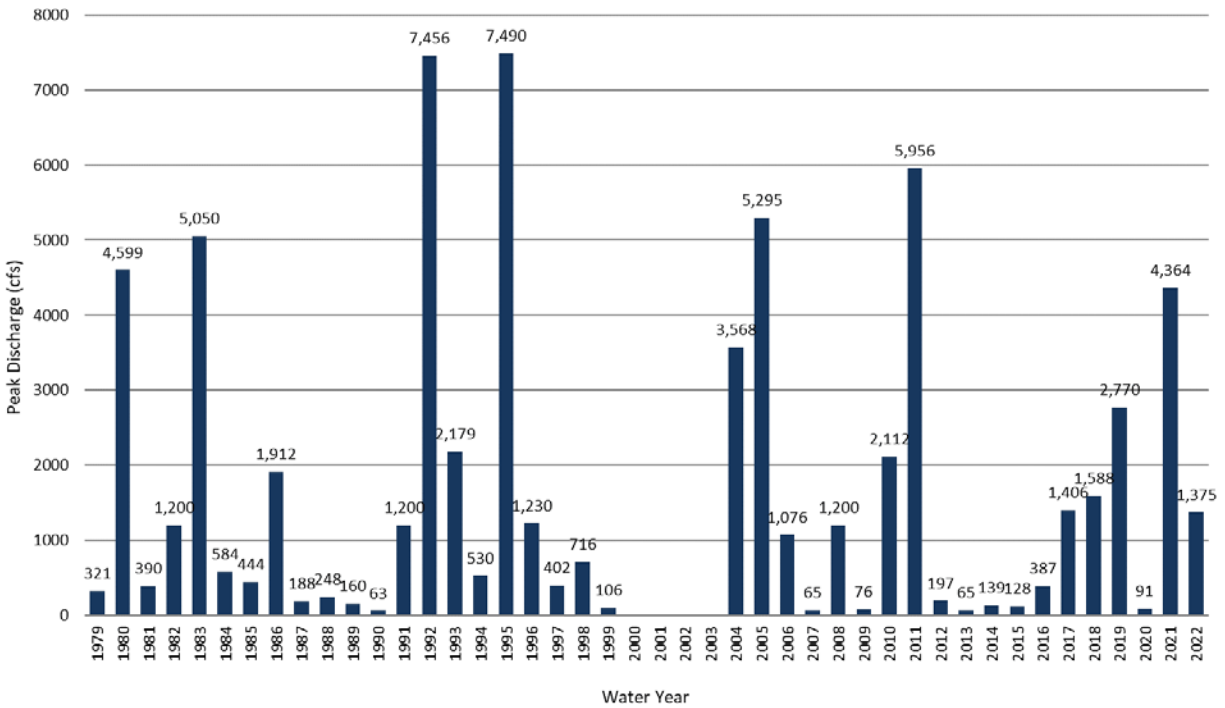
Figure 5: Chorro Creek at Canet Road, peak flow records, from 1979 to 2022.

Peak discharge describes the highest rate of flow during a given water year. Review of approximately 40 years of peak discharge data indicates large inter-annual variability in peak discharge at the Canet gauging station, with a range of 7,427 cfs (Figure 5).

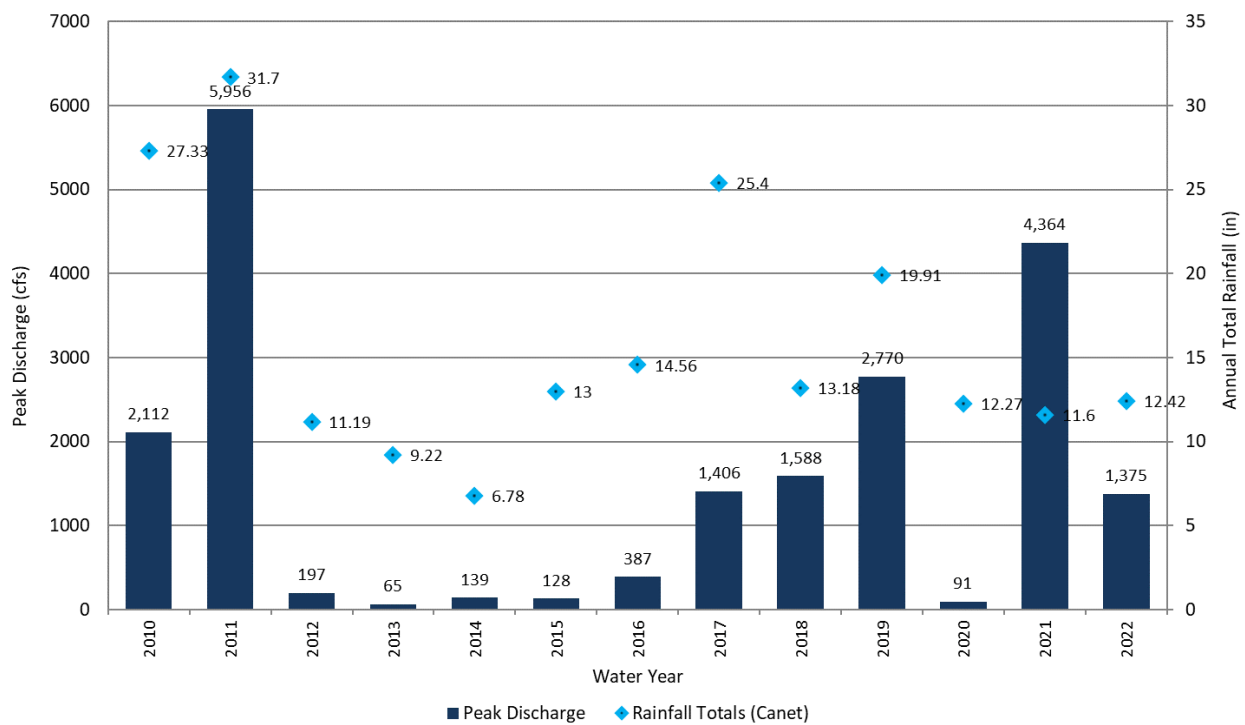
Figure 6: Chorro Creek at Canet Road, peak flow and annual rainfall totals from WY 2010 to WY 2022.

For example, WY 2017 presents as a high peak on the annual rain total graph (at 25.4 inches) but had a relatively low peak discharge (1,406 cfs). Conversely, WY 2021 had a low annual accumulated rainfall (11.6 inches) but one of the highest peak flows in the last decade. In the case of WY 2017, the rain events were spread out over a longer time period such that they did not result in the type of overland flows that typically contribute the largest inputs of sediment in a surface water system. Thus, annual rainfall totals are unlikely to be a reliable indicator of the relative sediment contribution to Morro Bay in a given year. Previous analyses by the Estuary Program also show that annual rainfall is a poor predictor of suspended sediment loads (MBNEP, 2011).
