## **Morro Bay National Estuary Program**

### **Morro Bay Eelgrass Report 2022**

November 2023

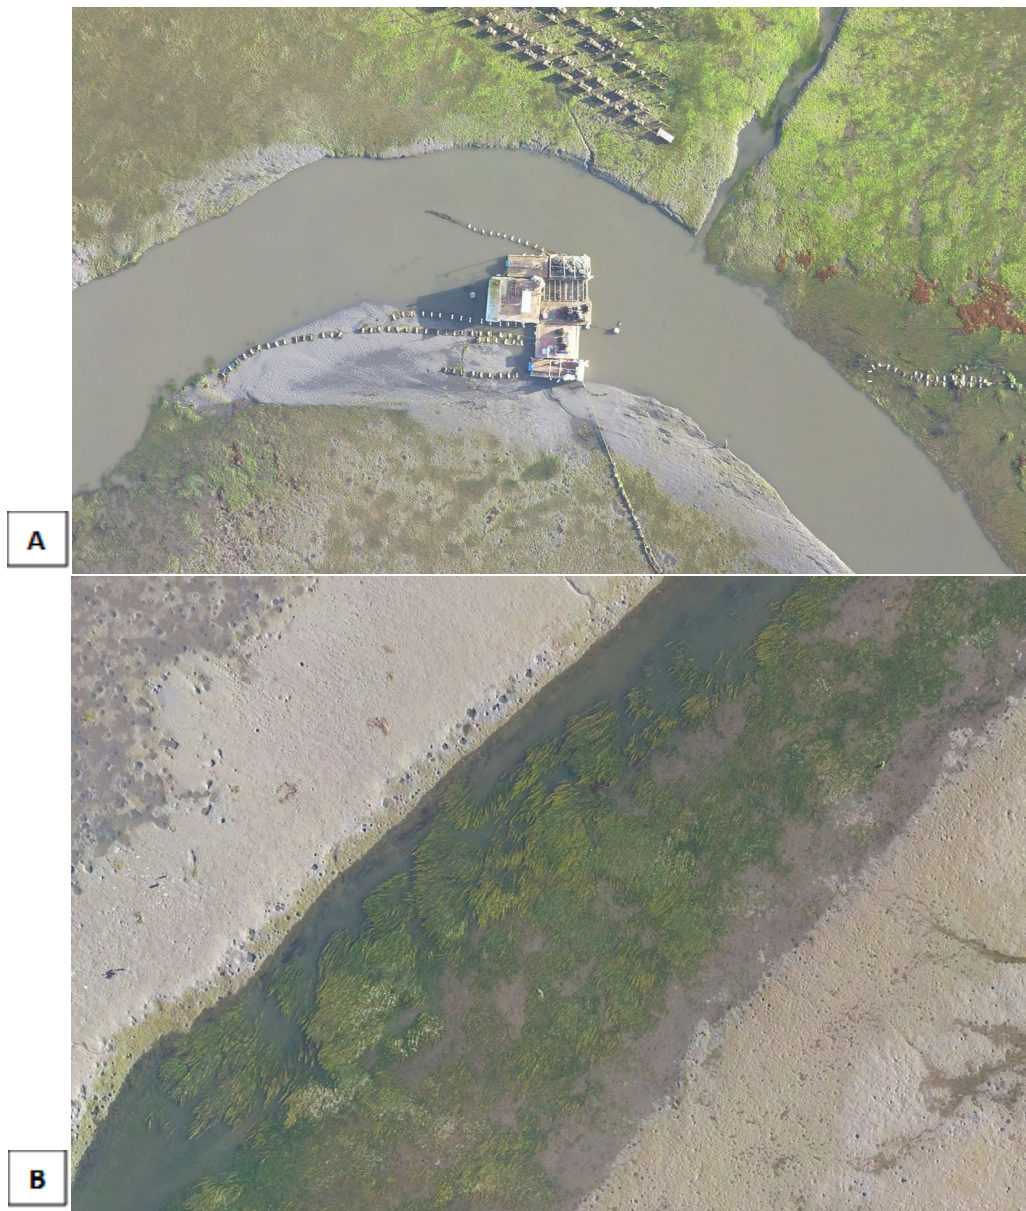
**Figure 2A, 2B.** Resolution of photos captured with Cal Poly’s UAV drone during spring of 2022. Figure 2A shows oyster farm infrastructure, and Figure 2B shows how the imagery is useful for detecting eelgrass that is partially submerged in water.

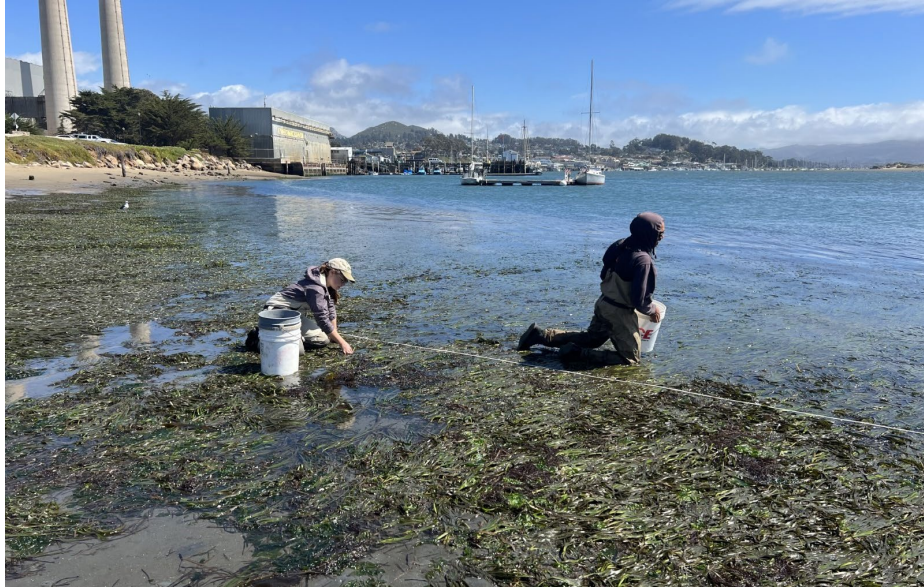
**Figure 5.** Eelgrass collection at Coleman Beach in March 2022.

Eelgrass rhizomes were collected from the Coleman donor bed for the 2022 restoration effort. Eelgrass was harvested on foot and by hand at low tides. No more than three rhizomes per square meter were collected, as required by the Estuary Program's scientific collection permit from CDFW. Harvesting and transplanting occurred in the spring, as previous experimental efforts showed higher success during the spring as opposed to the summer. Pre- and post-density eelgrass counts of the donor beds were collected before and after harvesting.

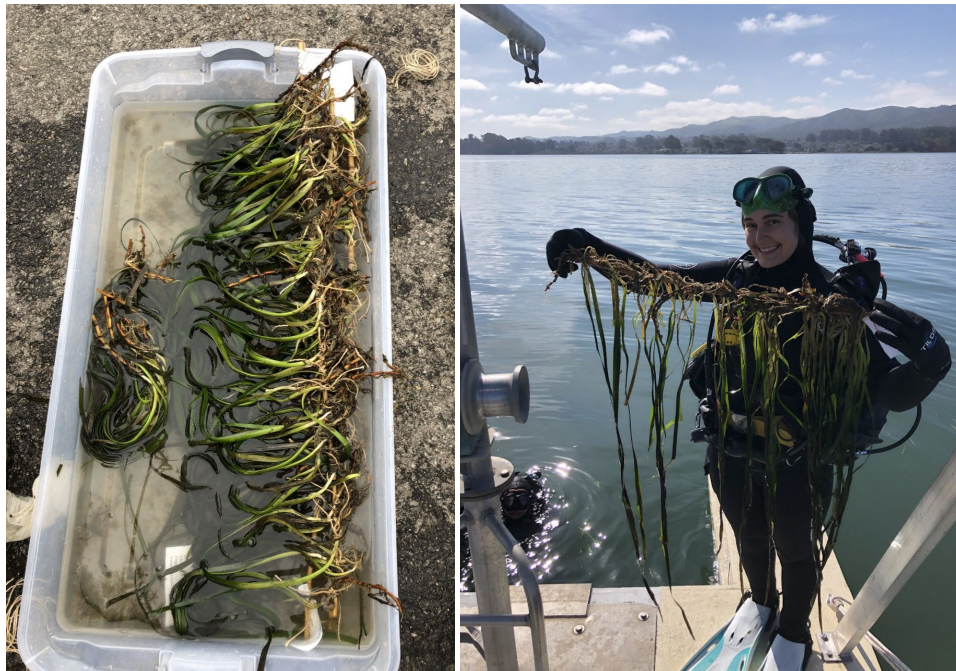
**Figure 6.** Preparation and scuba planting of eelgrass bamboo pieces by Tenera staff, Spring 2022.

For both of the restoration sites, three-foot bamboo stakes were used to transplant eelgrass. Each piece of bamboo had 25 rhizomes secured to it with jute string. Bamboo was then placed in the intertidal zone off the main channel and anchored to the sediment with garden stakes. The sites were accessed by boat and planting was conducted via scuba at high tide since the substrate is too muddy to navigate on foot. PVC plot markers were established at each planting so they could be revisited for monitoring.

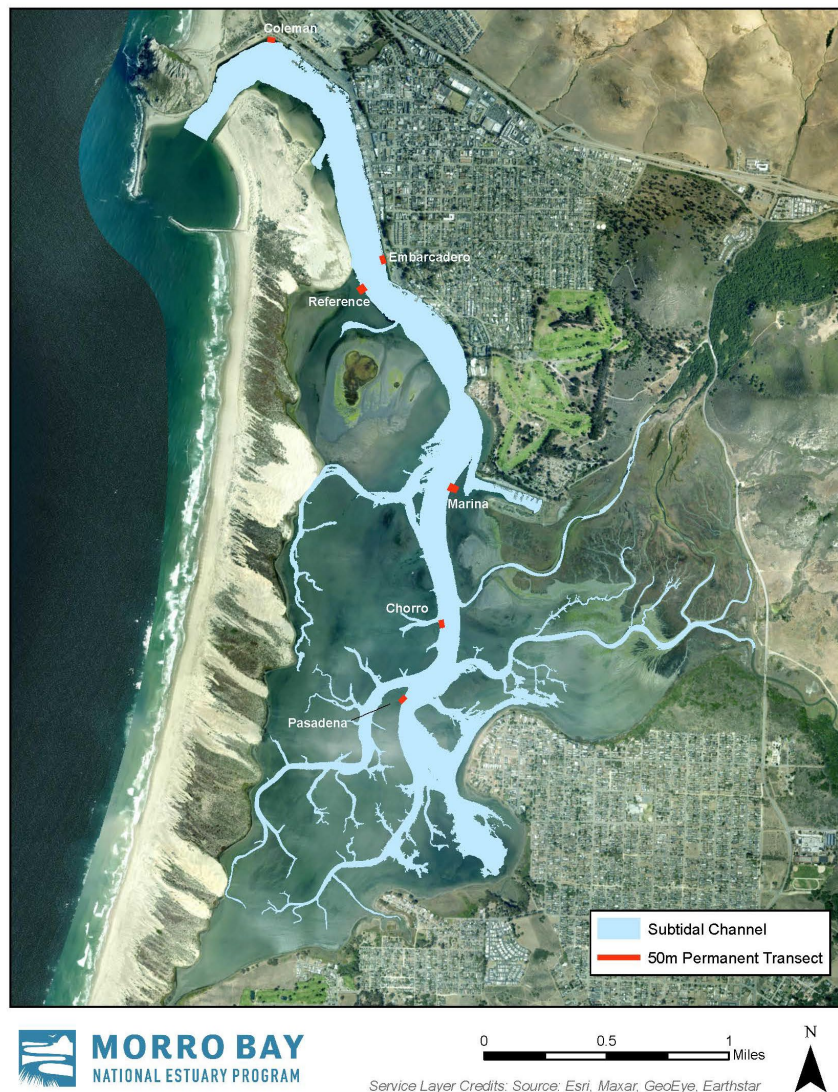
**Figure 9.** The six current permanent transect monitoring locations: Coleman, Embarcadero, Reference (previously named Tidelands), Marina, Chorro, and Pasadena.

Permanent transects were established to track changes in eelgrass shoot density throughout Morro Bay. There are currently six permanent transects, some having been established as far back as 2005. Four transects (Coleman, Reference, Chorro, Pasadena) were monitored annually from 2006 to 2010. No data were collected in 2011 due to staffing logistics. In November 2012, a fifth transect was established near the State Park Marina. From 2012 to 2016, some sites were not surveyed due to poor weather or tide conditions. In December 2017, a new transect was established on the eastern side of the channel at Tidelands Park, called “Embarcadero.” The transect now called “Reference” was originally named “Tidelands” but has since been renamed to avoid confusion.

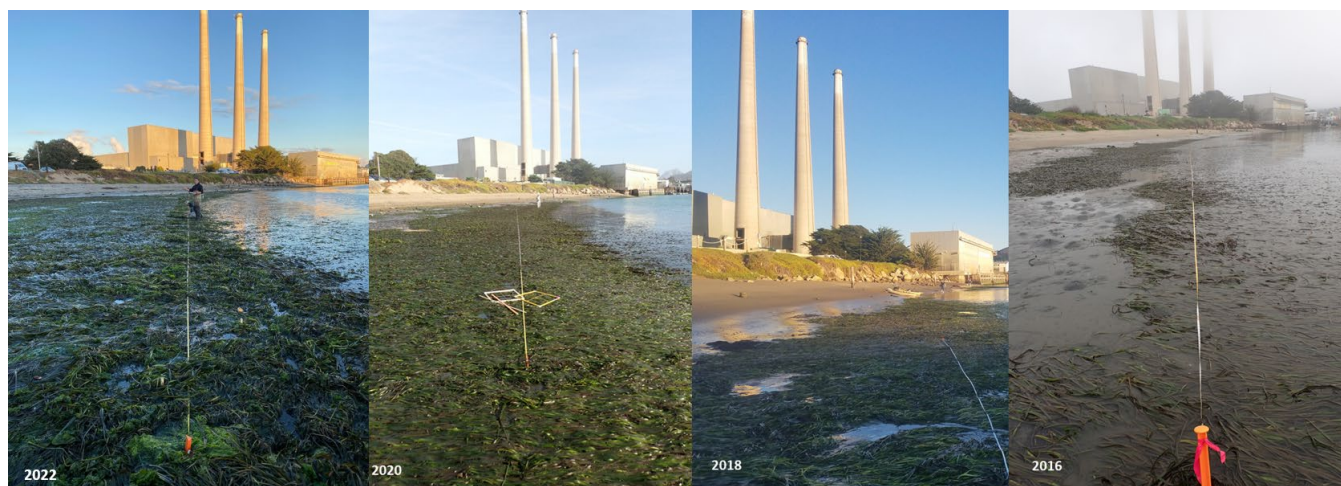
Average eelgrass density slightly decreased at this transect for the second year in a row but is still over ten times the density observed in 2014. Current shoot density is comparable to pre-decline levels seen in 2007.

**Figure 12.** Permanent transect monitoring at Coleman Transect, 2016 to 2022.

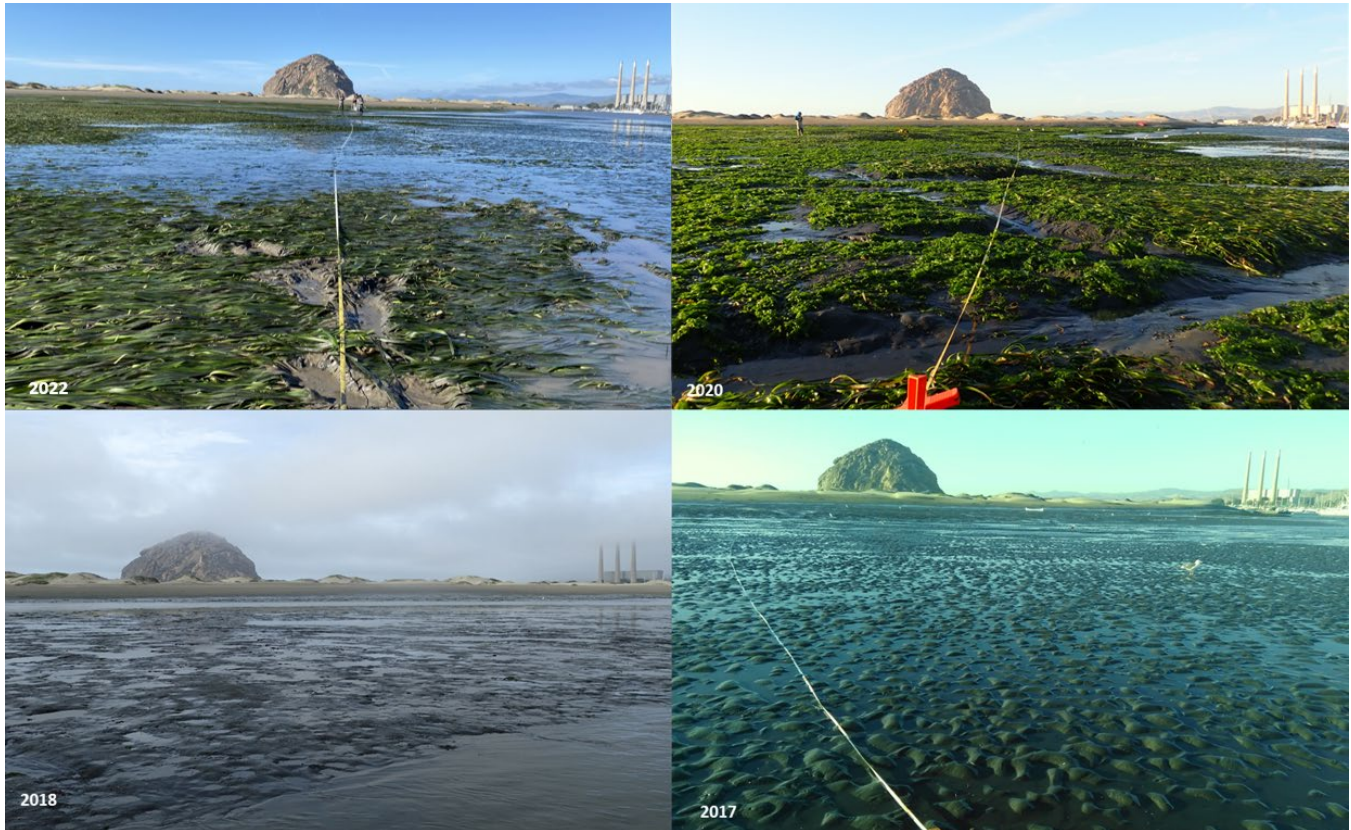
Eelgrass has made a significant comeback at this transect after having been virtually absent since 2017. Small patches of eelgrass began appearing in 2019 at higher elevations than previously observed and have transformed the landscape to consist of eelgrass “islands” separated by small channels. Shoot density is similar to the pre-decline density observed in 2007.

**Figure 13.** Permanent transect monitoring at Reference Transect (previously “Tidelands”), 2017 to 2022.

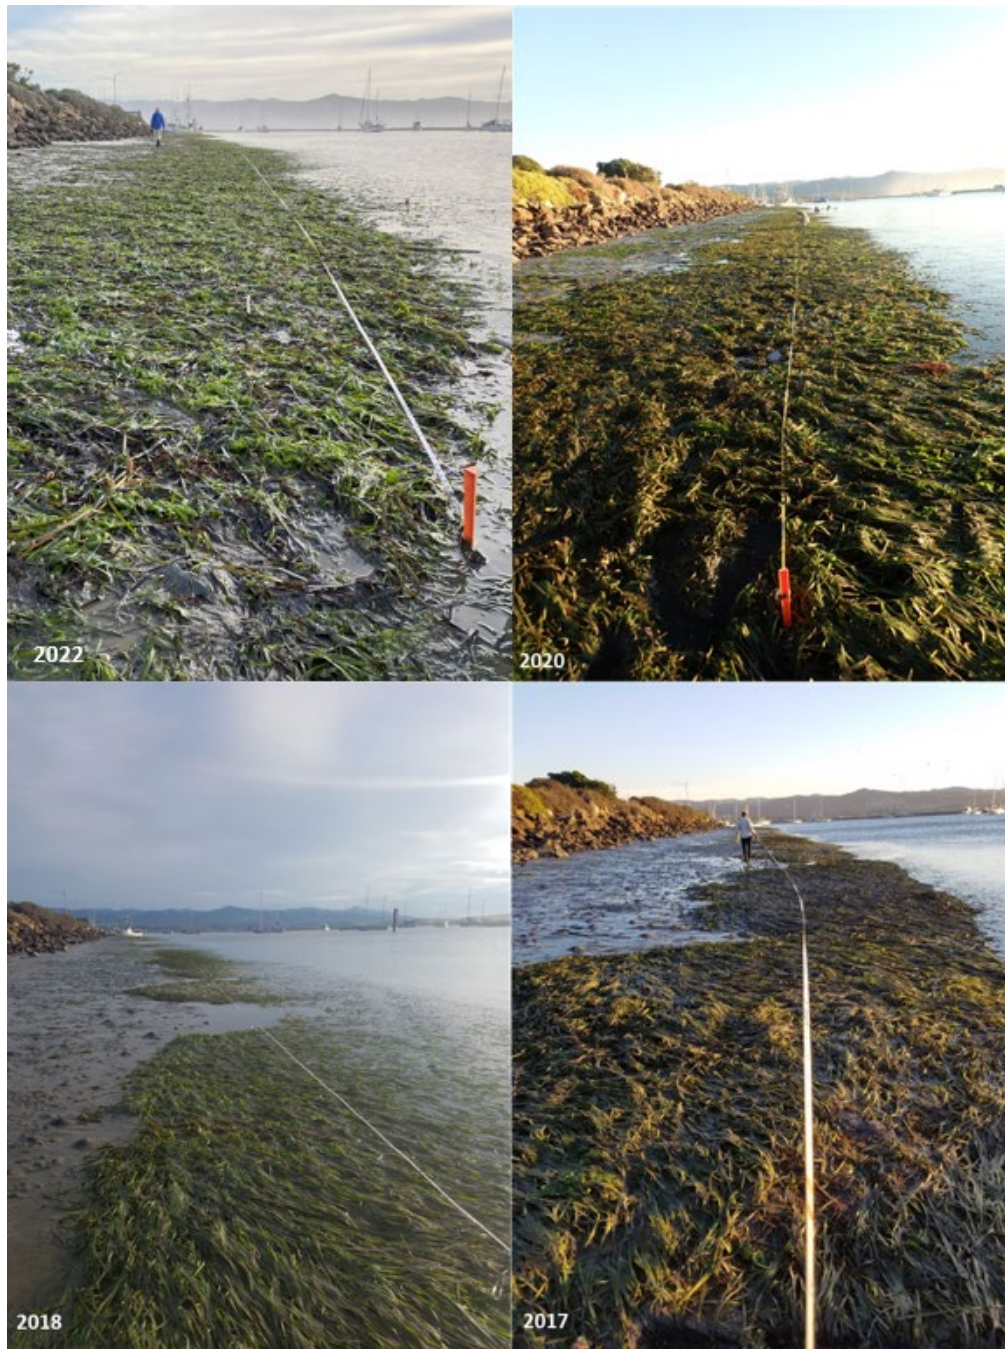
This transect was established in 2017 and is the newest of the six permanent transect monitoring sites. Eelgrass density in 2022 was the lowest recorded at this site since 2017 and marks the second year of decline in a row. The Embarcadero transect had been a harvest site for restoration efforts for multiple years.

**Figure 14.** Permanent transect monitoring at Embarcadero Transect, 2017 to 2022.

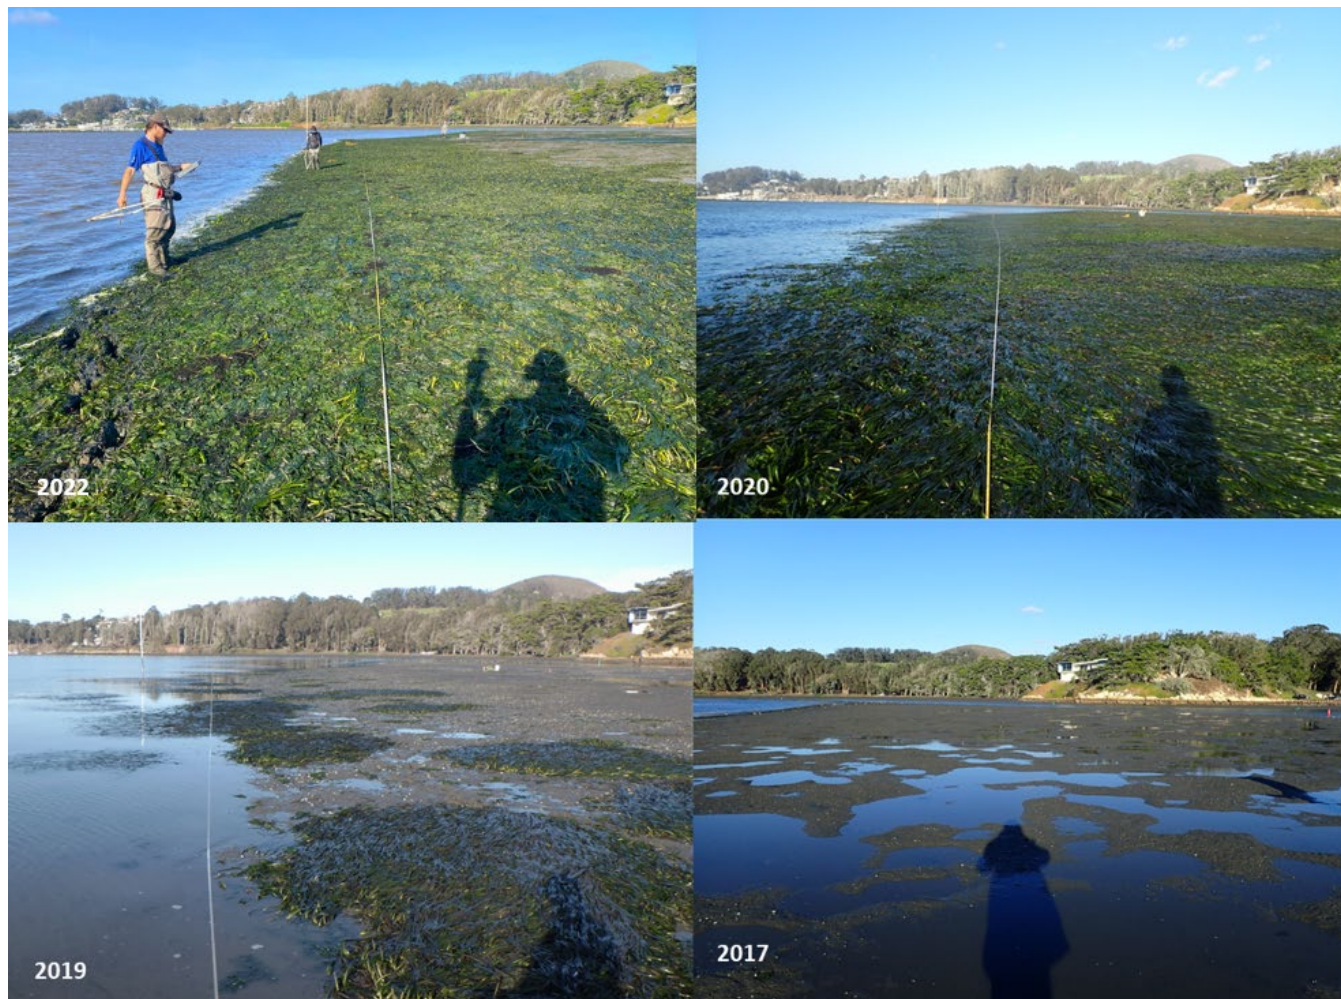
After this transect was established in 2012, no eelgrass was present from 2013 to 2017. Patchy eelgrass began appearing in 2018 and 2019 and has formed into one continuous bed. The shoot density observed in 2022 is the highest recorded after a decade of monitoring.

**Figure 15.** Permanent transect monitoring at Marina Transect, 2017 to 2022.

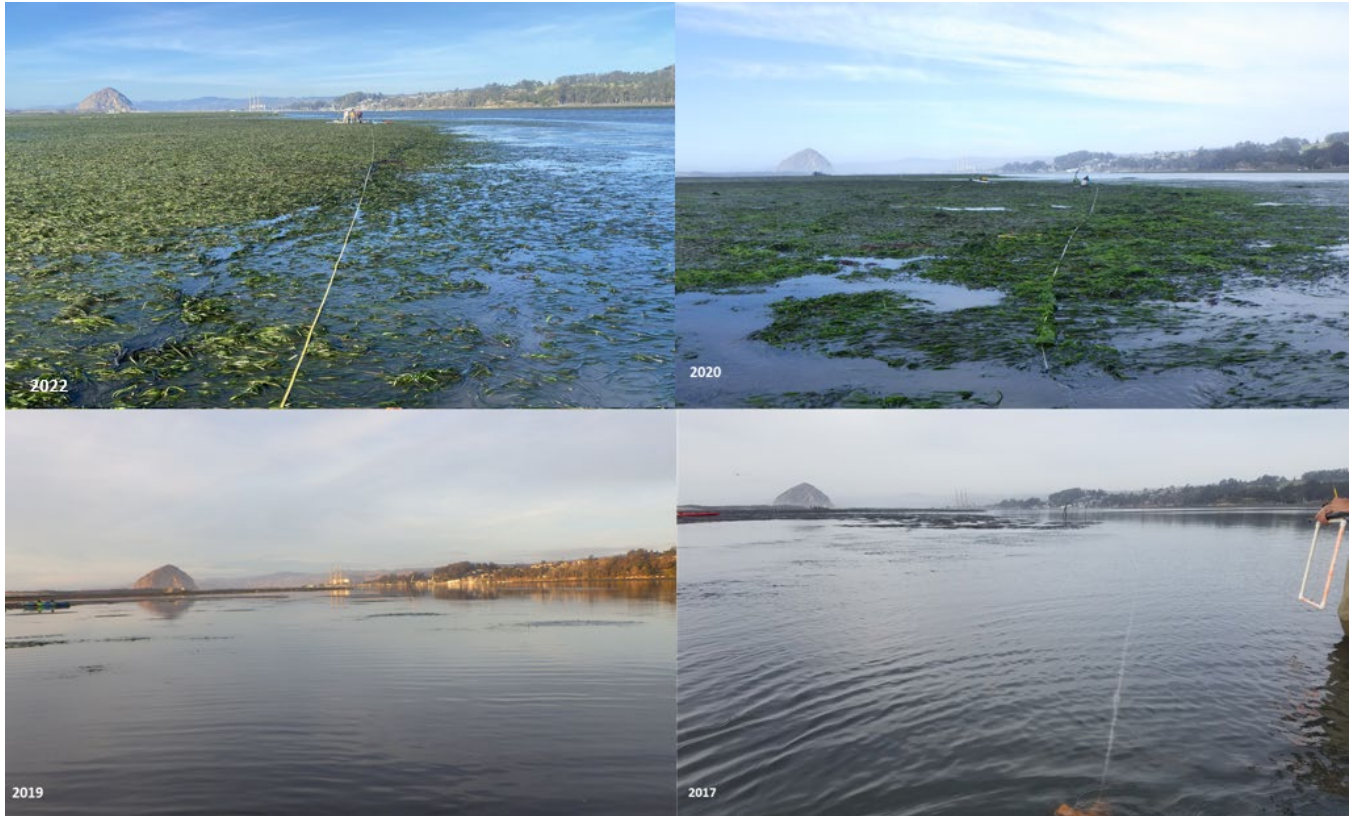
Shoot density at the Chorro transect returned to pre-decline levels in 2021 and has reached the highest density observed at this site since 2008. Eelgrass had not been recorded here since 2010 but reappeared in 2019. Surveys were not conducted at this transect in 2011 to 2012 and 2015 to 2016 due to staffing limitations and time constraints.

**Figure 16.** Permanent transect monitoring at Chorro Transect, 2017 to 2022.

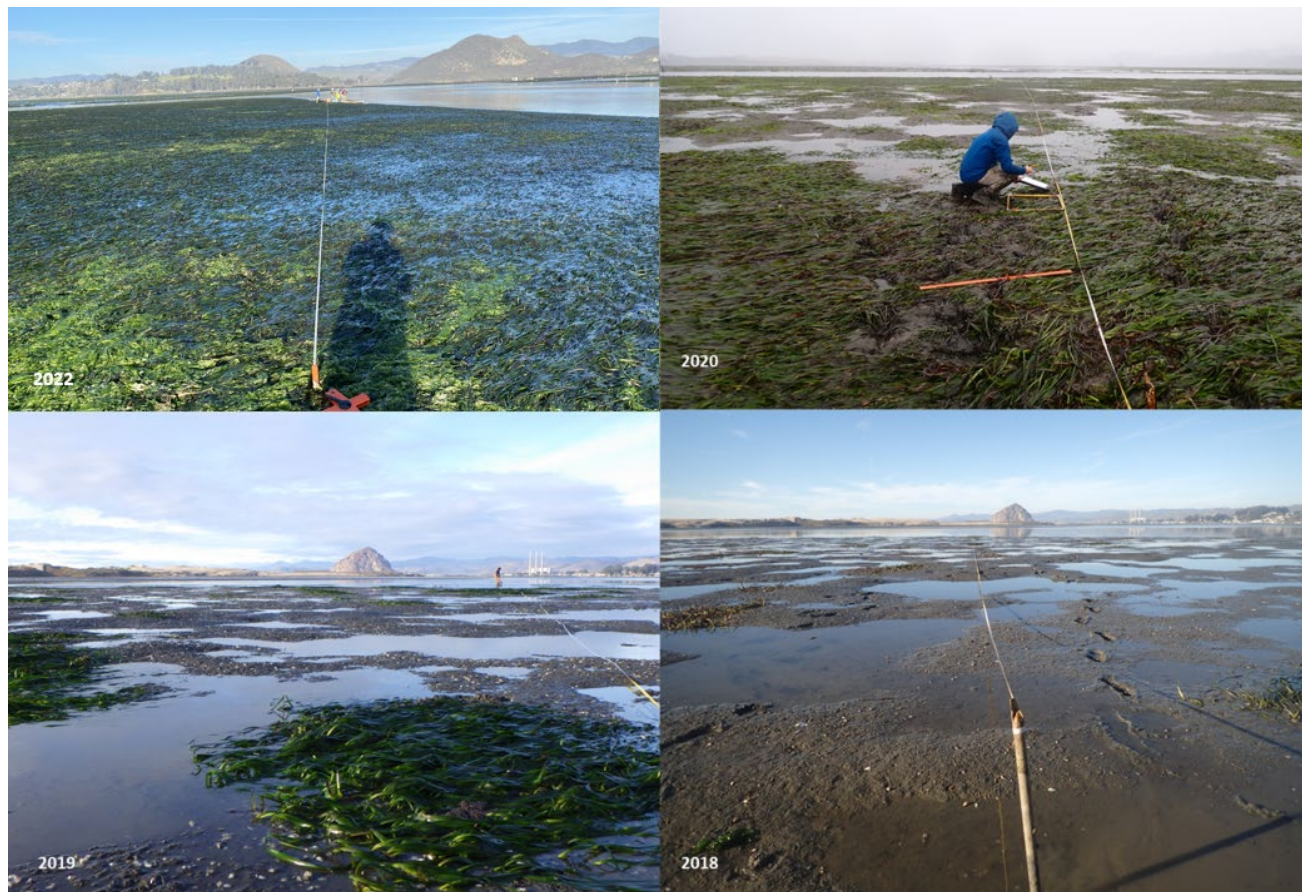
The Pasadena transect had the highest observed shoot density of 2021 and 2022. The photos below show the dramatic transformation that took place at this site over the past five years. In this relatively short time frame, eelgrass density has increased from 0 shoots/0.25 m<sup>2</sup> to 117 shoots/0.25 m<sup>2</sup>. The Pasadena transect was established in 2005, however the original transect location was lost and it had to be re-established at new coordinates in 2017. Due to the uncertainty of its original location, only data collected at Pasadena since 2017 has been included in the report.

**Figure 17.** Permanent transect monitoring at Pasadena Transect, 2018 to 2022.

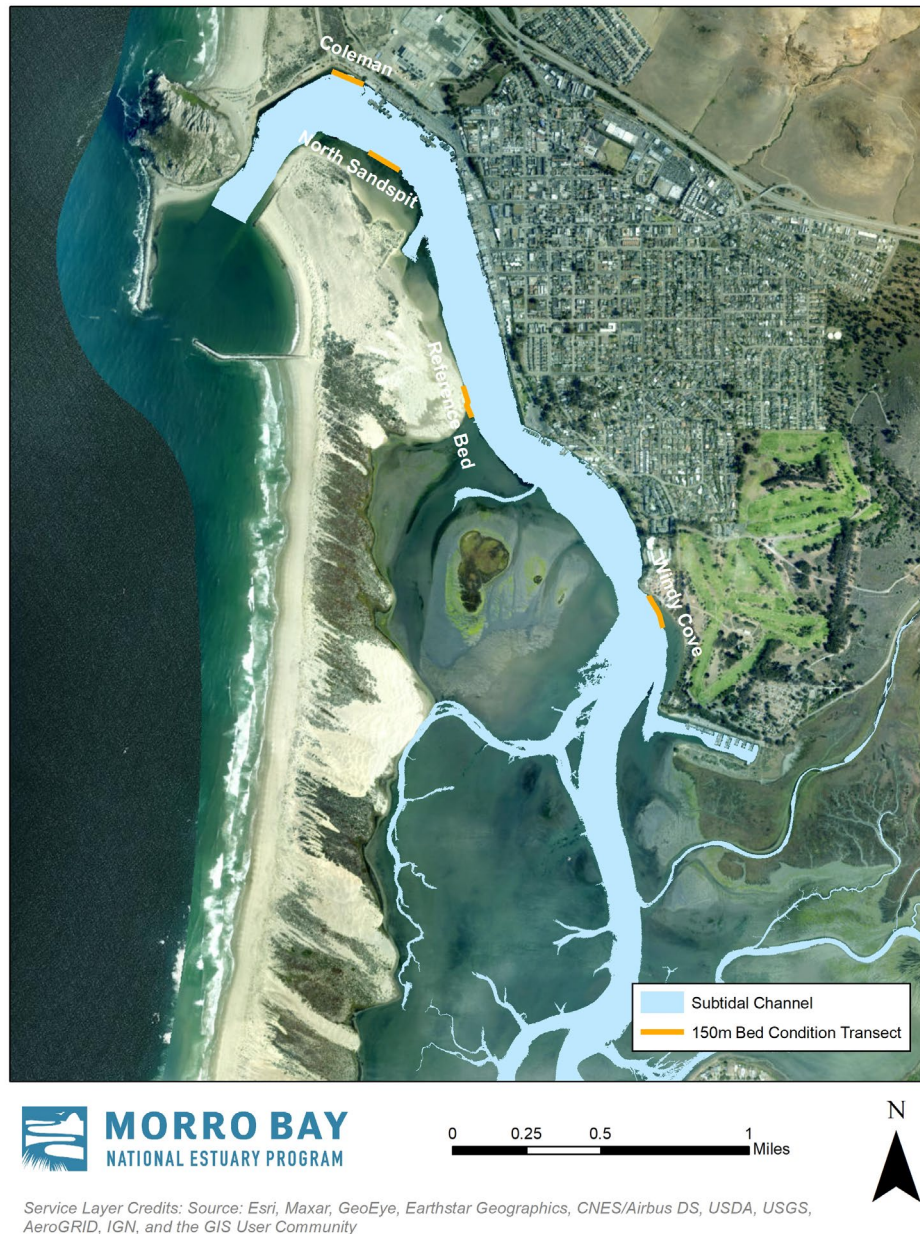
**Figure 18.** Bed condition monitoring sites at Coleman Beach, North Sandspit, Reference Bed and Windy Cove.

While in the field, eelgrass health is assessed using a combination of methods. Within each quadrat, stipe counts are conducted to determine eelgrass density, and plant and algae material are identified using the point-intercept method at 25 points. Between quadrats, eelgrass presence/absence is recorded along every meter of the transect to estimate the patchiness of the eelgrass bed.

An integral component of the Bed Condition protocol involves taking pictures of eelgrass plants and using photo processing to aid in the determination of blade health. At each site, five stipes are chosen from distinct locations within every quadrat. Each stipe is photographed with all the blades spread out against a whiteboard, so the full area of each blade is visible. These photos are then used to calculate percent cover estimates of eelgrass health indicators using ImageJ software.

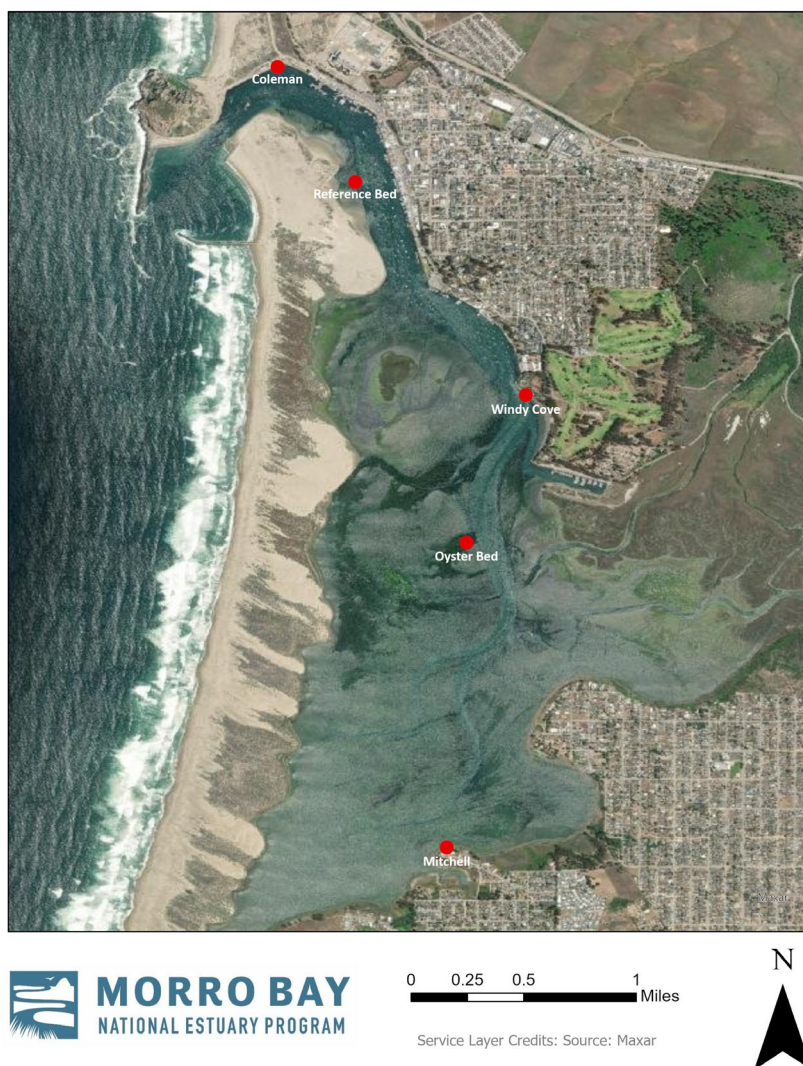
**Figure 21.** Eelgrass permanent plot monitoring locations.

In response to the decline of eelgrass in Morro Bay, permanent plots were installed in 2018 at five sites ranging from the front bay to the back bay (Figure 21). Three of these sites (Coleman, Reference Bed, and Windy Cove) are sites that had persistent eelgrass coverage through the period of recent eelgrass decline (2007 to 2016), while Oyster Bed and Mitchell represent areas where eelgrass coverage was lost.

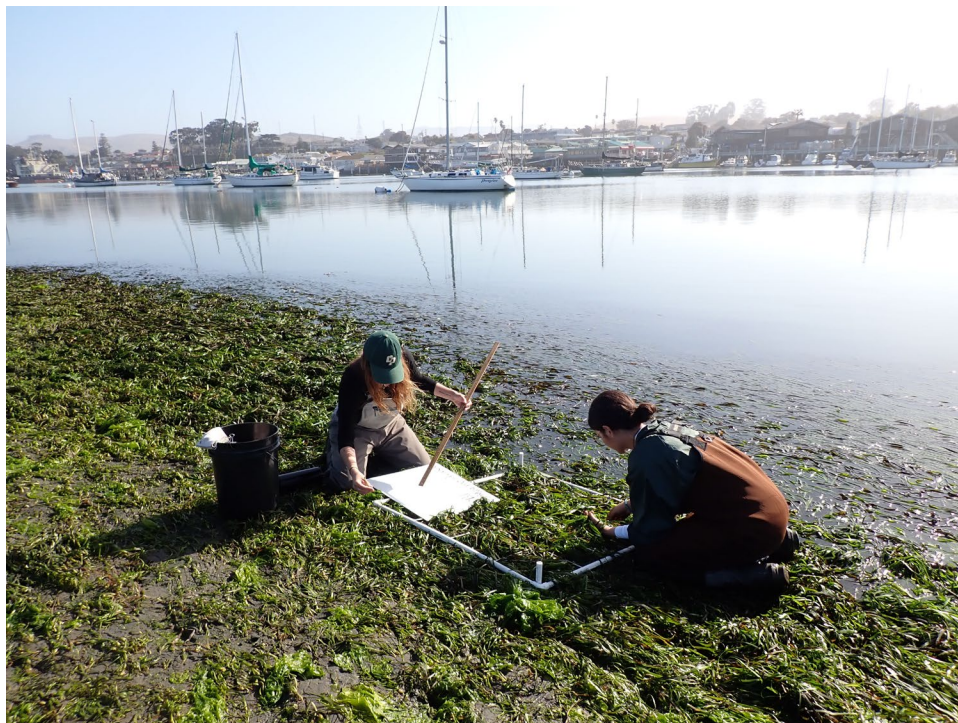
**Figure 22.** Density counts and blade length measurements. Stipes are counted in the center four quadrat squares and the longest blade for each stipe is measured with a meter stick, pictured at Reference Bed in spring 2022.

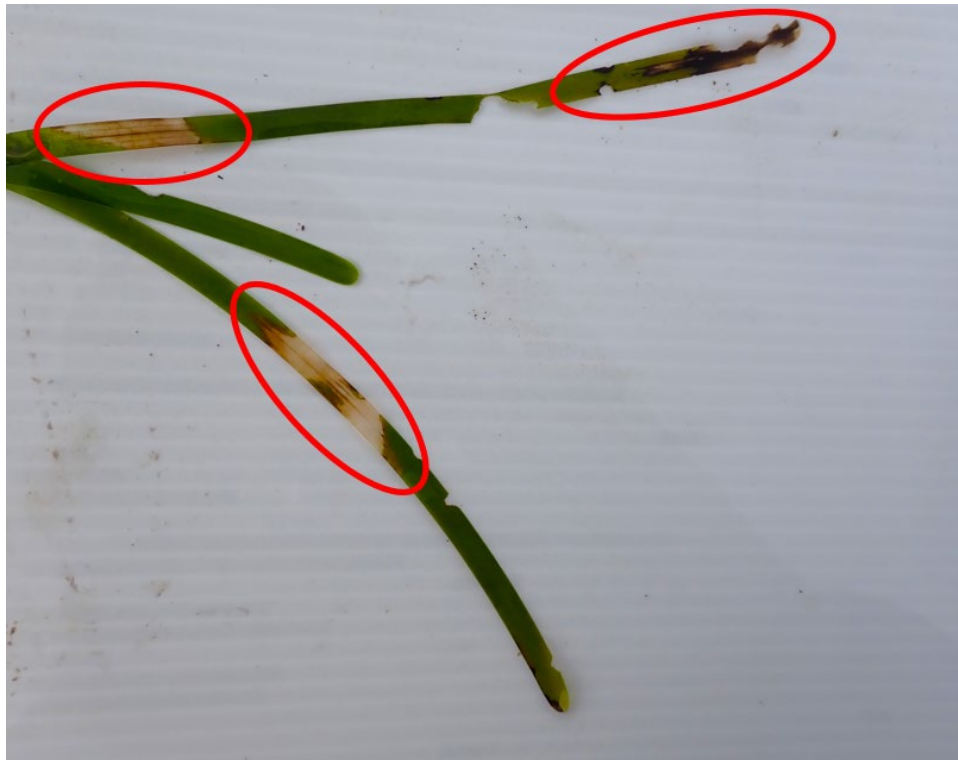
**Figure 27.** Stipe from Mitchell during the Spring 2022 monitoring. Most of the blades at the site were covered in spots of brown, necrotic tissue (circled in red).

Considering the indicators evaluated, several factors indicate that the location of the Mitchell site is less hospitable to eelgrass growth and recovery. This site has higher necrotic tissue and shorter blade lengths than other sites, indicating poor quality eelgrass, which is understandable given its location at the edge of pre-decline eelgrass extent. Through the permanent plot monitoring, we have found that eelgrass is able to grow across a range of conditions, and thus shows potential for high resilience.

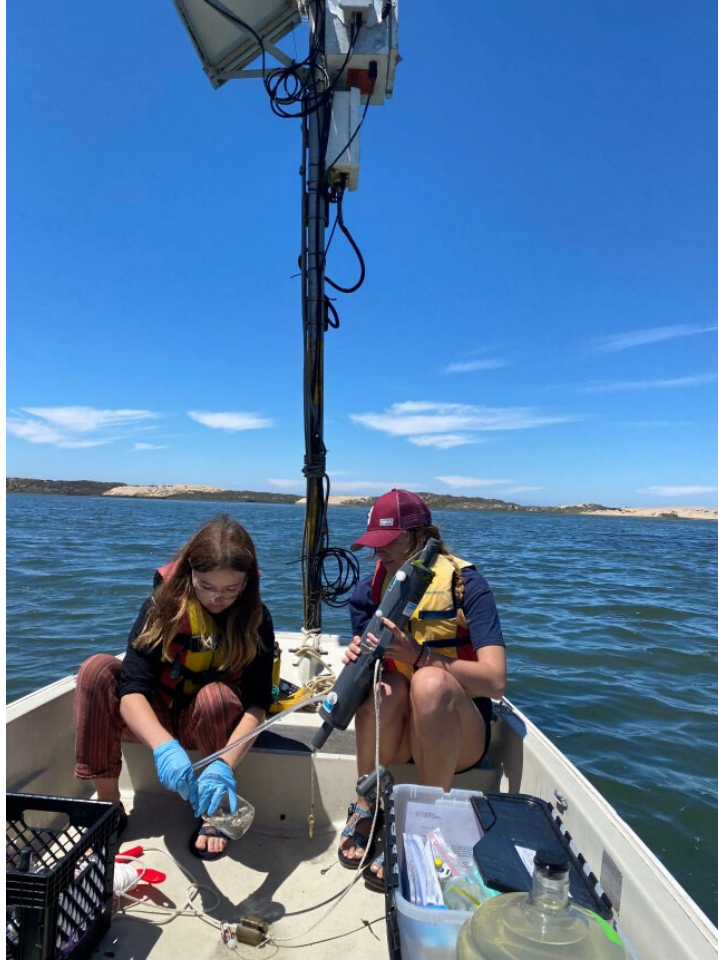
**Figure 28.** Dr. Emily Bockmon’s students collect water samples for carbonate chemistry analysis while anchored to the back bay weather station.

Dr. Emily Bockmon of Cal Poly's Chemistry Department oversaw numerous ocean acidification monitoring and carbonate chemistry sampling efforts. In 2020, two autonomous pH sensors were deployed, one at the bay mouth T-Pier and the other at a water quality sensor array in the back bay. Data is automatically uploaded from the sensor to the web and can be viewed here: <https://data.cencoos.org/#metadata/100050/station>. Data calibration, processing, and sensor maintenance are ongoing.
