Sediment Monitoring Report

For Water Year 2024

Morro Bay National Estuary Program
601 Embarcadero
Morro Bay, CA 93442

February 2026

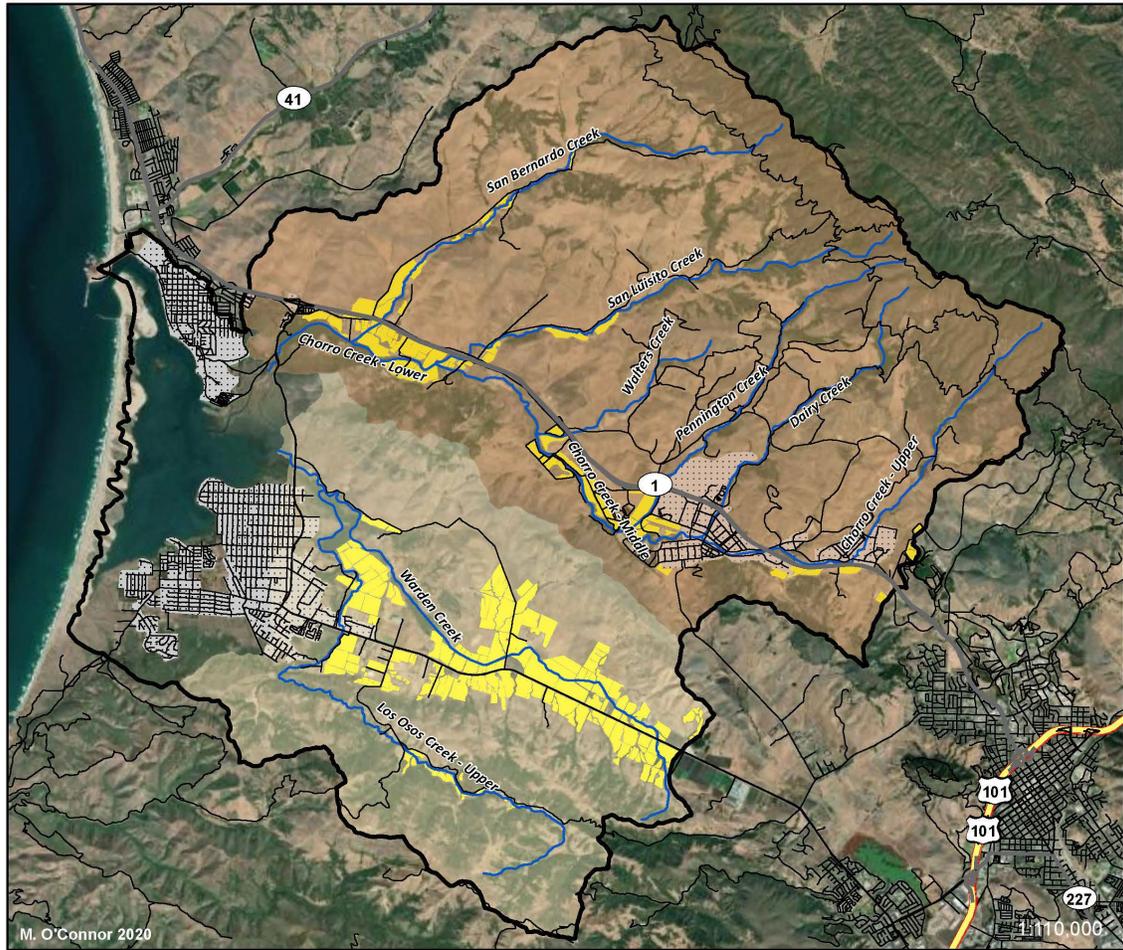
Figure 1. Map of the Morro Bay watershed.

The Morro Bay watershed is located in San Luis Obispo County on California's Central Coast and encompasses a drainage area of approximately 75 square miles. The inland watershed drains west to the Morro Bay estuary and Pacific Ocean via two primary creeks, Chorro Creek and Los Osos Creek.

The Chorro Creek subwatershed encompasses a drainage area of 43.4 square miles. Land use in the subwatershed is primarily agricultural, with much of the area used as rangeland for beef cattle operations. Notable urban areas include the City of Morro Bay, Cuesta College, the California Men's Colony prison complex, and Army National Guard Base Camp San Luis Obispo (Camp SLO). Chorro Creek receives drainage from several tributaries: Dairy Creek, Pennington Creek, Walters Creek, San Luisito Creek, and San Bernardo Creek.

The Los Osos Creek subwatershed encompasses a drainage area of 23.1 square miles. Land use in the subwatershed is primarily agricultural and residential. In contrast to the Chorro Creek subwatershed, agriculture in the Los Osos subwatershed is characterized by plowed rotational fields generating a variety of forage and truck crops. Much of the intensive farming operations in the watershed occur in the Warden Creek drainage area.

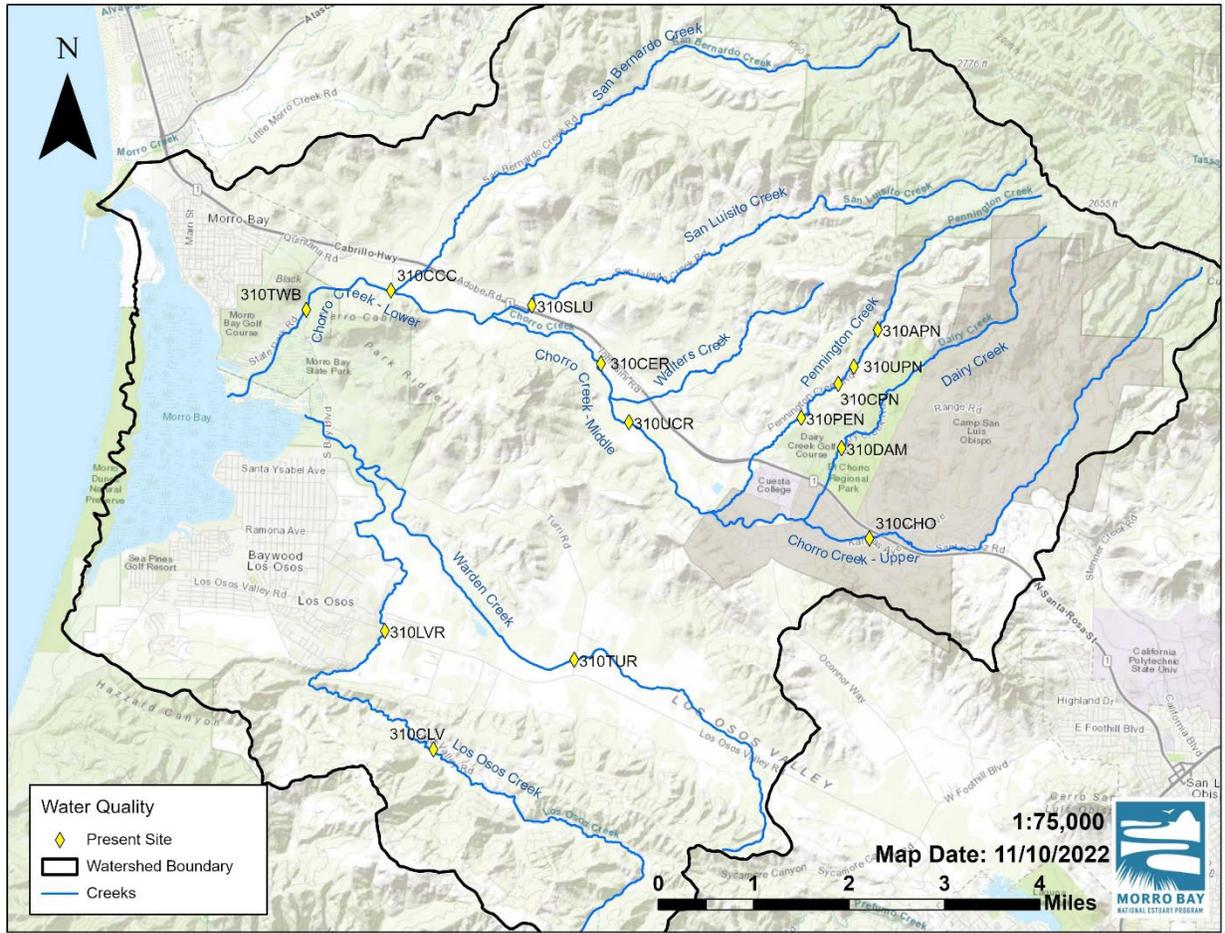
Figure 2. Map of the Estuary Program’s ambient water quality monitoring sites.

The Estuary Program's Monitoring Program has been conducting routine water quality monitoring throughout the estuary and watershed since 2002. Data is collected monthly by staff and trained volunteers per the program's Quality Assurance Project Plan (QAPP). Figure 2 illustrates a subset of ambient water quality monitoring sites located throughout the watershed. The sites shown are either perennial or semi-perennial and have long-running datasets.

Staff and volunteers measure a variety of water quality parameters including nephelometric turbidity and instantaneous flow volume. While this data is important for understanding long-term ambient trends across the watershed, it does not capture conditions during major winter storm events. Due to safety issues and monitoring constraints, data is only collected when streams are wadeable.

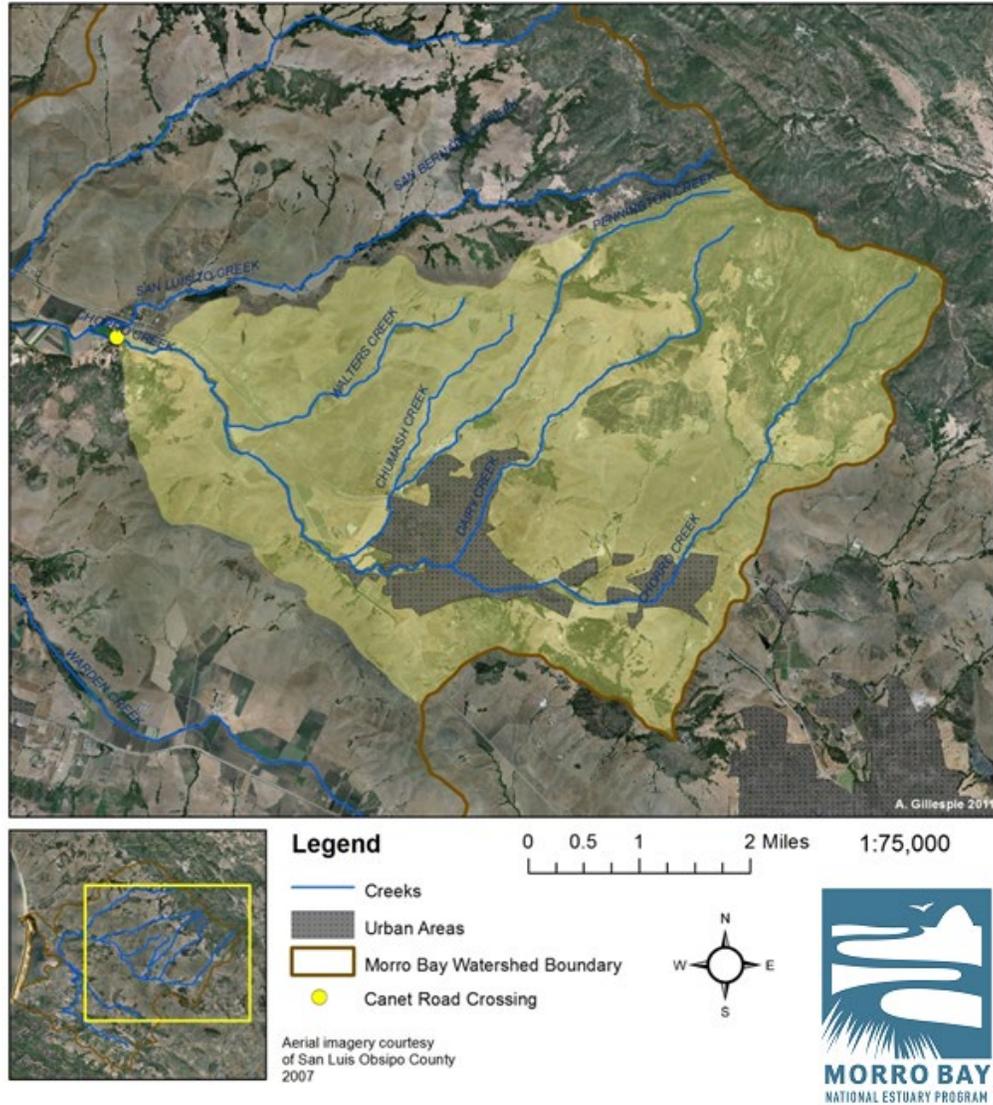
Figure 3. Map of watershed area that drains to Canet Road monitoring site.

The Station 753 gauge at Canet Road includes a drainage area of approximately 21.8 square miles of the 43-square-mile Chorro subwatershed. This area includes flows from the Pennington Creek, Dairy Creek, and Walters Creek tributaries, as shown in the map below.

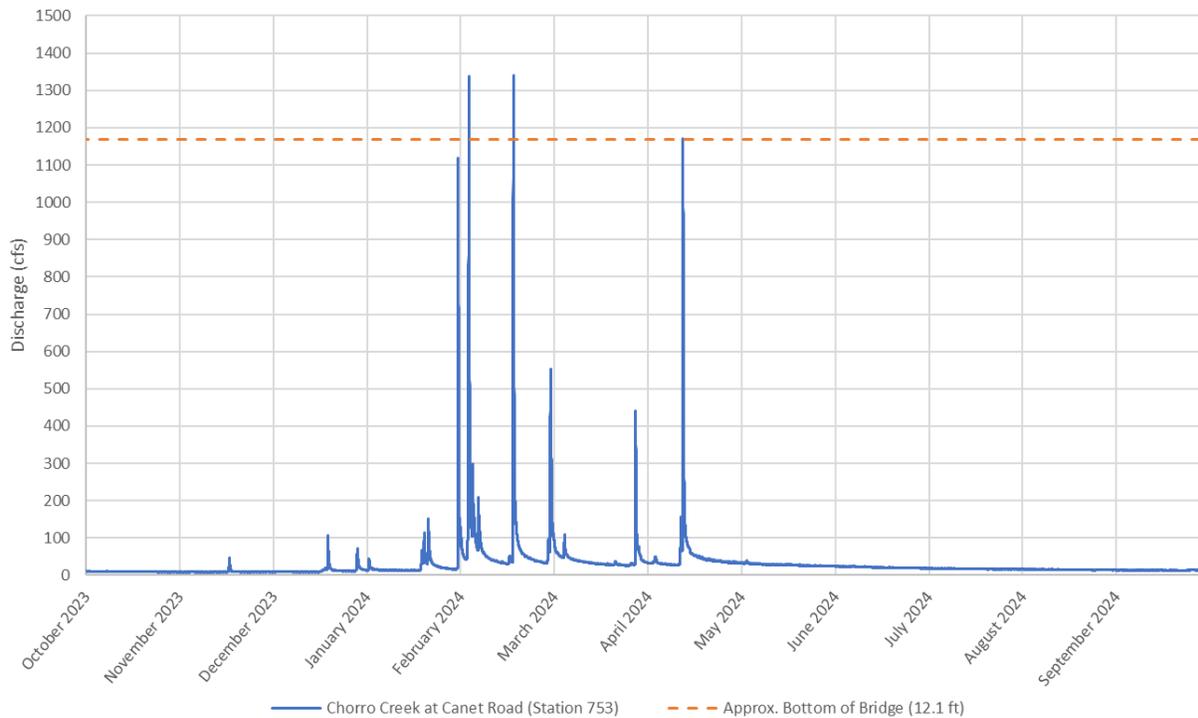
Figure 4. Chorro Creek hydrograph for WY2024 using rating curve equations for Station 753.

The hydrograph below shows Chorro Creek discharge during water year³ 2024 (WY2024), using the equations presented above. The orange dotted line represents the point at which water levels have exceeded the bottom of the bridge at Station 753 (approximately 12.1 feet). Bridge-topping events reflect conditions capable of transporting larger sediment loads.

For each of the following equations, **Q (cfs)** is the estimated discharge of Chorro Creek at Canet Road, and **Y** is the stage value in feet as recorded by the SLO County stream gauge at Station 753. Please note that the equations cannot accurately predict discharge when stage values are less than 3.75 feet or greater than 18.2 feet, as those values are outside of the known stage-discharge relationship.

1. For stage values between 3.75 feet and 4.02 feet, discharge is assumed to be zero: **Q (cfs) = 0**.
2. For stage values greater than 4.02 feet and less than or equal to 11.2 feet, estimate discharge with the equation: **Q (cfs) = 20.907*(Y - 3.75)² - 5.8341*(Y - 3.75)**.
3. For stage values greater than 11.2 feet but less than 13.7 feet, use the linear interpolation: **Q (cfs) = 56.826*Y + 480.48**.
4. For stage readings greater than 13.7 feet and less than or equal to 18.2 feet, use the equation: **Q (cfs) = 1200 + 88.02*[(Y - 13.2) + 0.3259]²**.

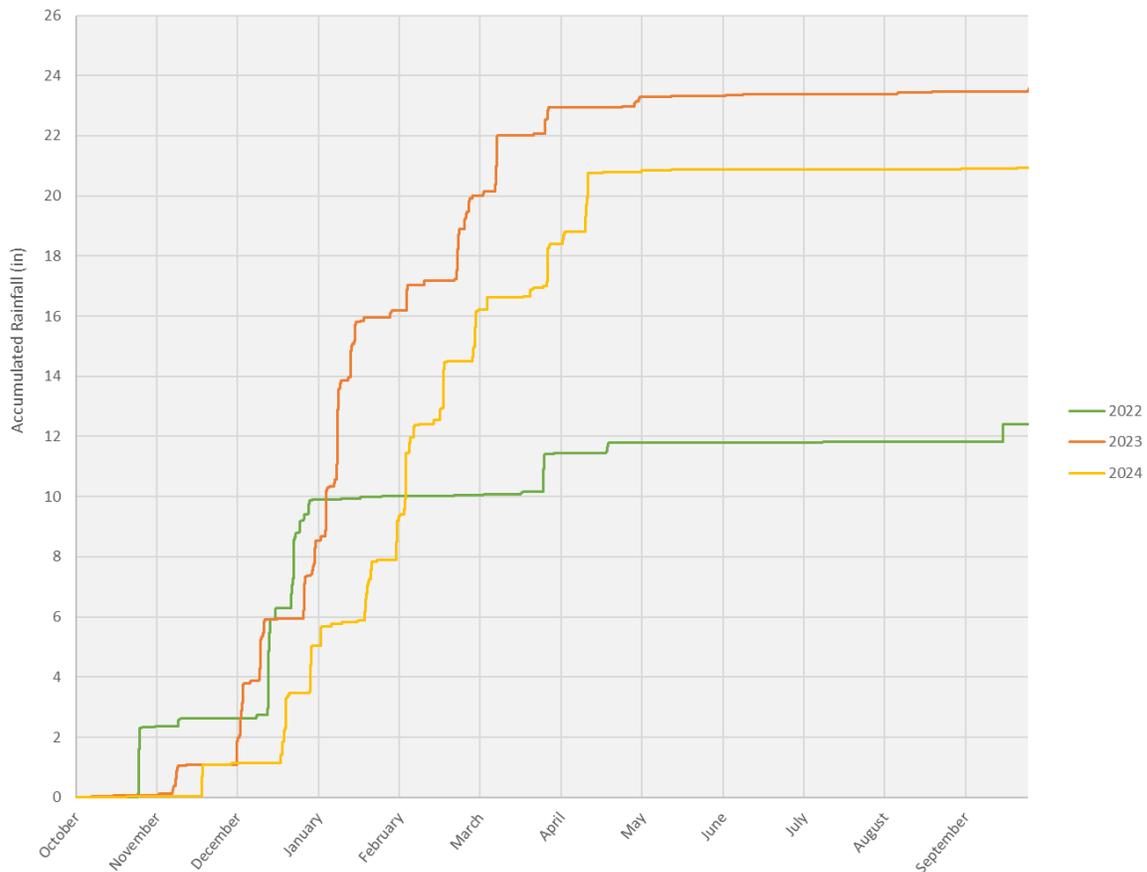
Figure 5. Accumulated annual rainfall for WY2020 to WY2024.

The graph below shows accumulated rainfall for WY2022 through WY2024, illustrating precipitation timing and intensity variability from year to year. Vertical peaks on the graph indicate high-intensity rainfall over a short period of time, while flat horizontal lines represent dry periods. WY2022 (in green) shows early season rainfall with a low overall accumulated rainfall. WY2023 (in orange) presents as a high rainfall year with a sharp increase in accumulated rainfall between January and February. WY2024 (in yellow) represents a more average water year, with later moderate intensity storms. Both WY2023 and WY2024 had rains later in the year than is typical, with storms occurring as late as April.

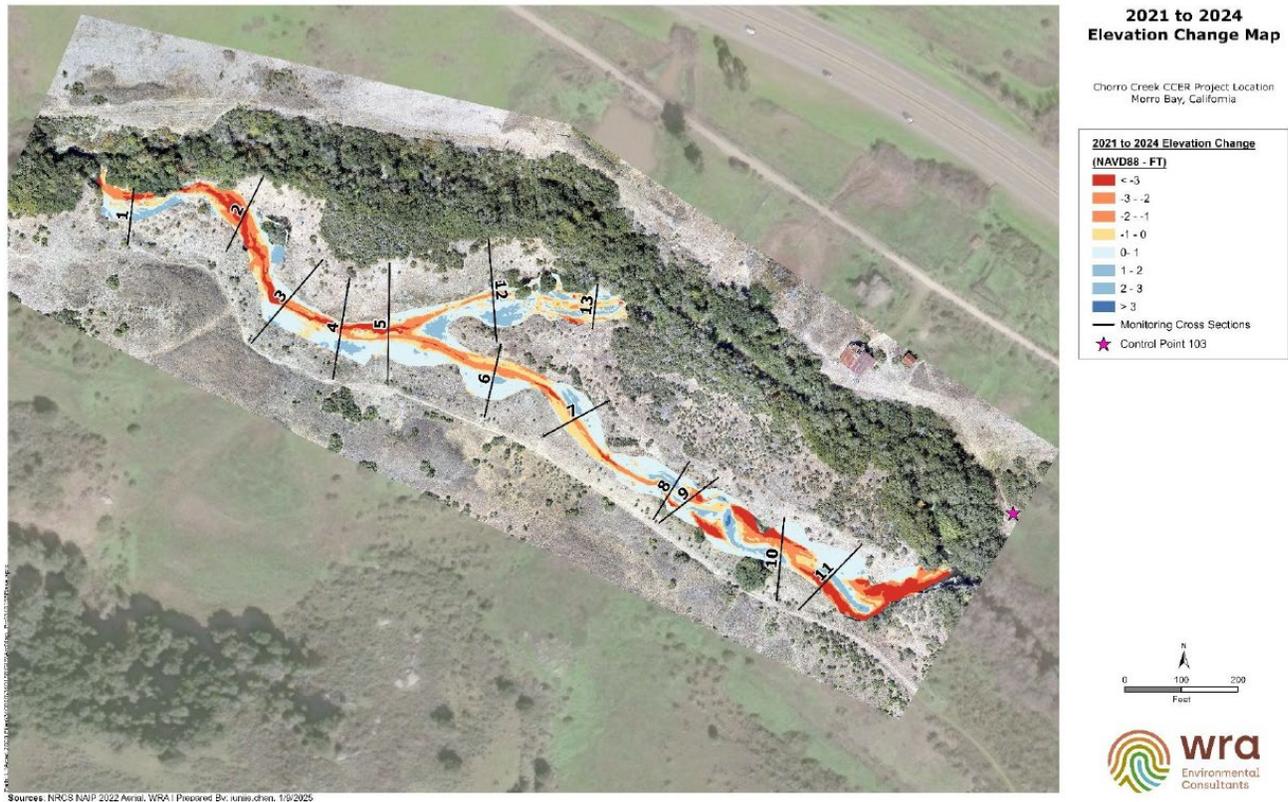
Figure 6. Elevation change at the Chorro Creek Ecological Reserve (CCER) between 2021 and 2024. Map courtesy of WRA Environmental Consultants.

The combined LiDAR and stream survey data revealed spatially variable patterns of sediment deposition and erosion. Figure 6 shows the elevation change at the CCER project site between 2021 and 2024 with negative elevation changes in shades of red and orange (erosion), positive elevation changes in shades of blue (deposition), and no elevation change in light blue.

In the upstream area of the project site (XS11 to XS8 in Figure 8), significant incision was identified with elevation losses of over three feet in some areas. Toward the middle of the site (XS7 to XS4), geomorphic patterns were more complex with some active erosion, sediment transfer, and localized deposition. The downstream region (XS3 to XS1) showed moderate erosion and some deposition toward the channel outlet. The former main channel, now functioning as side channel (XS12 and XS13), showed clear signs of deposition, reflecting its effectiveness at sediment capture and reducing downstream sediment transport.

The California Department of Fish and Wildlife’s Criteria for Fish Passage recommends that elevation drops exceeding one foot should have downstream jump pools with depths of at least two feet to support migratory fish passage (CDFW, 2002). To evaluate fish passage implications, the longitudinal profile results were analyzed with special attention for areas where the elevation dropped more than one foot. Water surface levels were also analyzed to assess jump pool depth. Several notable drops identified included a 3.89-foot drop near the downstream end of the project site (XS1), a 4.13-foot drop toward the middle of the site (between XS3 and XS4), and a 3.47-foot drop on the lower part of the upstream end (XS8). Water surface elevations measured at cross-sections suggested that some pools, such as those near the downstream end (0.69 feet at XS1; 0.95 feet at XS4), likely provide insufficient depths for fish passage.

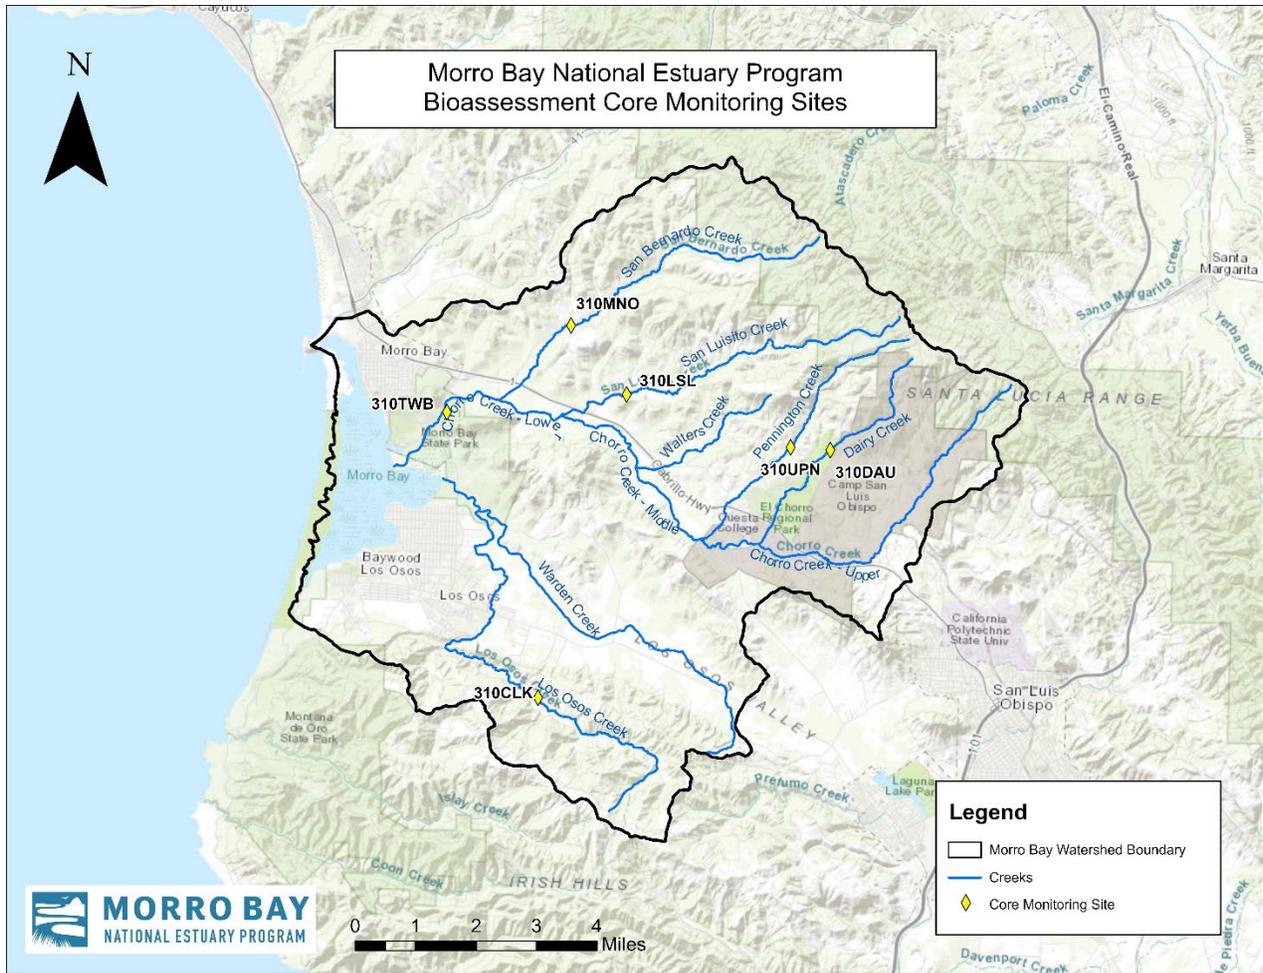
Figure 7. Core bioassessment monitoring sites in the Morro Bay watershed.

The Estuary Program monitors ten bioassessment sites each year based on program data needs, hydrologic conditions, and site accessibility. Sites are designated as “core” or “rotating.” Core sites are monitored every year, and rotating sites are monitored approximately every three years. The six core monitoring sites are included in this sediment analysis. Five of the six core monitoring sites are located in the Chorro subwatershed, and one is located in the Los Osos subwatershed (site code 310CLK). The sites within the Chorro subwatershed are Pennington Creek (310UPN), San Bernardo Creek (310MNO), San Luisito Creek (310LSL), Dairy Creek (310DAU), and lower Chorro Creek (310TWB).

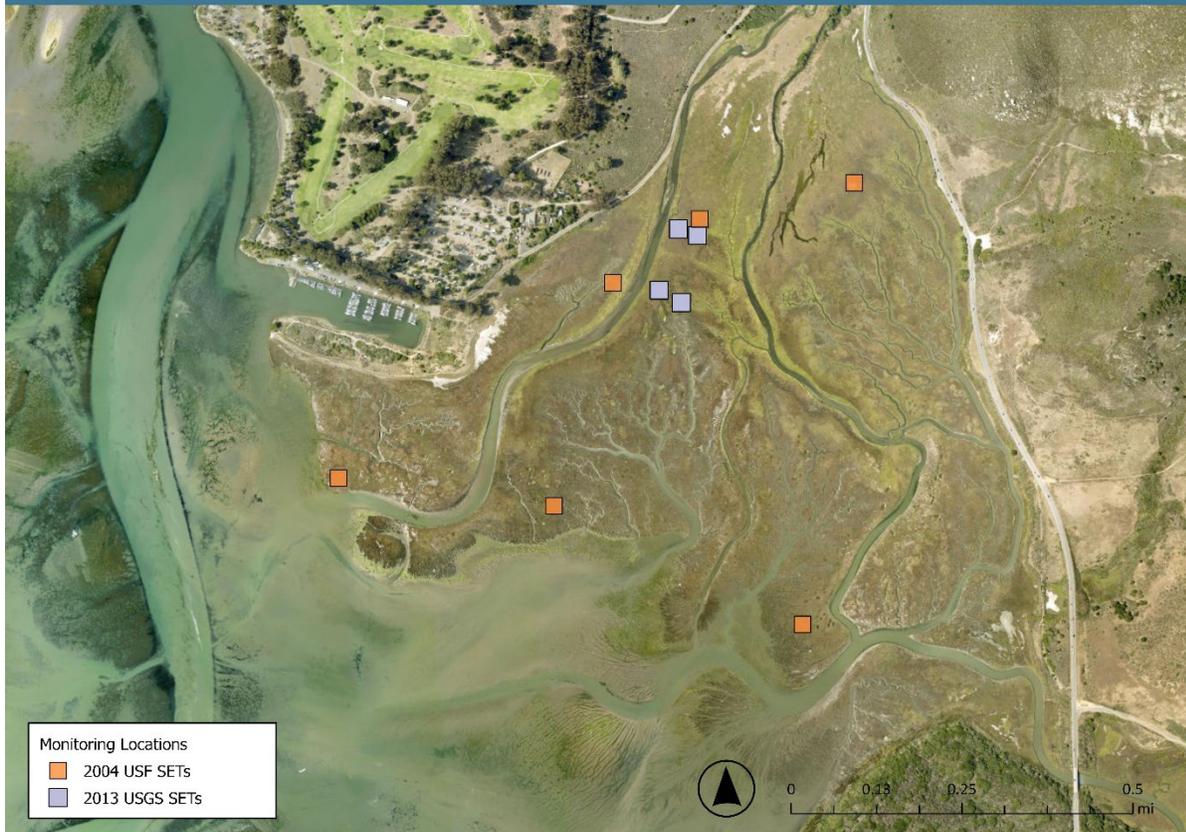
To monitor long term sedimentation and elevation change in the salt marsh, USGS and USF utilize a combination of methods including surface elevation tables (SETs) and feldspar marker horizon plots. SETs are mechanical devices anchored to fixed monuments in the ground and used to precisely measure changes in marsh elevation. Feldspar marker horizons involve sprinkling a thin layer of feldspar clay on the surface of the plot and measuring the amount of sediment that naturally settles on it over time.

Figure 8. SET and feldspar locations in Morro Bay. Sites in orange represent monitoring locations established by USF in 2004, and sites in purple represent those established by USGS in 2013.
