# **Morro Bay National Estuary Program**

## **Morro Bay Eelgrass Report 2024 & 2025**

October 2026

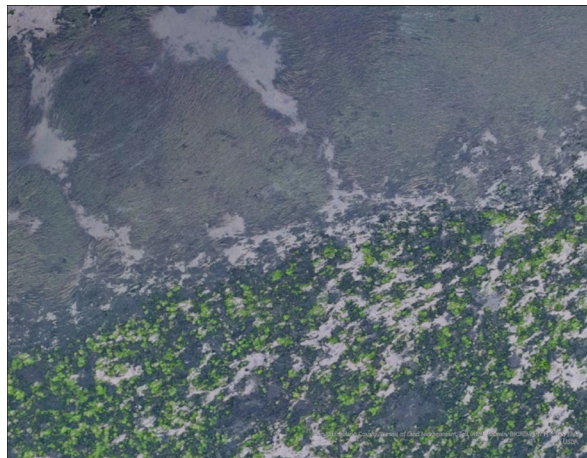
**Figure 2.** Demonstration of the image resolution captured with M&A's UAV drone during spring of 2025. High resolution imagery allows for the differentiation between eelgrass beds and algae mats, which are otherwise difficult to classify visually. Eelgrass beds (top half of image) are typically dark green and exhibit a wavy, hairlike texture due to the long, slender blades. Algae mats (bottom half) are generally light green and appear in a more random, strewn-about fashion.

The 2025 data were ground-truthed using a combination of underwater drop video camera, low-tide surveys conducted by both M&A and the Estuary Program, and extremely low-altitude UAV imagery to get a closer look at eelgrass morphological characteristics. Over 1,000 ground-truth points were collected, half of which were used for guiding classifications and half for assessing the accuracy of the final map. Comparing the ground-truthing results with the final acreage resulted in an accuracy assessment of 98.5%.

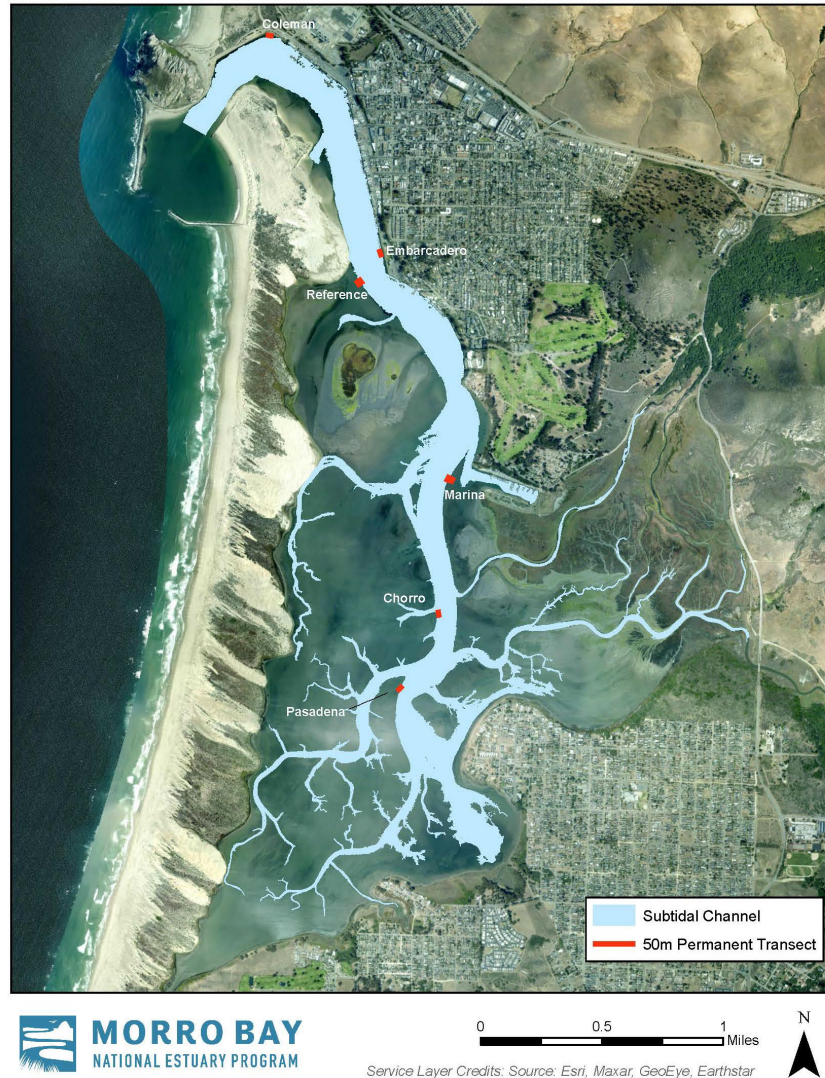
**Figure 5.** The six current permanent transect monitoring locations: Coleman, Embarcadero, Reference (previously named Tidelands), Marina, Chorro, and Pasadena.

Permanent transects were established to track changes in eelgrass shoot density throughout Morro Bay starting in 2005. There are six transects currently monitored in the bay (Figure 5). Four transects (Coleman, Reference, Chorro, Pasadena) were monitored annually from 2006 to 2010. No data were collected in 2011 due to staffing logistics. In November 2012, a fifth transect was established near the State Park Marina. From 2012 to 2016, some sites were not surveyed due to poor weather or tide conditions. In December 2017, a new transect was established on the eastern side of the channel at Tidelands Park, called “Embarcadero.” The transect now called “Reference” was originally named “Tidelands” but has since been renamed to avoid confusion.

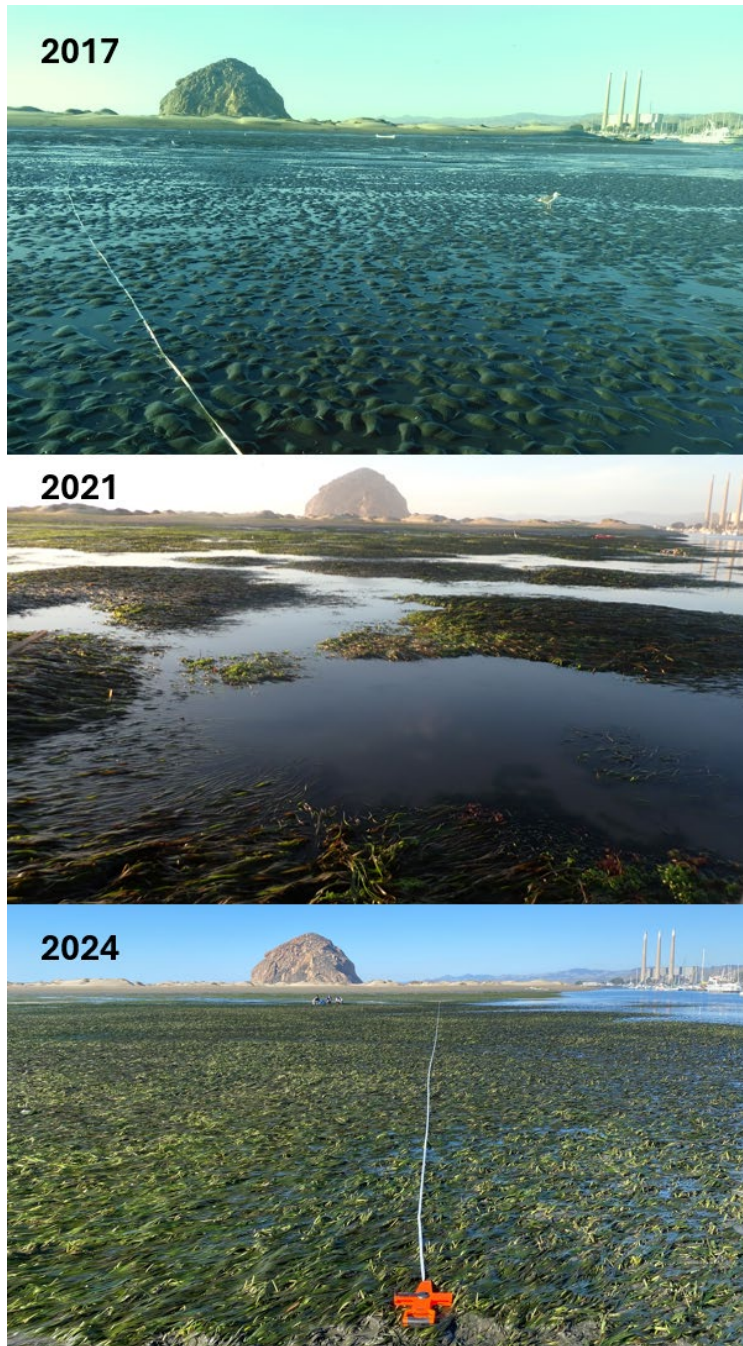
**Figure 10.** Permanent Transect monitoring at Reference Transect, 2017 to 2024. As was the case for many sites across the estuary, Reference was a mudflat in 2017 that has since expanded to a fully continuous eelgrass bed spanning as far as the eye can see. At this site in particular, recovery was patchy at first, starting out as eelgrass “islands” that retained sediment while the area around it eroded. These islands have since grown together into one large eelgrass bed that had the highest density of all survey sites in both 2024 and 2025.

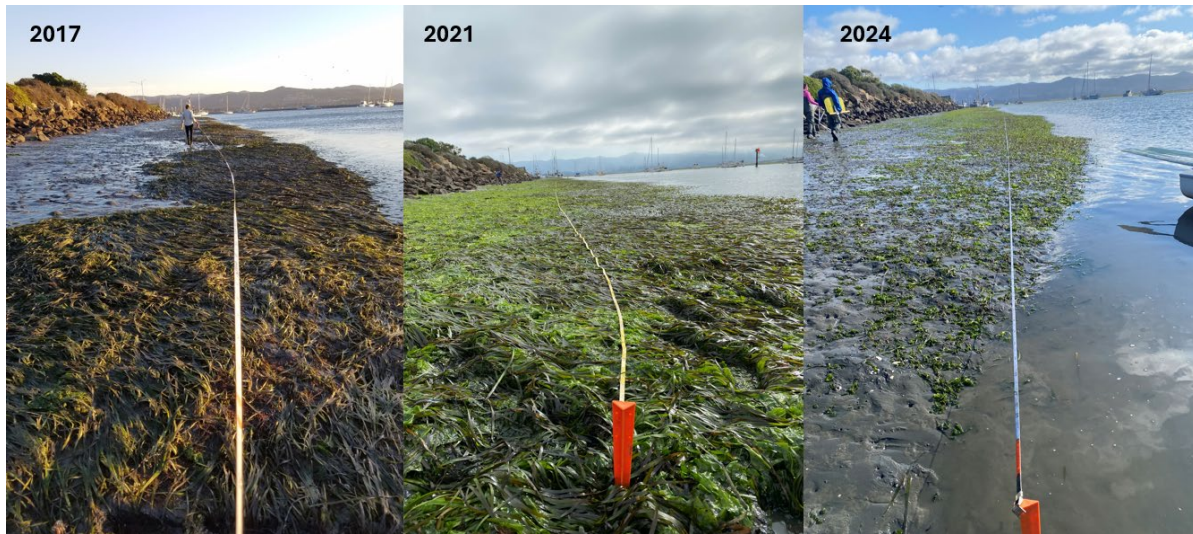
**Figure 11.** Permanent Transect monitoring at Embarcadero Transect, 2017 to 2024. This site has been an anomaly in recent years, experiencing a significant decline in eelgrass density while other sites have been stable or increasing. Starting in 2020, green algae made up a quarter of visible canopy at this site, which is notably higher than the rest of our monitoring locations. Algae coverage reached nearly 50% in 2023, after which eelgrass density fell considerably.

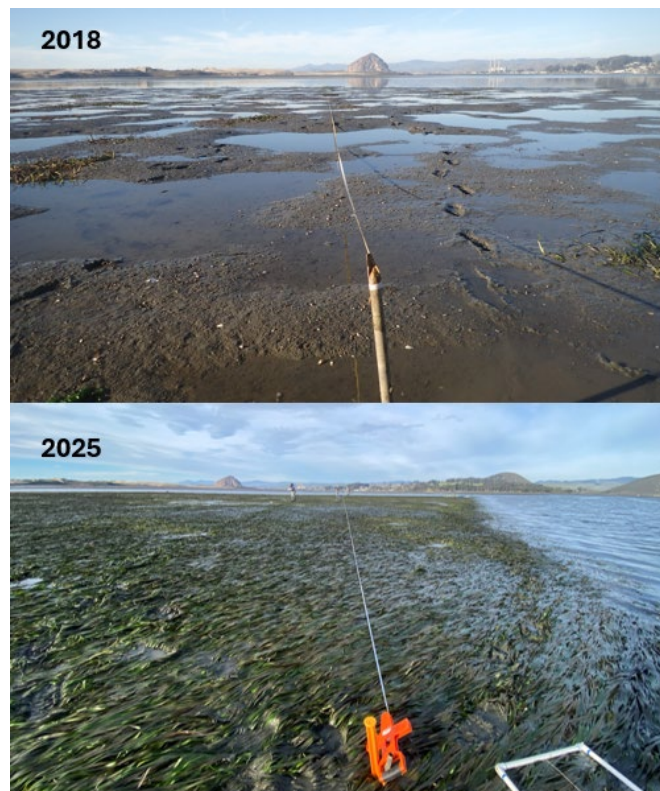
**Figure 12.** Permanent Transect monitoring at Pasadena Transect, 2018 and 2025. Pasadena serves as a representation of the Back Bay eelgrass recovery post-2017. The warmer and shallower Back Bay experienced the highest acreage declines from 2007 to 2017, but have since become covered in dense, continuous beds.

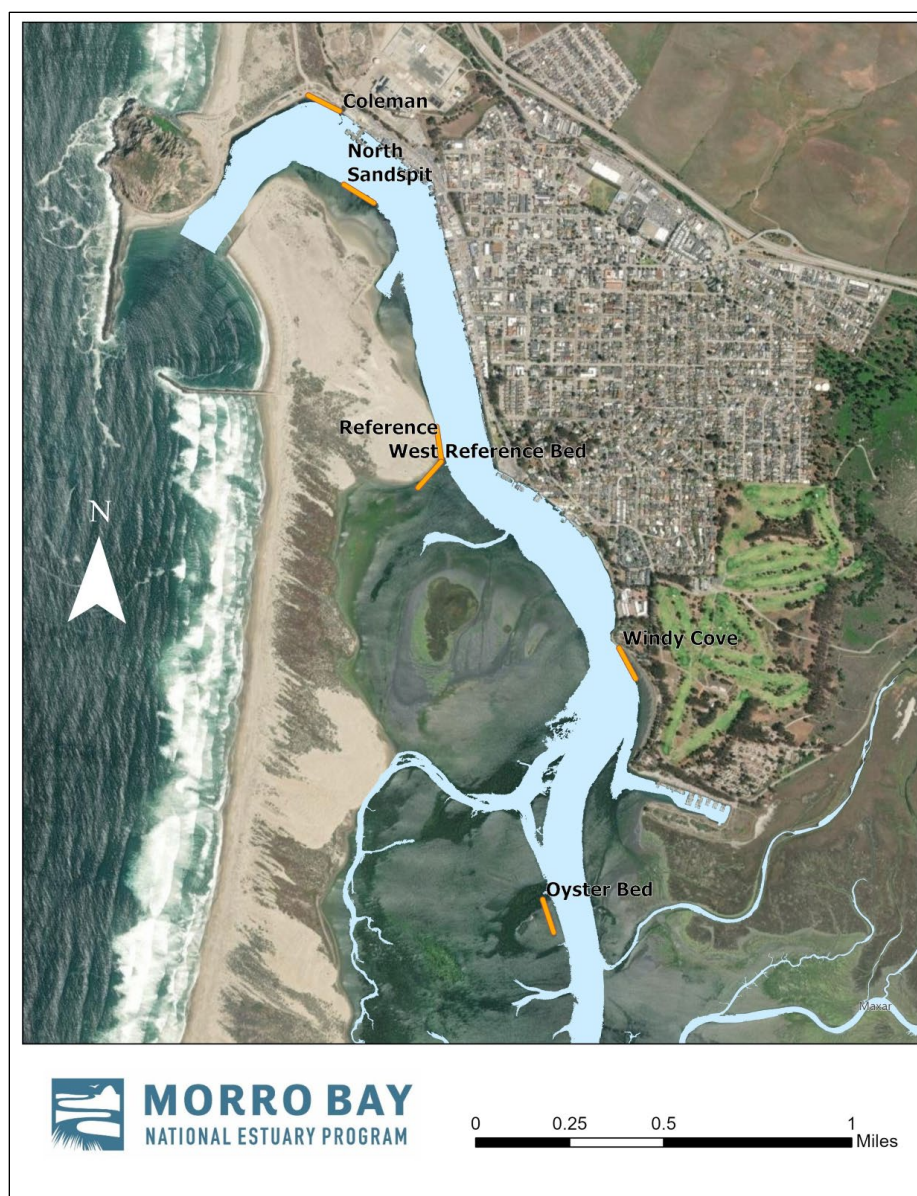
**Figure 13.** Bed condition monitoring sites at Coleman Beach, North Sandspit, Reference Bed, Reference West, Windy Cove, and Oyster Bed.

The Estuary Program conducted spring 2024 and 2025 bed condition monitoring at Coleman Beach, North Sandspit, Reference Bed, Windy Cove, and Oyster Bed sites (Figure 13). North Sandspit and Reference Bed were both established at the beginning of the project but have had gaps between sampling years due to a lack of available tides. The Reference Bed site was modified to include an additional transect (Reference West) running perpendicular to the historic transect, which has experienced significant erosion and now contains only a few dwindling patches of eelgrass. The Oyster Bed transect was established and monitored for the first time in 2023. This site was originally a Permanent Plot monitoring site, but after this project was discontinued in 2022, the site was modified into a 150-meter transect to fit the protocol of the Bed Condition project. The figures below display results from preliminary data analysis using only the spring intertidal data from 2016 to 2025.

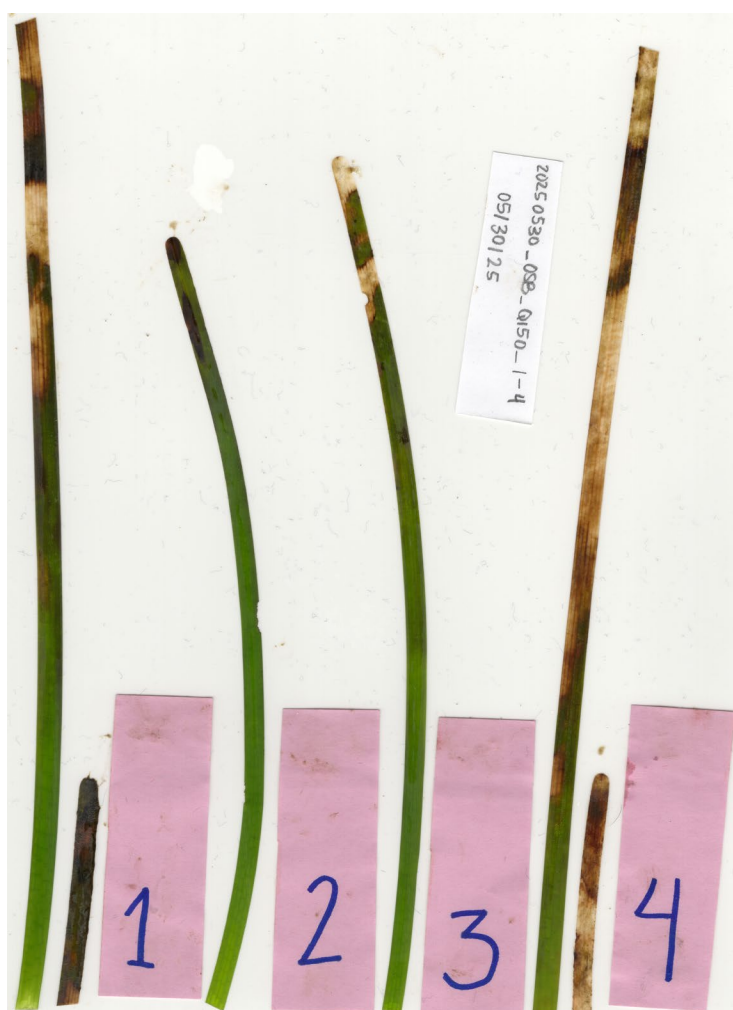
**Figure 16.** Eelgrass blades from Oyster Bed during the spring 2025 Bed Condition survey. These blades were collected under a California Department Fish and Wildlife (CDFW) Scientific Collection Permit and scanned to analyze the severity of eelgrass wasting disease. Scans from 2024 and 2025 are being manually annotated to train a computer vision model. Scans from 2026 will be used to test the accuracy of the model.

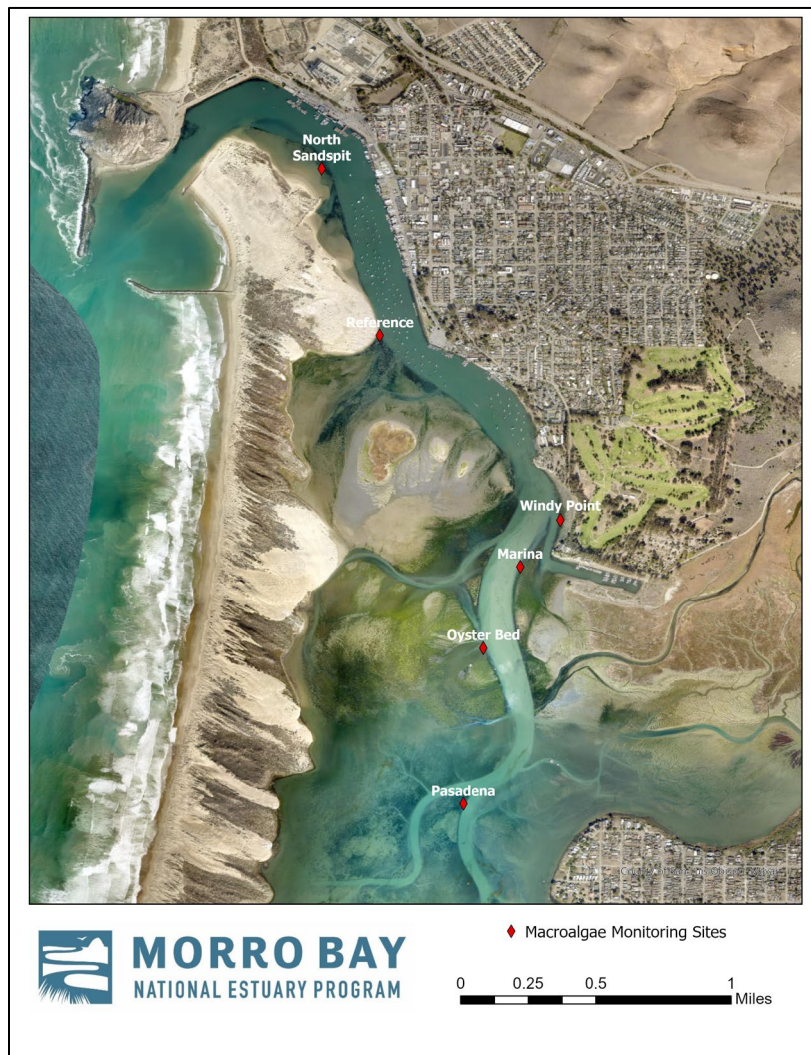
**Figure 18.** Macroalgae monitoring site locations.

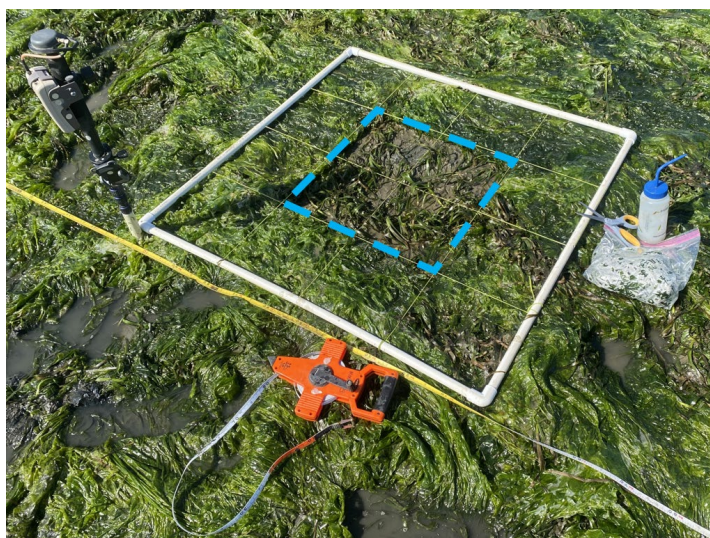
**Figure 20.** Algae biomass samples are collected from the four center squares of a one-meter by one-meter quadrat, as indicated by the blue dashed line in the photo above. The *Ulva* mat has been cut away and collected for dry weight processing, revealing shoots of eelgrass hidden underneath the algal mat.

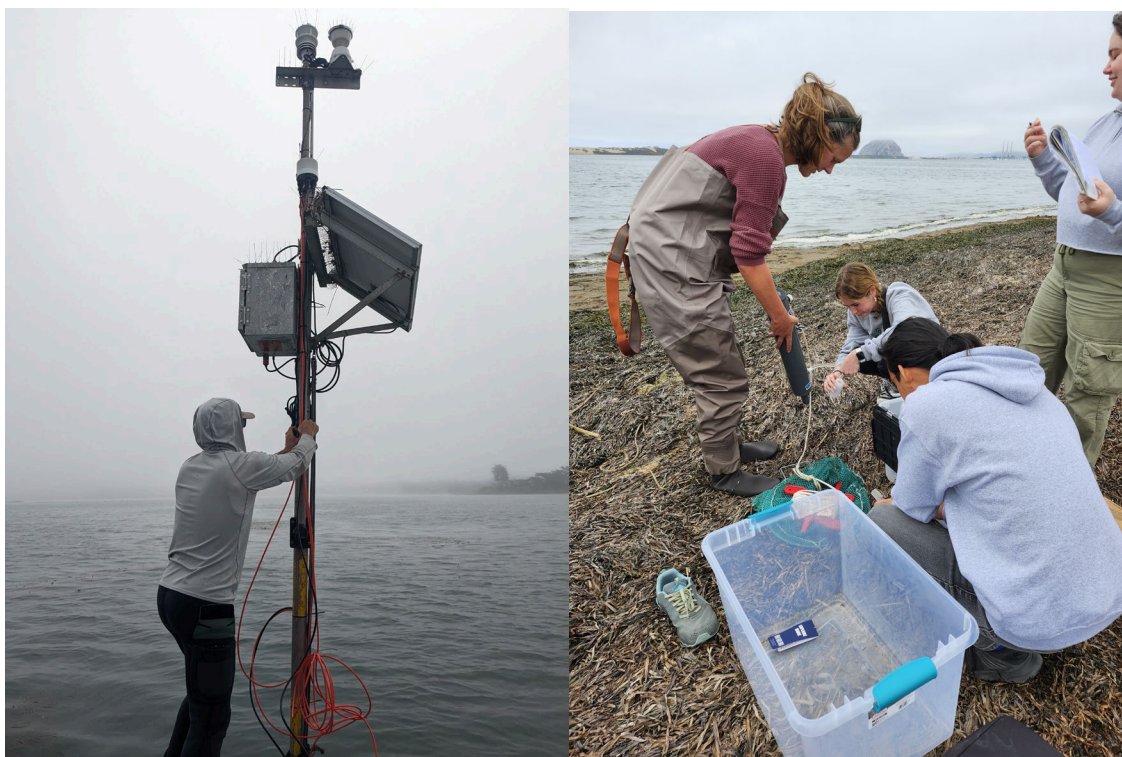
**Figure 24.** Senior research scientist Ian Robbins checks on the instruments at the back bay sensor station (left). The top of the station houses meteorological instruments for measuring weather parameters and a solar panel to power all the sensors. Dr. Bockmon and her students collect water from Pasadena Park using a Niskin sampler (right). Photos courtesy of Ian Robbins and Dr. Emily Bockmon.

Dr. Ryan Walter from Cal Poly's Physics Department continues to maintain water quality instrument packages at the front bay and the back bay, as well as a weather station in the back bay. Funding for these stations are provided by the Central and Northern California Ocean Observing System (CeNCOOS) and the Estuary Program. A real-time data stream is available here: <https://www.cencoos.org/observations/sensor-platforms/shore-stations/>. Additionally, Dr. Walter maintains temperature sensors at the mouth of the bay and back of the bay.

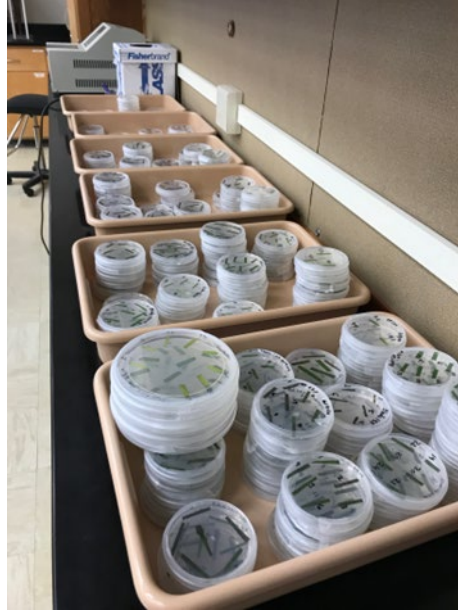
**Figure 25.** Eelgrass blade segments are placed in petri dishes and incubated at room temperature to promote the growth of *Labyrinthula* spp. for whole-genome sequencing. Photo courtesy of Dr. Silvio Favoreto.
